Proposal of Methodology for Evaluation of a Vertical Shanty Building in Beira, Mozambique

Keywords: colonial heritage; inspection of buildings; rehabilitation of buildings; pathologies; methodology

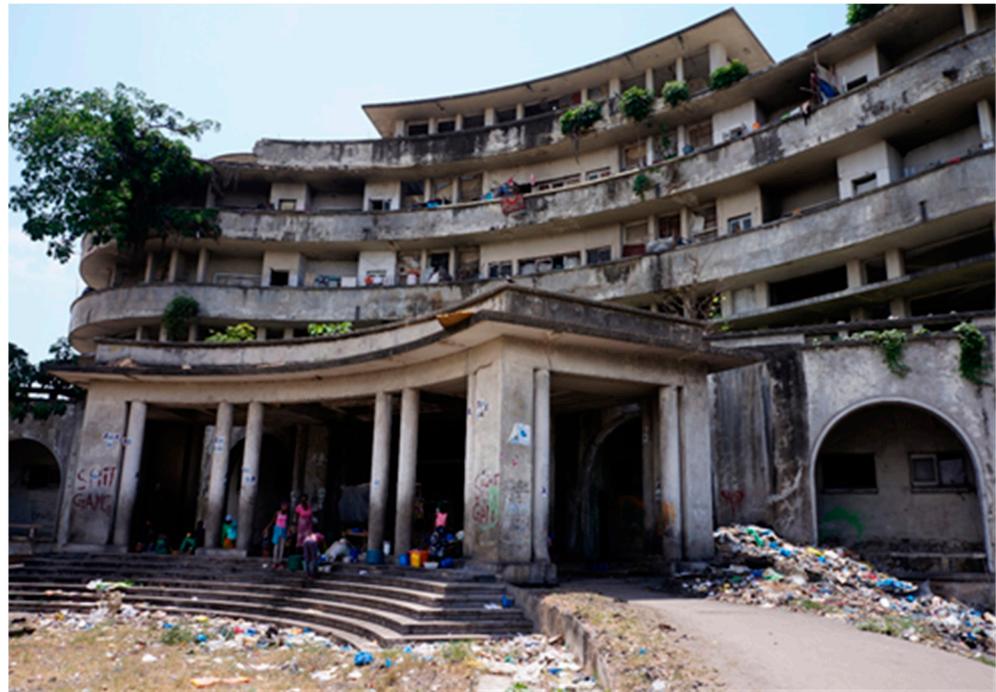
Figure 2. “Grande Hotel” of Beira, current state (December 2019).

There is no maintenance of the construction or public spaces. Garbage is dumped everywhere and is never cleaned. Damaged roofs and frames have no glass. Elevator-free wells are now openly accessible holes that are dangerous after dark for young and old. The garden gives space to Mozambique's first Olympic swimming pool. It contains highly polluted water and is used for fishing, consumption, washing, and public washbasin like so many other places. According to the local Red Cross, there is a high risk of cholera, diarrhea, malaria, HIV, and others [10].

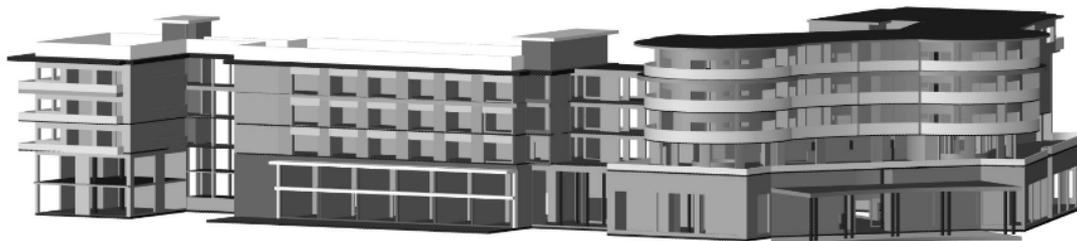
Figure 4. Survey and 3D modeling of the building.

A dimensional survey (Survey and 3D modeling of the building, Figure 4) and the project's (Figure 5) verification were carried out. The building presents the following characteristics: a height of 25 m, total floor surface 21,000 m², and site area 29,150 m². The structure consists of piles molded in situ, reinforced concrete pillars, angular beams, and reinforced concrete slabs. The elevator and the stairs are made of reinforced concrete. The masonry is made of ceramic brick. The roofs are flat with infiltration slabs.

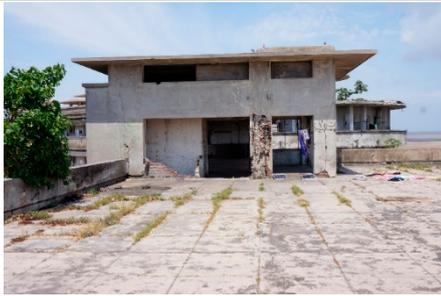
Table 1. Visual inspection of the “Grande Hotel”, Beira, Mozambique.

Type of damages: The types of damages that manifest themselves are of mechanical and chemical origin. Regarding mechanical damages, we can observe cracks and, for chemical damages, vegetation growth. These damages are classified as secondary damages.

Causes: For the damages described above, the causes are direct biological (interaction between materials and biological agents that causes vegetation growth), and direct causes, previous damages (obstruction of coverage).

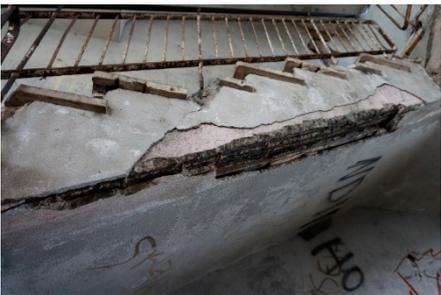
Types of damages: The types of damages that manifest themselves are of mechanical and chemical origin. We can observe the mechanical damage in the figure detachment of concrete and cracks and chemical injuries corrosion of the reinforcement. The damages described are classified as secondary.

Causes: For the damages described above, the causes are mechanical direct, mechanical stresses at the origin of the cracks, and concrete detachment. On the other hand, direct physical causes, exposure to the environment also work.

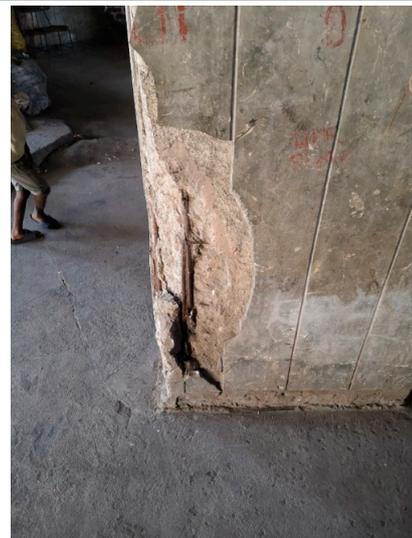
Types of damages: The types of damages that manifest themselves are of mechanical and chemical origin. We can observe the mechanical damage in the figure detachment of concrete and cracks and chemical injuries corrosion of the reinforcement. The damages described are classified as secondary.

Causes: For the damages described above, the causes are direct mechanical, differentiated settlements in the foundations and mechanical stresses at the origin of the concrete cracks and detachment. On the other hand, direct physical causes, exposure to the environment also work.

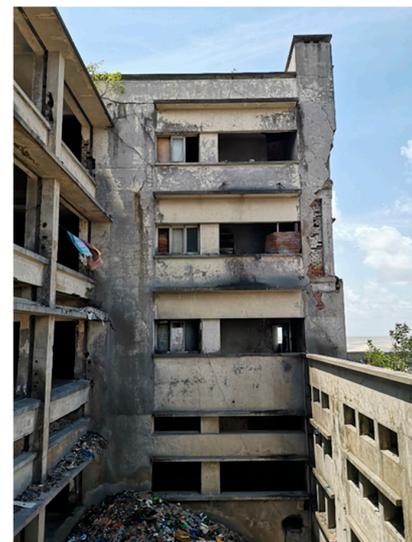
Type of damages: The damages observed in the figure are of chemical, physical, and mechanical origin. For chemical damages, efflorescence's, and plant organisms, i.e., vegetation growth, for physical damages, black spots, greenish spots, and dirt, are observed. And related to mechanical damages, cracks and coating fall is observed. In terms of classification, damages of chemical, mechanical, and physical origin are classified as secondary; only dirt is classified as primary.

Causes: The causes of the damages in the figure on left are, directly, previous damages (moisture by lateral absorption of the waters of the obstructed drainage system that are in some way at the origin of the appearance of efflorescence's, black spots, greenish and dirt, direct mechanical causes (unforeseen mechanical stresses that are causing cracks in the wall region, direct physical causes (temperature variations and retraction of the mortar causing cracks in the facades), and direct biological causes (interaction between biological agents and the materials that propitiate vegetation growth). On the other hand, there are indirect causes of the execution project that may be allied to the appearance of pathologies and inappropriate materials and technologies for solutions.
