Effects of Degradation in Textolite Elements of Damaged Surge Arresters

Keywords: surge arrester; TSE glass textolite; discharge (short circuit) current; EDS method

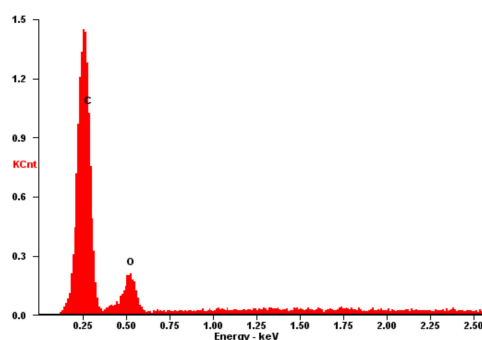
Figure 3 shows the results of the EDS test on the reference surface of the textolite material, with the determined elemental composition. Only epoxy resin, i.e., the binder of the laminate, was present in the top layer of the material. EDS measurements, which were carried out in four different areas, showed only a slight spread of the results. The laminate surface contained $66.0 \div 71.5\%$ of carbon (C) and $28.5 \div 31.0\%$ of oxygen (O) by weight, omitting the content of hydrogen (H), which could not be analysed using the EDS technique. The elements present in the textile support, namely, silicon (Si) and metals, were not registered because were covered with a top layer of the organic resin.

Figure 3. Typical EDS spectrum recorded for the surface of the reference sample textolite material. Only carbon and oxygen were present, which were derived from an organic epoxy resin. They represented 71.5% and 28.5% by weight, respectively.

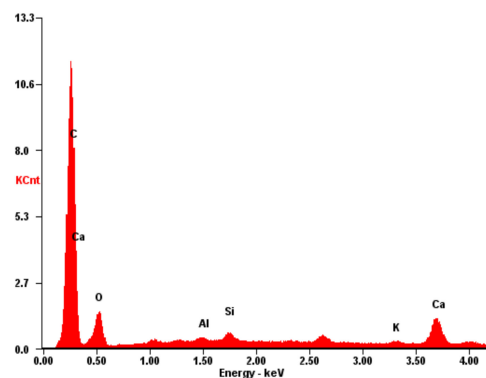
EDS measurements (at four different points) of the surface of the samples, showing a relatively slight degree of degradation, revealed some variation in the elemental composition of the surface. The carbon content practically did not change in relation to the reference sample and amounted to $67.0 \div 69.4\%$. The amount of oxygen slightly decreased to the level of $27.1 \div 28.3\%$. On the other hand, there were registered elements from the glass fibres of the textile support, which appeared on the surface of the material: calcium (Ca) at the level of $1.5 \div 2.4\%$, silicon (Si) at over 1.0% and aluminium (Al) in the order of tenths of a per cent (Figure 5 and Table 1).

Figure 5. Typical EDS spectrum registered for the textolite material with slightly marked degradation effects. There was already a low content of fibreglass support elements, namely, silicon (Si), calcium (Ca) and aluminium (Al), at the levels of 1.1%, 2.4% and 0.4%, respectively.

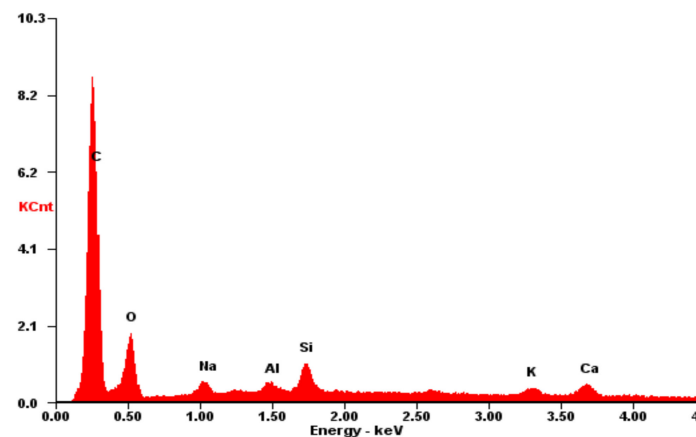
EDS analysis of the textolite material with clearly visible degradation effects (Figure 8) documented the increase in the share of the textile support in the elementary composition of the material surface. The carbon content decreased by a few per cent to the level of $64.0 \div 65.7\%$. The amount of oxygen also slightly decreased to $26.3 \div 27.1\%$. At the same time, the amount of silicon increased to approximately 2.5%, calcium to between 2.0 and 3.0%, and aluminium to above 1.0%. Other components of the glass also appeared in a small amount, namely, the alkali metals sodium (Na) and potassium (K).

Figure 8. The EDS spectrum recorded for the textolite material with evidently marked degradation effects. The contents of the elements present in fibreglass textile support (silicon, calcium, aluminium, potassium and sodium) are clearly visible.

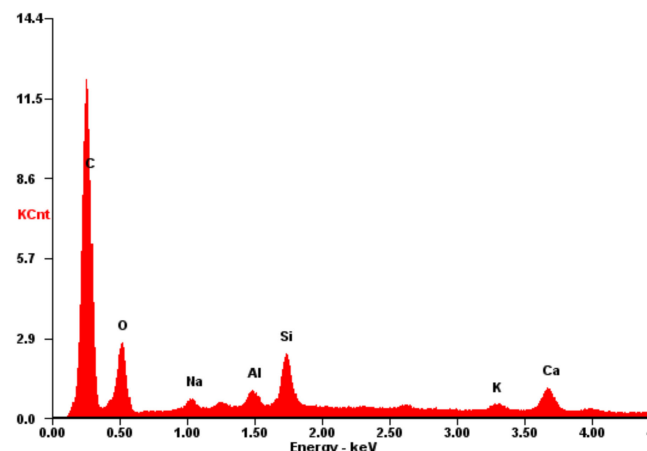
The results of the EDS tests in the areas with advanced degradation effects clearly showed a further, significant increase in the share of the textile support in the elemental composition of the material surface (Figure 11). Carbon content was between 60.7% and 62.7% and the oxygen contribution, in the range of 22.8% ÷ 25.0%, decreased by a few percentage points. This demonstrated a significant loss of organic epoxy resin in the top layer of the textolite material. At the same time, the amounts of the elements present in the glass fibres of the support increased: silicon to 3.9% ÷ 5.4%, calcium to 3.3% ÷ 4.2% and aluminium to a level between 1.0% and 2.0%.

Figure 11. A typical EDS spectrum registered for the textolite material with advanced degradation effects. On the surface, there is a significant share of the elements present in the fibreglass support, namely, silicon and metals.

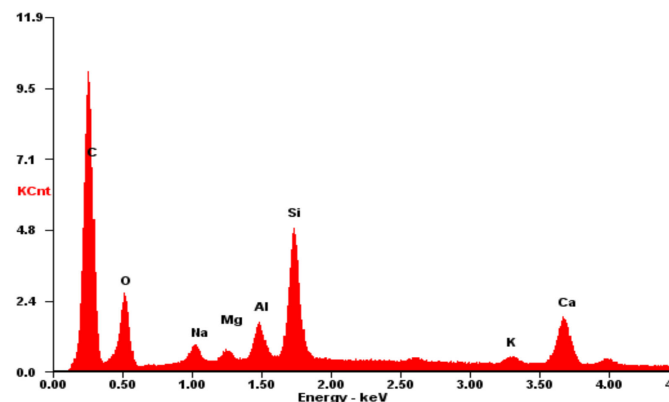
There were so many fibre bundles of the textile support on the surface of the material sample that the elements from glass constituted a significant component in the elementary composition of the top layer of the laminate. The EDS analysis of fragments of the textolite material in the areas with intensified degradation effects clearly showed a further, clear increase in the share of fibreglass support in the elemental composition of the laminate surface (Table 2 and Figure 14). Both the carbon content between 56.7% and 60.5% and the oxygen content in the range of 21.9% ÷ 23.6% were further slightly decreased. At the same time, the amount of silicon significantly increased to 6.7% ÷ 8.4%, calcium increased to 4.6% ÷ 8.0% and aluminium increased to a level between 2.0% and 3.0%. On the EDS spectrum (Figure 14), they were very visible. Thus, the weight fraction of elements derived from the glass was already a dozen or so per cent, not counting the oxygen part.

Figure 14. Exemplary EDS spectrum recorded for a textolite material with enhanced degradation effects. The contribution of the elements present in the fibreglass support, especially silicon, calcium and aluminium, was important. Oxygen was present in both the organic and the amorphous phases.

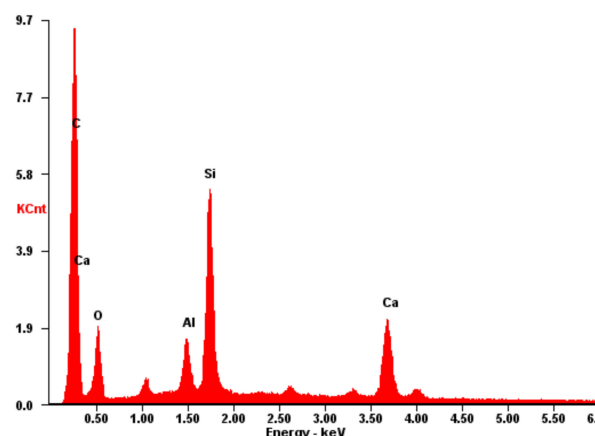
The examined areas of the textolite elements from damaged surge arresters, which showed strong degradation, were distinguished by a large variety. This was especially true of the amount of the carbonised epoxy resin layer remaining on the surface. As a consequence, the EDS tests carried out at various points of a heavily degraded surface showed a very large variation in the results. The content of carbon and oxygen decreased further in favour of the elements coming from the glass fibres. The total weight share of the elements of textile support in the elemental composition of the upper layer of the laminate increased to the level of about 20%, excluding the oxygen part. The carbon content was at most about 60%, compared with the starting amount of almost 70%. The initial oxygen content, around 30%, dropped by over one-third. The amount of silicon, calcium and aluminium continued to increase. The values obtained from the individual EDS measurements were so different that even broad ranges for individual elements were not presented. Figure 19 shows an exemplary spectrum recorded for a sample of the material with a significant amount of charred and cracked epoxy resin on the surface.

Figure 19. Exemplary EDS spectrum recorded for a textolite material with very strong degradation effects. The results for the sample with a significant amount of highly charred and cracked epoxy resin on the surface. There was a large share of elements present in the glass support, i.e., silicon and metals. Oxygen was present in both components of the laminate.

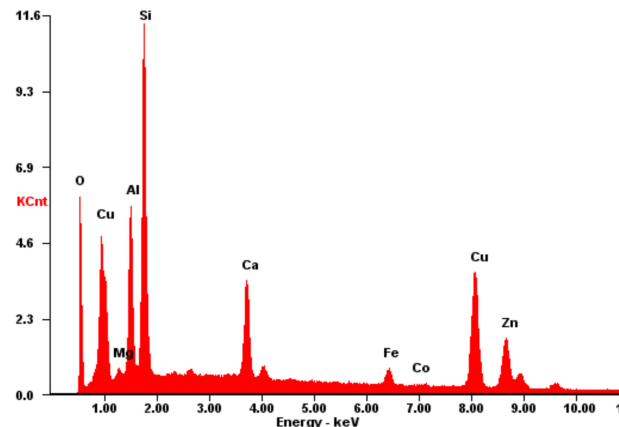
As in the case of heavily degraded surfaces, the EDS tests, which were carried out at different points in the occurrence of greenish sediment, gave results that differed significantly from one another. This was not surprising. The significant differences concerned the amount of the resin that was preserved on the surface, the exposed textile support fragments and the surface on which the sediment was located. At the same time, the sediment had different thicknesses and possibly also a non-uniform chemical composition. Figure 22 shows an exemplary EDS spectrum. It was obtained for an area where there was practically no epoxy resin, which melted and burned out, revealing the textile support.

Figure 22. Exemplary EDS spectrum registered for a fragment of a textolite material with sediment made of copper compounds and very strong degradation effects. Copper was present from the sediment layer, along with elements from the glass support.
