Article Failure Analysis of a Centrifugal Compressor Impeller Made of 17-4PH Steel in the Moist Hydrogen Sulfide Environment

Jakub Łagodziński *[®], Zbigniew Kozanecki and Eliza Tkacz

Institute of Turbomachinery, Lodz University of Technology, 90-924 Lodz, Poland; zbigniew.kozanecki@p.lodz.pl (Z.K.); eliza.tkacz@p.lodz.pl (E.T.)

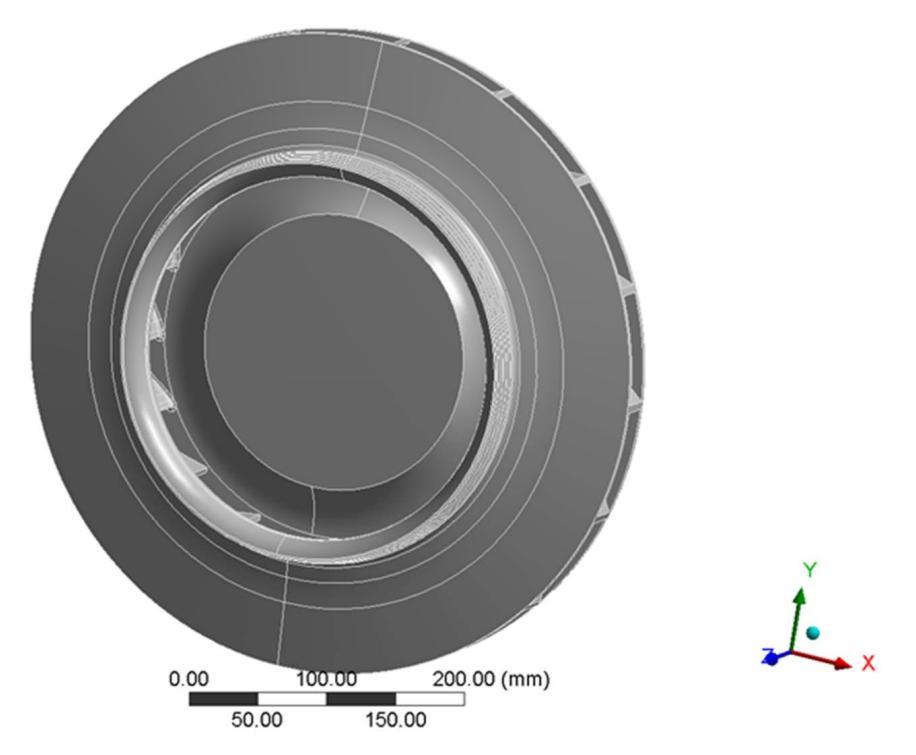
To confirm the given hypothesis and understand the mechanism of the failure, the stress levels and distribution need to be found. For complex geometries, the use of threedimensional Finite Element Method analysis is a common engineering practice. In order to model the geometry, a real spare impeller has been scanned using visible light band method. Thanks to 3D scanning, the object was transferred to the computer environment in a short time and with good accuracy. The obtained geometry is shown in Figure 4. One cannot forget that the impeller was mounted on the shaft with two keyways. However, the exact radius of keyways corners could not be found from the 3D scanning technique, so it was assumed to be 0.5 mm.

Figure 4. 3D model of the geometry of the impeller under analysis.

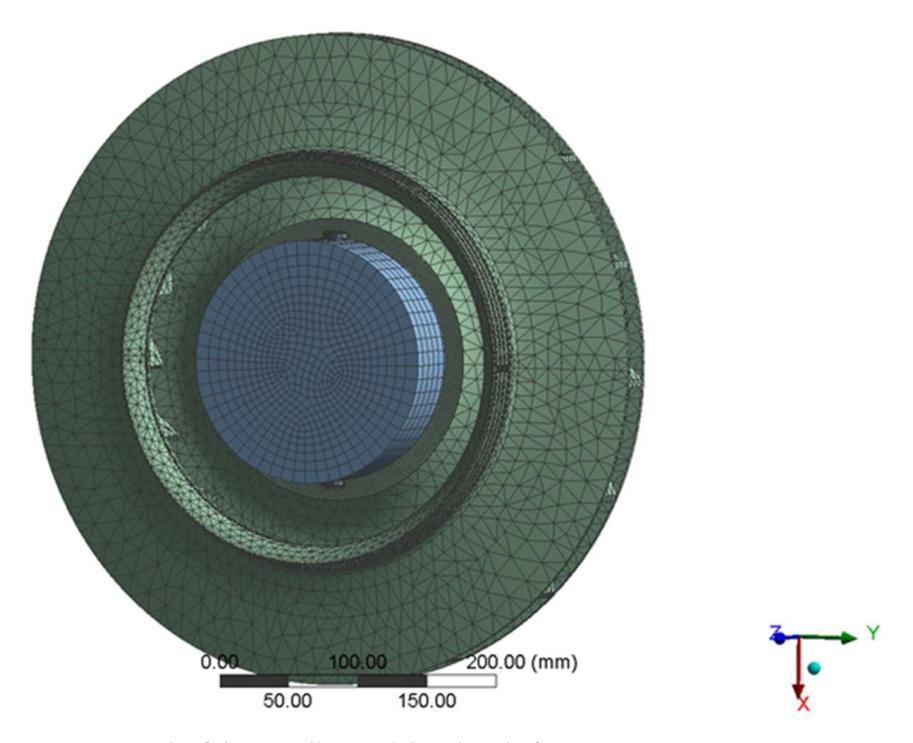
A mesh of the model is presented in Figure 5. It consisted of 185,403 nodes and 62,670 elements. The mesh was mainly an unstructured grid with high enough mesh density in chamfers and corners to reveal expected stress concentration.

Figure 5. Mesh of the impeller model with a shaft section.

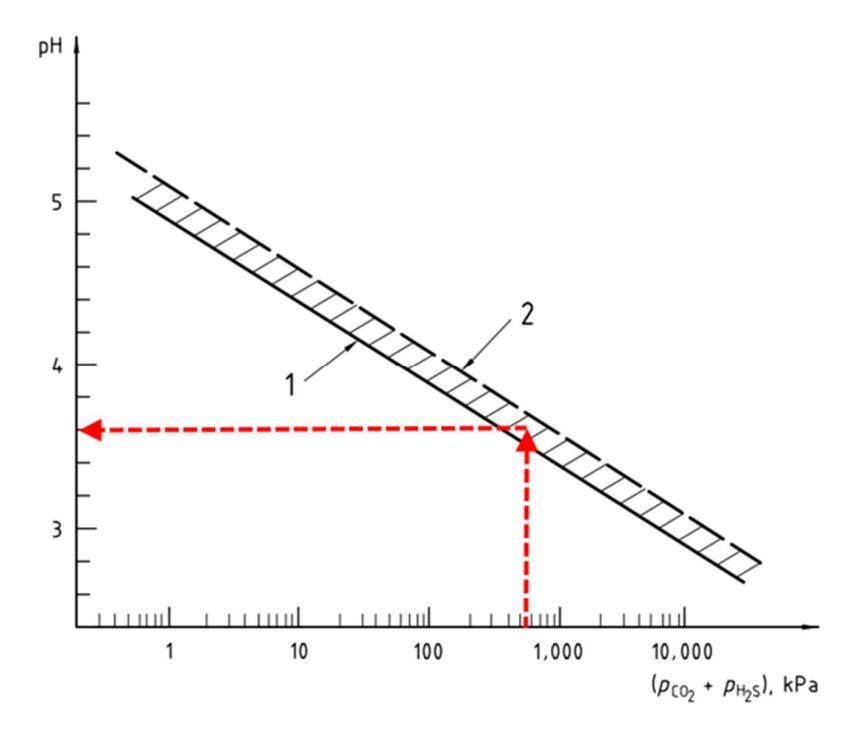
Thus, according to ISO 15156-1, chapter 7.2.1.2, both parameters (the fluid acidity and its pressure) need to be taken into account to evaluate a threat of failure due to the Sulfide Stress Cracking (SSC). This is achieved first by finding the pH level based on partial pressures of H₂S and carbon dioxide (CO₂) in the working medium. In our case, there was no CO₂ fraction in the medium under analysis, only hydrogen disulfide with a partial pressure of 545 kPa to be considered. For this pressure, the acidity of pH = 3.5 was read (Figure 10). Second, the compressor operation point can be found by transferring this information to Figure 11, where four regions are indicated based on partial pressures of H₂S and pH of the environment.

The compressor in the case under consideration was operating in Region 3.

Figure 10. Environment pH vs. partial pressure of H₂S and CO₂ [5].

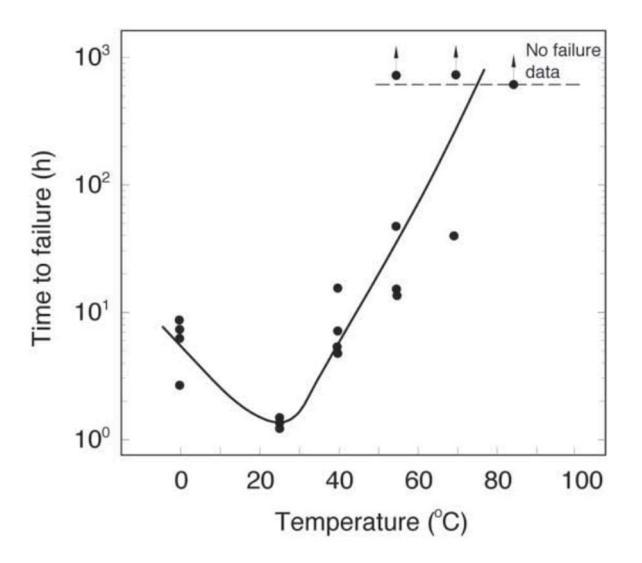
The steel resistance to Sulfide Stress Cracking is highly dependent on the temperature of the working medium. The chart presented in Figure 13 shows an influence of the environment temperature on the mean time to failure of a sample. The sample under testing was made of high-yield steel and subjected to an aggressive H₂S environment. A conclusion can be drawn from this chart that martensitic stainless steels have the lowest resistance to SSC at 25 °C. For higher temperatures, up to 80 °C, the mean time to failure increases, and above this temperature level, no failures were observed.

Figure 13. Time to sample failure vs. temperature [11].
