# Integrated Application of GPR and Ultrasonic Testing in the Diagnostics of a Historical Floor

**Abstract:** The paper presents the results of integrated ground penetrating radar (GPR) and ultrasonic testing (UT) measurements conducted on a historical floor in St. Nicholas' Church, Gdańsk, Poland. The described inspection was the first stage of the technical state assessment of the building. The aim of the study was the detection of underfloor air gaps, which were observed in a few trial pits. The condition of the ground under the floor was determined by localizing other inclusions such as rubble, human remains, brick walls and pipes. To identify the phenomenon of electromagnetic and ultrasonic wave propagation within the air gap, laboratory tests were conducted on physical models consisting of two concrete slabs stacked on top of each other and gradually moved apart to simulate a slot of varying thickness. The conducted research was supported by the numerical models of electromagnetic wave propagation. The obtained results showed that the integration of the GPR and UT methods provided an effective imaging of the floor and the area under it. Ultrasonic testing was proved to be a

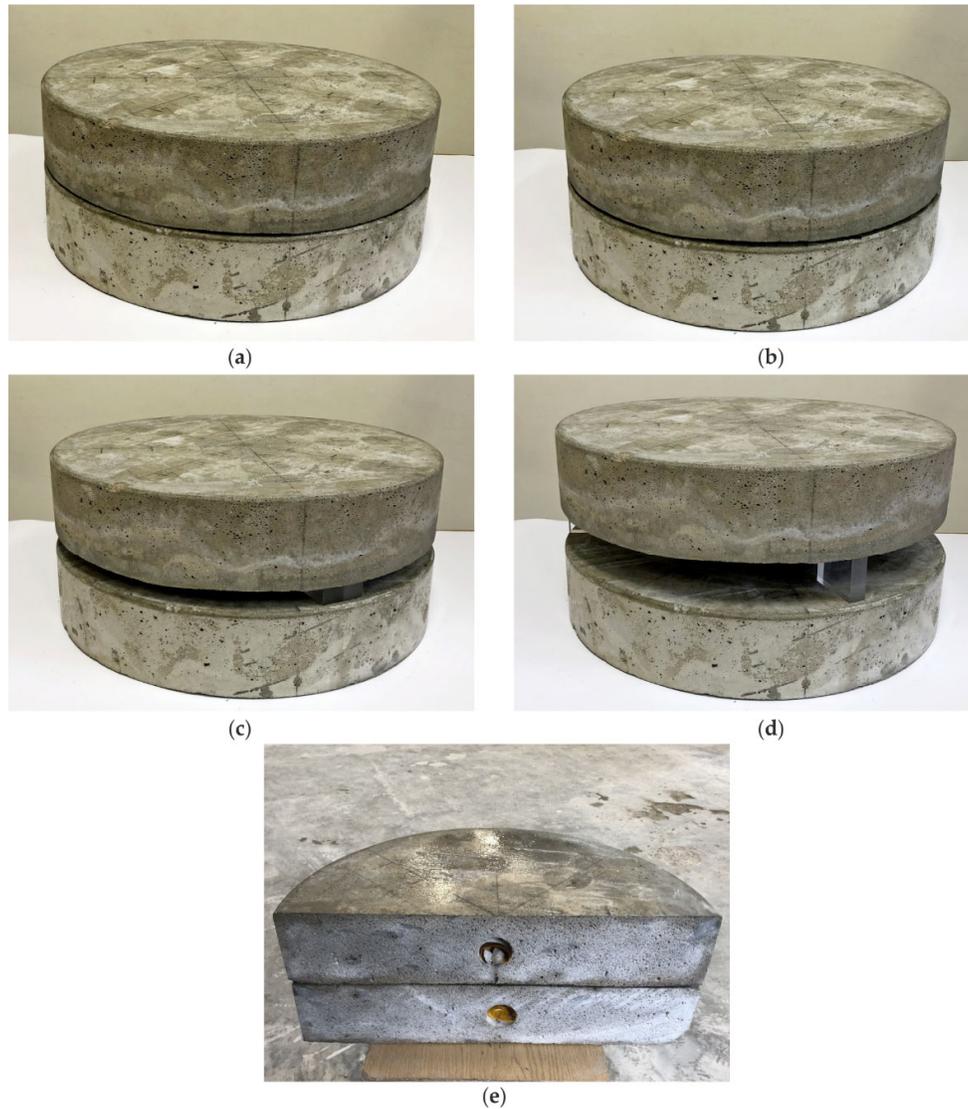
Additional investigations were conducted at the laboratory, on two circular concrete slabs. The slabs had a diameter of 49 cm and a thickness of 10 cm. One of the slabs had a table tennis ball with a diameter of 40 mm embedded in its center, at the half height of the slab. During the tests, the slabs were stacked on top of each other and gradually moved apart to simulate air gaps of varying thickness: 1, 4, 20 and 50 mm (see Figure 4).

**Figure 4.** Circular concrete slabs with air gaps of different thickness: (a) 1 mm; (b) 4 mm; (c) 20 mm; (d) 50 mm; and (e) upper plate after cutting.

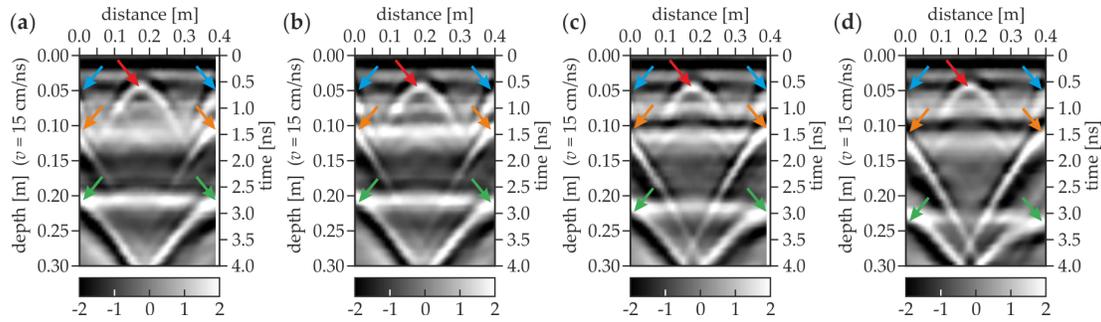
The results for the concrete slabs were first discussed as an initial step towards a more detailed analysis of the floor. Figure 11 shows the experimental GPR B-scans for the concrete slabs with different thicknesses of the air gap. The scan length was approximately 0.4 m. The depth axis was determined with the assumption that the electromagnetic wave velocity was equal to 15 cm/ns (based on the “depth to known reflector method” [45]). For the air gap thickness equal to 1 mm (Figure 11a), the half hyperbolas were clearly detected at the depth of 0.1 m (orange arrows) and 0.2 m (green arrows), representing the reflections from the bottom faces of the upper and the lower slabs, respectively. This observation indicated the proper assumption of the electromagnetic wave velocity in the analyzed elements. The bottom faces of both slabs were visible as the lines with an intensity different from the adjacent part of the B-scan. The position of the reflection from the upper slab did not change, whereas the lower slab appeared deeper when increasing the air gap thickness (compare Figure 11a–d). For the air gaps with the thicknesses of 4, 20 and 50 mm, the position of the bottom plate was detected at about 20.5, 22 and 24 cm depths, respectively. This change showed the increase in the distance between both slabs and indicated a high compatibility of the obtained numerical results with the real thicknesses of the gaps. The identified gaps thicknesses were slightly different from the actual ones because the depth axis in Figure 11 was calculated for the velocity of the electromagnetic wave in concrete (15 cm/ns). In addition, the line at the depth of 0.1 m transformed into two separate lines, which indicated the opening of the air gap. It should also be mentioned that the line representing the bottom face of the lower slab became less pronounced for the greater distances between the slabs. This remark allowed concluding that the larger the air gap was, the harder it was to detect elements below it. Moreover, other half hyperbolas (denoted by blue arrows) were present at the depth of about 0.05 m, indicating a technological break during the concreting of the upper slab (visible in all B-scans, see Figure 11a–d). The upper slab was prepared in two stages unlike the lower one, in which no additional perturbations could be seen. A full hyperbola was observed in the center of each B-scan at the depth of about 0.05 m (marked by the red arrow), revealing the presence of the table tennis ball, which was placed in the upper slab between both stages of concreting.

**Figure 11.** Experimental GPR B-scans for concrete slabs with air gap of thicknesses (a) 1 mm (trace D-1); (b) 4 mm (trace D-2); (c) 20 mm (trace D-3); and (d) 50 mm (trace D-4).

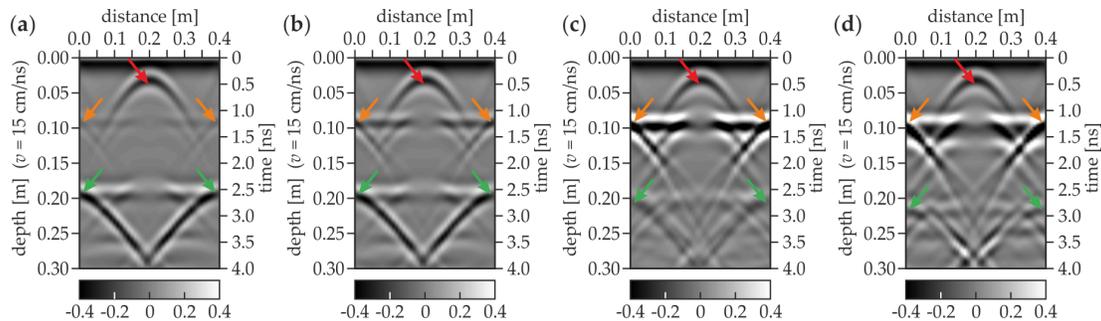
The numerical GPR B-scans corresponding with the above-described experimental results are presented in Figure 12. The half hyperbolas marked by the orange and green arrows clearly show the bottom faces of the upper and the lower slabs, respectively. The line denoting the bottom face of the lower slab became less noticeable and appeared deeper when increasing the distance between both slabs (cf. Figure 12a–d). For air gaps with thicknesses of 4, 20 and 50 mm, the position of the bottom plate is detected at about 19, 21 and 22 cm depths, respectively. The opening of the air gap was observed as the shift of the reflection from the bottom face of the lower slab occurred and also by the gradual separation of the single line into two lines. The hyperbola revealing the presence of the table tennis ball (red arrow) was clearly visible at the depth of 0.05 m. However, the technological break was not detectable (it was not modelled). The high agreement of the experimental and numerical results allowed concluding that the modelling of electromagnetic wave propagation was correct. The possibility of detecting air gaps and concentrated inclusions was confirmed.

**Figure 12.** Numerical GPR B-scans for concrete slabs with air gap of thicknesses (a) 1 mm (model #2.1); (b) 4 mm (model #2.2); (c) 20 mm (model #2.3); and (d) 50 mm (model #2.4).

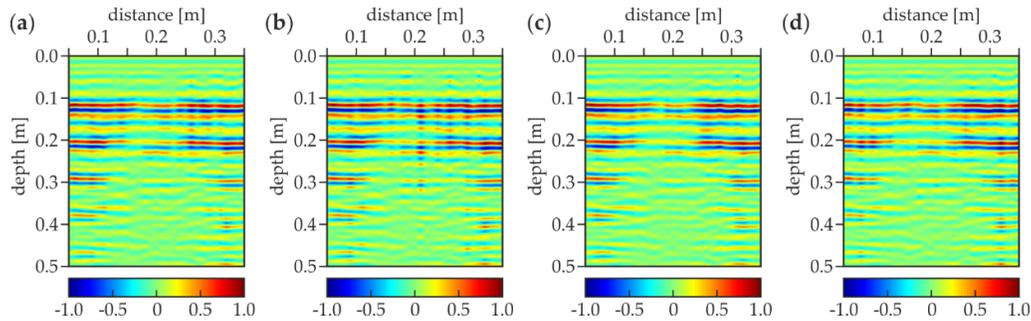
The UT B-scans for the analyzed slabs are presented in Figure 13. The ultrasonic pressure wave velocity determined before the main tests was equal to 2055 m/s. The scan length was reduced to 0.3 m due to the dimensions of the used UT antenna. There were no noticeable differences between all scans (Figure 13a–d), thus it could be concluded that the thickness of the air gap did not affect the results obtained. The lines at the depth of about 0.1 m representing the reflections from the bottom face of the upper slab were seen in all B-scans. Moreover, these lines were repeated regularly along the depth axis with the step of about 0.1 m (the slab thickness). Ultrasonic waves did not penetrate into the lower slab, they were fully reflected from the bottom face of the upper slab. The deeper lines were only the multiple reflections from the faces of the upper slab. The intensity of these lines decreased with the depth because of the damping of the ultrasonic waves. It is worth noting that the deeper lines appeared only near the edges of the slab. The presence of the boundaries strengthened the reflections, thus the signals were damped slower at the sides compared with the center of the slab. An important observation is that the table tennis ball was not observed at all. The reason might be the limitation of the used UT antenna. The Pundit PL-200PE instruction states that inclusions with

a diameter of at least 30 mm should be detected, however, this condition deals with cylindrical elements. Being a relatively small spherical (concentrated) inclusion, the ball was not possible to be detected, despite the fact that its diameter was greater than minimum. To sum up, the air voids could be successfully detected using the UT technique, but without estimating the thickness. On the other hand, the content of the element below the air gap could not be imaged because the ultrasonic waves were entirely reflected from the air gap. Additionally, small concentrated inclusions could not be detected.

**Figure 13.** Ultrasonic B-scans for concrete slabs with air gap of thicknesses (a) 1 mm (trace D-1); (b) 4 mm (trace D-2); (c) 20 mm (trace D-3); and (d) 50 mm (trace D-4).

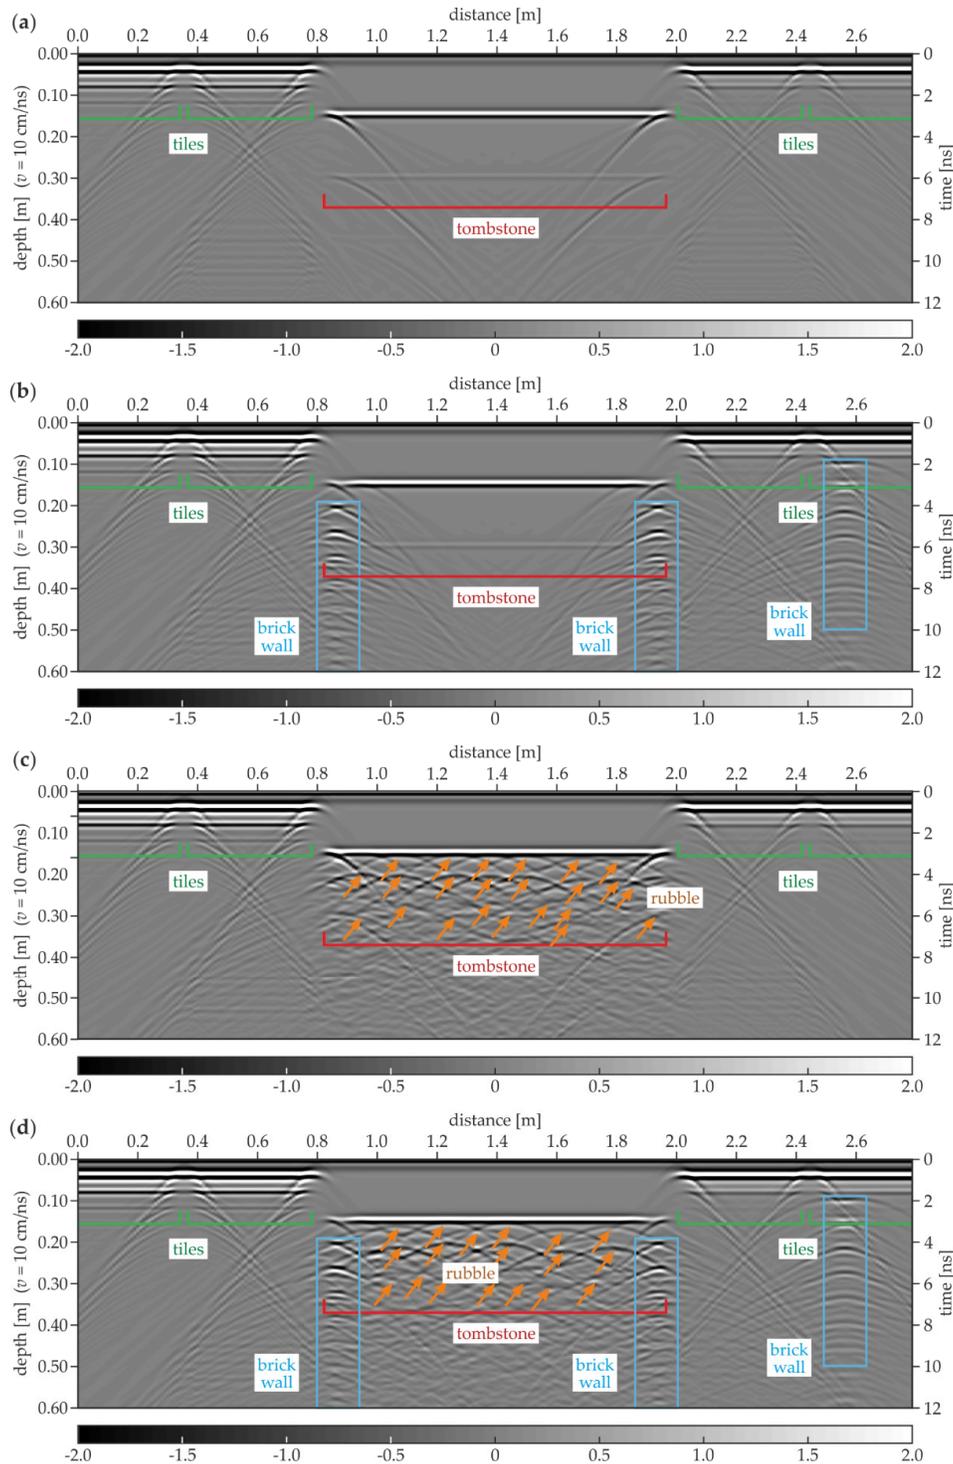
Figure 14 shows the GPR B-scans acquired in the numerical models of the considered floor. Taking into account the complexity of the analyzed medium, the electromagnetic wave velocity was set as constant and equal to 10 cm/ns. The strategy applied did not take into account the heterogeneity factor. Therefore, the results were only approximations of the real subsurface geometry. However, this fact did not disable the proper interpretation of the results. In the model #1.1 (Figure 14a), the positions of the stone tiles were clearly identified based on the line patterns denoting the reflections from the vertical joints between tiles. The half hyperbolas at the ends of the tombstone were visible in the center of the scan. The lower faces of the tiles and the tombstone were located at the depths of 0.04 and 0.15 m, respectively. Some additional reflections with a lower intensity were observed below, indicating the further wave reflections from the analyzed elements (e.g., at the depth of 0.08 m below the tiles and 0.3 m below the tombstone). The difference between the tiles laid with and without the air gap was small, i.e., additional reflections below the tiles located above the air gap were insignificantly stronger. This observation might lead to the hypothesis that the detection of the small air gaps based on the GPR scanning could be problematic. For the model #1.2 (Figure 14b), the conclusions from the identification of the tombstone and the tiles were the same as for model #1.1. However, additional hyperbola patterns appeared, being the reflections from all singular bricks of the walls located below the edges of the tombstone. It is worth noting that the intensity of the hyperbolas decreased with the depth, which is a common relation observed for electromagnetic waves. Similarly, another brick wall was visible at the distance of 2.55 m. It is interesting to note that the walls seemed to be located at different depths. This apparent observation was the result of the assumption that the electromagnetic wave velocity was constant. The wave needed more time to travel through the tombstone (to reach the edge walls) compared with the stone tiles and the sand (above the additional wall). In the model #1.3 (Figure 14c), the additional hyperbolas were observed below the tombstone, proving the presence of the rubble. The great amount of the inclusions made the interpretation of the scan more complicated. It is also worth noting that the deeper hyperbolas had a much lower intensity, thus the identification of inclusions located deeper was straitened. The interpretation of the reflections below the tombstone was far more difficult when considering the simultaneous presence of the rubble and the brick walls (model #1.4, Figure 14d). The superimposition of the hyperbolas denoting the rubble and the singular bricks made them undistinguishable. Therefore, it was not possible to state whether a certain hyperbola denoted the

brick or any different kind of inclusion. To sum up, the results obtained from the numerical calculations gave some information about the possibilities and limitations of GPR scanning. The location of the tombstone and the tiles could be determined. The rubble below the tombstone was detectable as well as the brick walls; however, when these elements appeared together, the interpretation was complicated. What is essential is that the air gaps were difficult for the identification.

**Figure 14.** Numerical GPR B-scans for the floor: (a) model #1.1; (b) model #1.2; (c) model #1.3; (d) model #1.4.
