Risk Analysis for Earthquake-Damaged Buildings Using Point Cloud and BIM Data: A Case Study of the Daeseong Apartment Complex in Pohang, South Korea

Citation: Park, E.S.; Seo, H.C. Risk Analysis for Earthquake-Damaged Buildings Using Point Cloud and BIM Data: A Case Study of the Daeseong Apartment Complex in Pohang, South Korea. *Sustainability* **2021**, *13*, 456. <https://doi.org/10.3390/su13020456>

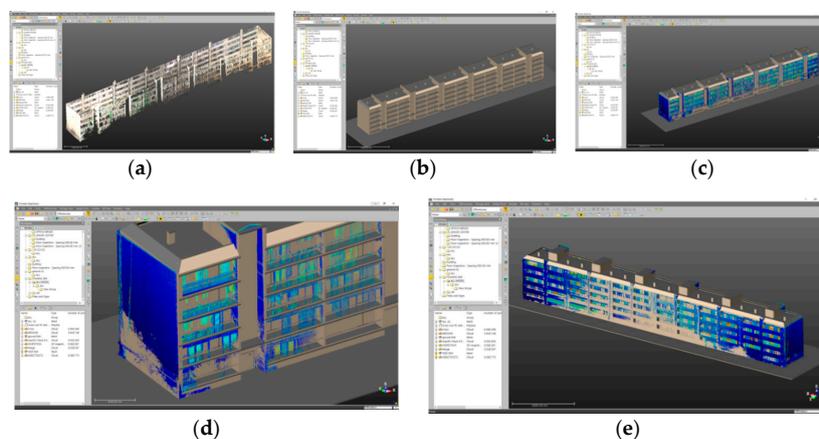
The blue color shown in Figure 6 is the point cloud obtained by scanning the building E of the Daeseong Apartment Complex, therefore representing the actual damage after the earthquake. The gray color reflects the undamaged status through a BIM model based on the 2D drawings. Figure 6d,e shows the result of combining the two kinds of data, and the colored part shows a mismatch.

Figure 6. Combination of the point cloud and Building Information Modeling (BIM) data for existing drawings of Building E. (a) Point cloud data for Building E; (b) BIM data for Building E; (c) Data combination; (d) Point cloud data combined with BIM data; (e) Point cloud data combined with BIM data.

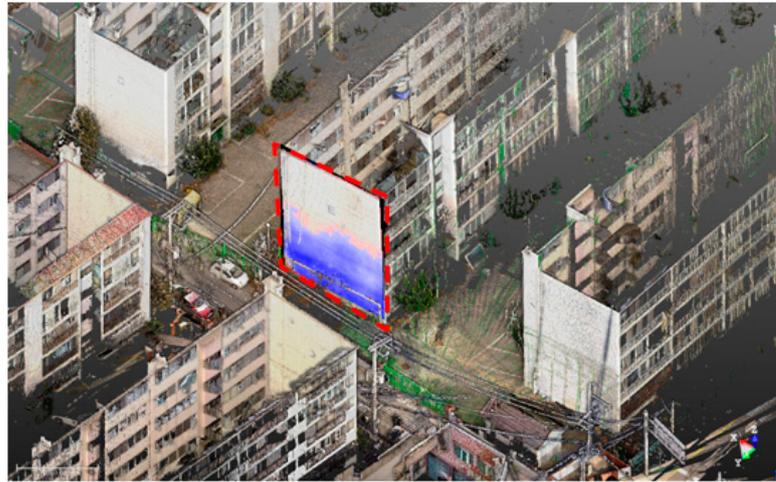
Figure 8. Spatial information analysis of Building E's outer west wall.

A risk analysis was conducted by analyzing the smoothness of the building's east and west walls using the combined point cloud and BIM data as shown in Figure 8. For the analysis of the smoothness of the walls, the flatness of the walls was analyzed by combining the 3D measurement point information gathered from the point cloud data for Building E's side walls, as measured using 3D scanners with BIM information based on the existing design information. In addition, the information was used to analyze the overall deflection of the building's outer walls, as well as the deformation and displacement of the vertical and transverse cross-sections as visual data.

Figure 9 shows the smoothness analysis results for Building E's east and west sides. Significant differences in displacement between the upper and lower parts of the building E's west side were observed. The difference was found to be a maximum of 35 mm (from 0

to 35 mm) in the lower part and 84 mm (from 40 to 84 mm) in the upper part, indicating that the deformation of the building occurred as a result of the lateral force exerted by the earthquake on the vulnerable side.

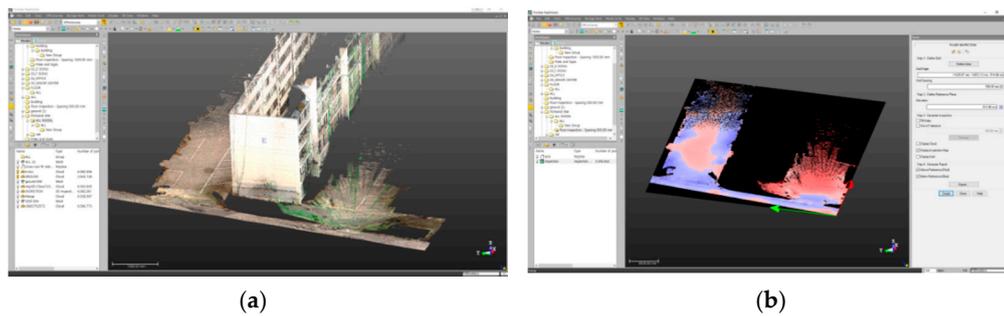
The ground smoothness at the front and back of Building E was analyzed to determine the risk associated with the terrain surrounding the Daeseong Apartment Complex based on the point cloud data as shown in Figure 12.

Figure 12. Analysis of the front and back of Building E. (a) Roads around Building E; (b) Analysis of the roads around Building E.
