Acoustic Tomography as a Supporting Tool in the Sustainable Management of Historic Greenery: Example of the Church Garden in Horostyta (Poland)

Abstract: Senile trees in historic church gardens have natural, aesthetic, historical, and cultural value. Cutting them down too hastily annihilates the achievements of entire generations. We should try to preserve the greenery surrounding historic churches and integrate it into a clear compositional arrangement with the sacral architecture. The primary purpose of the paper was to describe the process of inventorying 200-year-old trees and to present the revalorization project for the garden around the historic Orthodox church in Horostyta, located in the Lublin Voivodeship, in southeastern Poland. The church complex consists of a wooden 18th-century building, bell tower, garden, and cemetery. Within the church garden's boundaries, there are 15 trees, with two predominant species: *Acer pseudoplatanus* L. and *Tilia cordata* Mill. These trees are of varying ages and health conditions. We used acoustic tomography to perform tree health diagnostics. Three trees, for which the initial visual assessment was disturbing, were examined thanks to

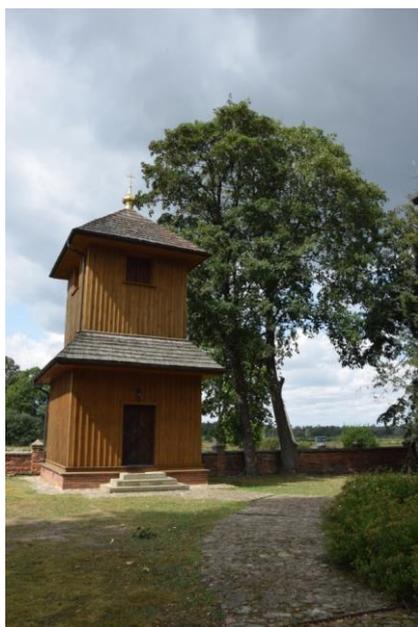
Figure 9. Wooden belfry next to two sycamore maples (by M. Dudkiewicz).

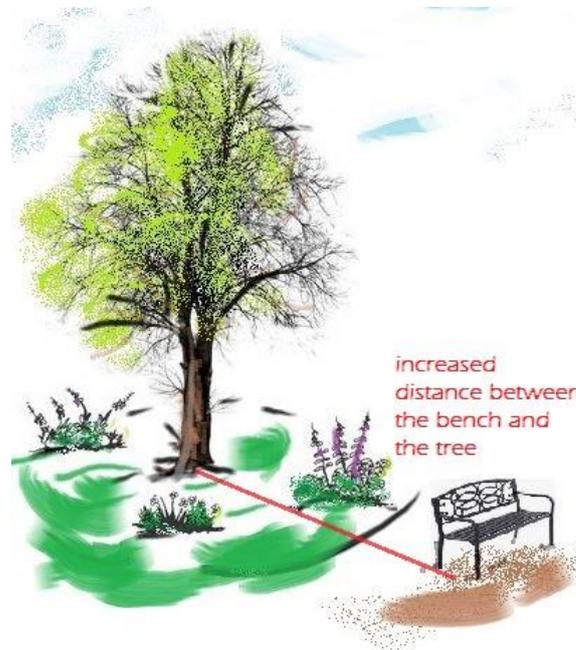
Figure 21. Senile tree in a historic garden—planted perennials can move traffic and benches are located beyond the projection of the tree crown (by M. Dudkiewicz).

Risk Prevention	Minimizing and Correcting Threats
<ol style="list-style-type: none"> 1. Rational design of space around ancient trees. Shaping safe compositions (separating trees with shrubs and flowerbeds from sidewalks and benches) (Figure 21). 2. Proper care performed following the principles of arboriculture by a team qualified in the care of veteran trees. 3. Monitoring and objective assessment of trees in terms of safety hazards, allowing for making decisions about dealing with the tree. 4. Education of garden owners and users. 	<ol style="list-style-type: none"> 1. Making decisions adequate to the level of risk using minimal to advanced diagnostic methods, e.g., sonic tomography. 2. Closing the tree in the tree protection zone (crown range plus 1 m) from public traffic. 3. Fencing off the projection of the tree crown with string or tape. Placement of warning signs, e.g., bands on the trunk and signs on the lawn (Figures 22–24). 4. Cuts correcting the crown and improving the tree’s statistics, using mechanical reinforcements. 5. Improvement of passage conditions, removal of the concrete surface around trees, replacement with air spades, mycorrhiza. 6. If the tree is next to a fence, adaptations of the foundations and fence (Figures 25 and 26).

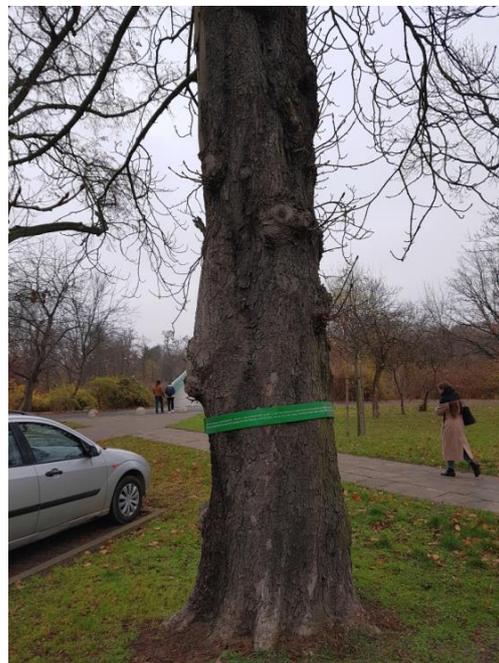
Figure 22. Rubber band on the trunk with dendrometric data of the ancient tree and a request to be careful when parking under the tree crown, especially during a storm. Center for Contemporary Art Ujazdowski Castle in Warsaw (photo M. Dudkiewicz, 2022).

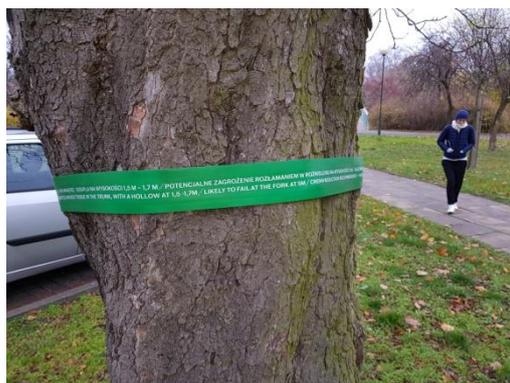
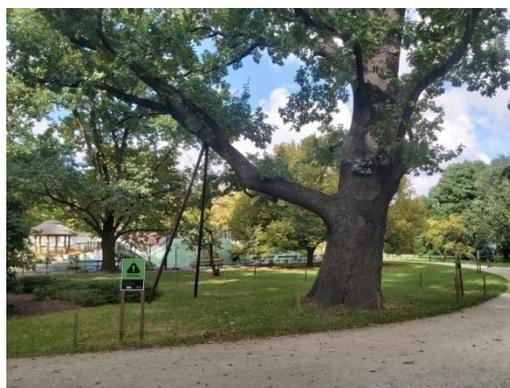
Figure 23. (a) Rubber band on the trunk with dendrometric data of the ancient tree. Center for Contemporary Art Ujazdowski Castle in Warsaw (photo M. Dudkiewicz, 2022). (b) Fencing off an ancient oak with a rope and placing signs warning about falling branches. Ujazdowski Park in Warsaw (photo M. Dudkiewicz, 2022).

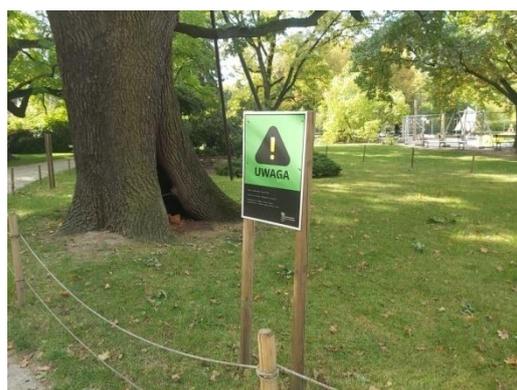
Figure 24. A sign with the inscription: Area of an old stand. Danger of falling branches. Staying near old trees is associated with the risk of loss of life and health (photo M. Dudkiewicz, 2022).

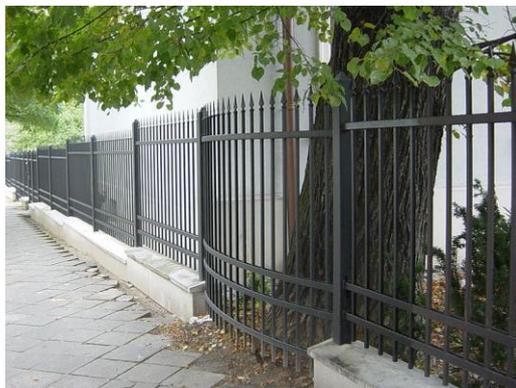
Figure 25. Planned lack of foundations to protect an ancient linden tree (photo M. Dudkiewicz, 2018).

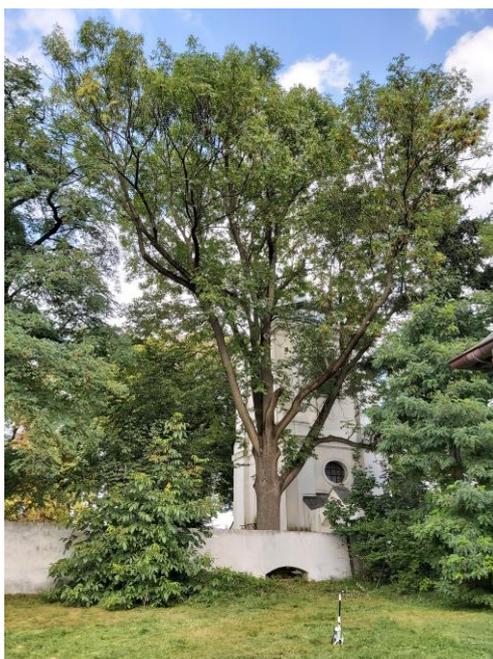
Figure 26. Planned cut-out in the wall to leave room for the development of ancient ash roots at St. Paul in Sandomierz (photo M. Dudkiewicz, 2020).
