# Primary and Secondary Environmental Effects Triggered by the 30 October 2020, Mw = 7.0, Samos (Eastern Aegean Sea, Greece) Earthquake Based on Post-Event Field Surveys and InSAR Analysis

**Abstract:** On 30 October 2020, an Mw = 7.0 earthquake struck the eastern Aegean Sea. It triggered earthquake environmental effects (EEEs) on Samos Island detected by field surveys, relevant questionnaires, and Interferometric Synthetic Aperture Radar (InSAR) analysis. The primary EEEs detected in the field comprise coseismic uplift imprinted on rocky coasts and port facilities around Samos and coseismic surface ruptures in northern Samos. The secondary EEEs were mainly observed in northern Samos and include slope failures, liquefaction, hydrological anomalies, and ground cracks. With the contribution of the InSAR, subsidence was detected and slope movements were also identified in inaccessible areas. Moreover, the type of the surface deformation detected by InSAR is qualitatively identical to field observations. As regards the EEE distribution, effects were generated in all fault blocks. By applying the Environmental Seismic Intensity (ESI-07) scale, the maximum intensities were observed in n

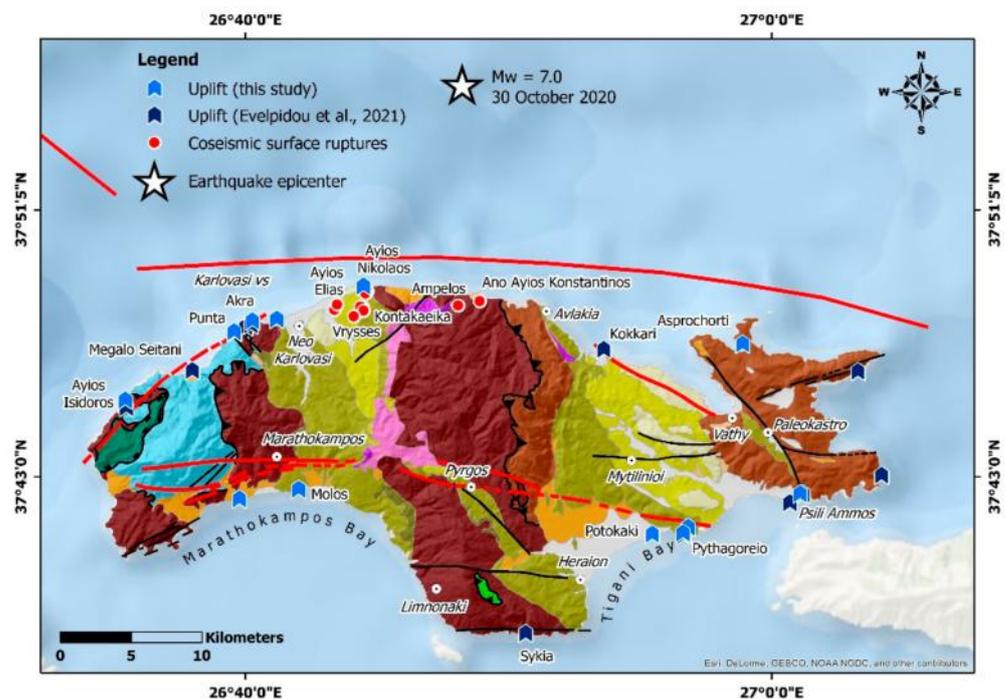
The 30 October 2020,  $M_w = 7.0$ , Samos earthquake induced several primary environmental effects. Permanent coseismic surface deformation, more specifically uplift, was observed in coastal spots of northwestern, northeastern, southeastern, south, and southwestern Samos (Figure 7). Moreover, coseismic surface ruptures were observed in the northern part of Samos (Figure 7).

**Figure 7.** Neotectonic map illustrating the sites of the detected primary environmental effects in Samos island triggered by the 30 October 2020,  $M_w = 7.0$ , earthquake. Details for the geological formations and faults in Figure 2.

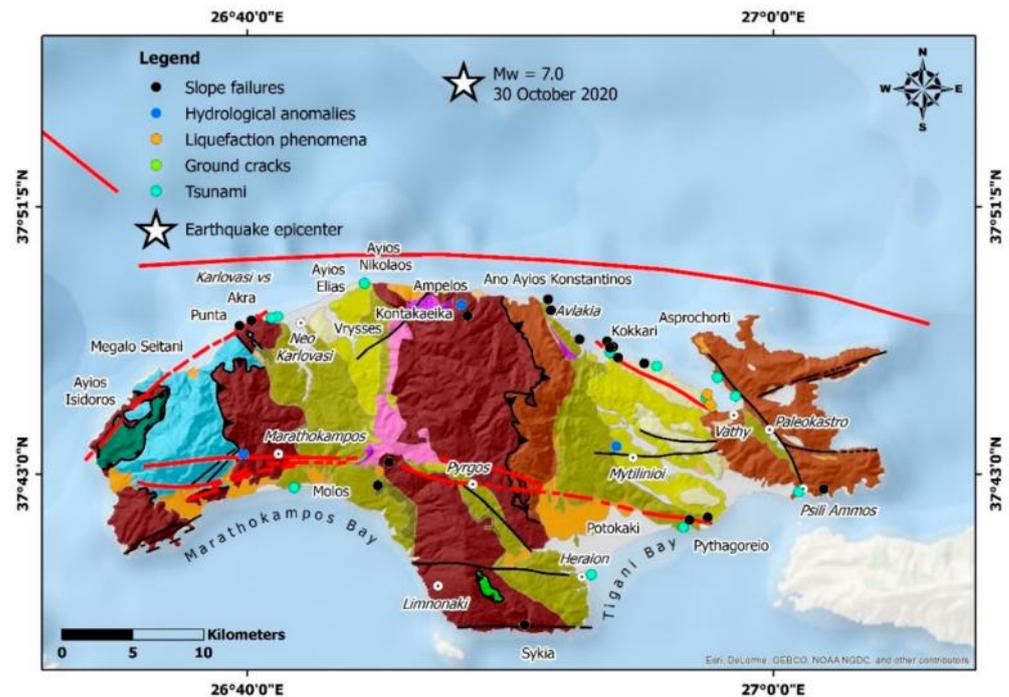
The 30 October 2020,  $M_w = 7.0$ , Samos earthquake induced secondary environmental effects. These effects included slope failures, liquefaction phenomena, hydrological anomalies, and ground cracks at several sites of the earthquake-affected Samos Island (Figure 18).

**Figure 18.** Neotectonic map illustrating the sites of the detected secondary environmental effects on Samos island triggered by the 30 October 2020,  $M_w = 7.0$ , earthquake. The sites affected by the tsunami are from [16]. Details for the geological formations and faults in the legend of Figure 5.

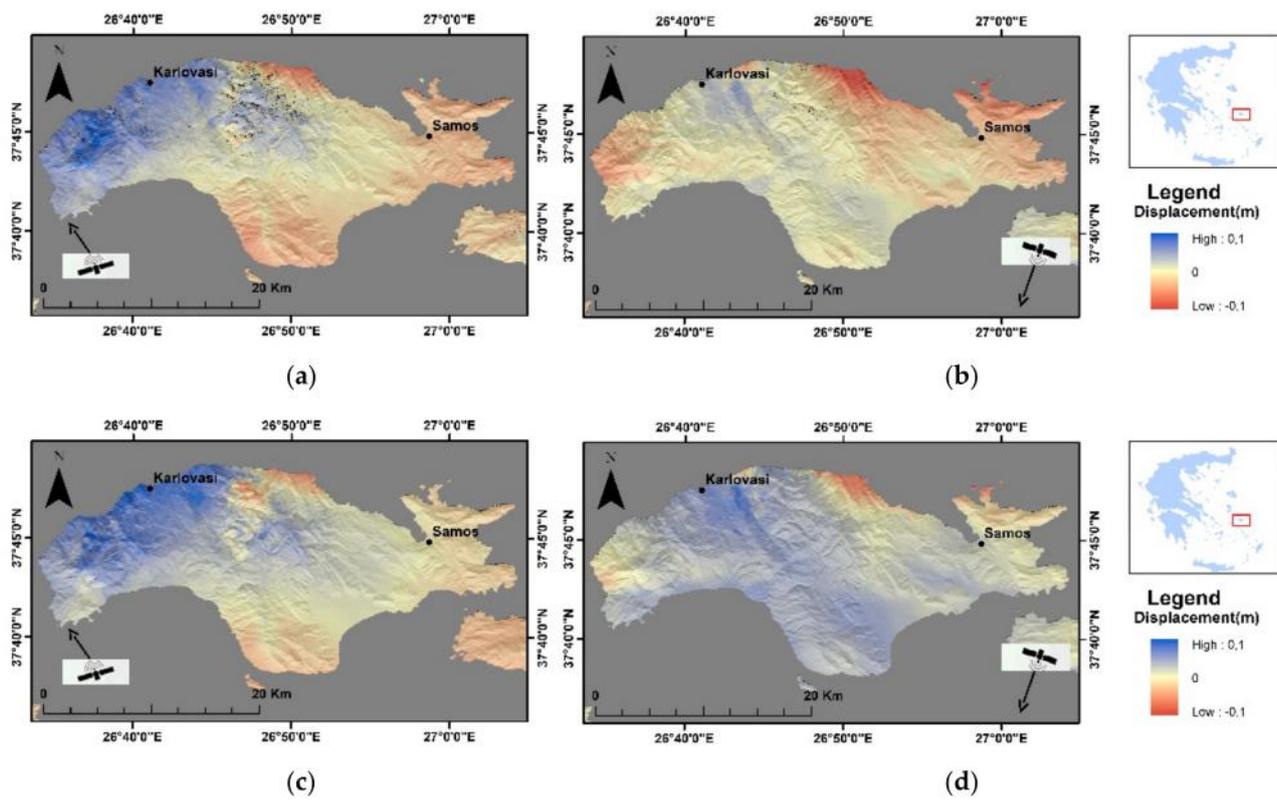
The displacement maps are similar qualitatively in terms of the direction of the displacement uplift in the central and the northwestern parts of the island and downlift along the coastal area (Figure 27). The displacement maps are very close quantitatively, showing an uplift of up to 13 cm along the line of sight (LOS) and a downlift of up to  $-12$  cm in the LOS for the ascending data and 9 cm and  $-14$  cm in the LOS, respectively, for the descending interferometric pair (Figure 27).

**Figure 27.** The line of sight (LOS) displacement maps in meters in ascending and descending geometry resulting from the SARscape (a,b) and SNAP (c,d) softwares.

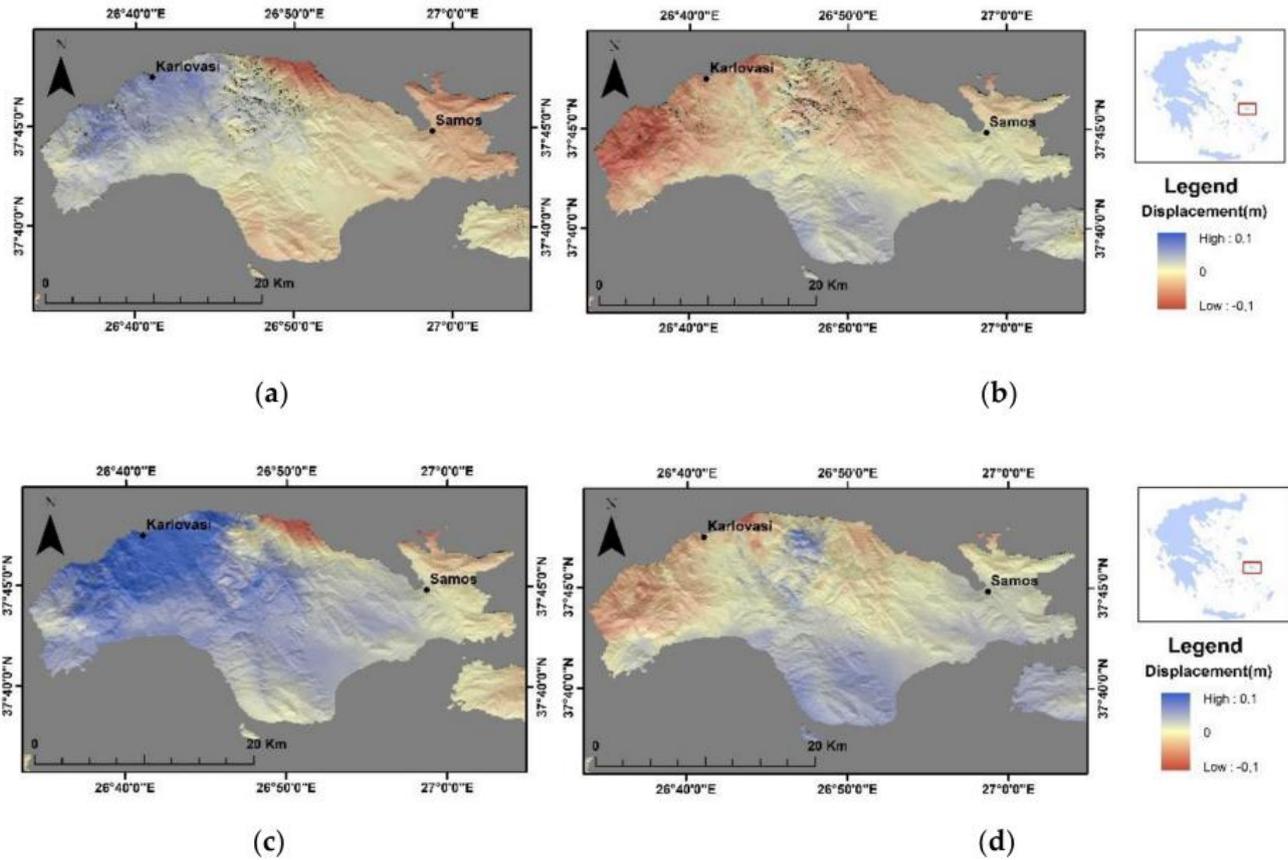
The up–down and east–west displacement decomposition results show that in the vertical displacement the positive values mean upward up to 13 cm and negative values downward up to  $-14$  cm and, respectively, for the horizontal displacement map positive values mean eastward up to 8 cm and negative values westward up to  $-12$  cm (Figure 28).

**Figure 28.** The vertical (a,c) and east–west (2D) (b,d) displacement maps were created by using the displacement decomposition tool in the SARscape software (a,b) and by further calculations performed through mathematical operations between the two layers in the LOS in the SNAP software (c,d).

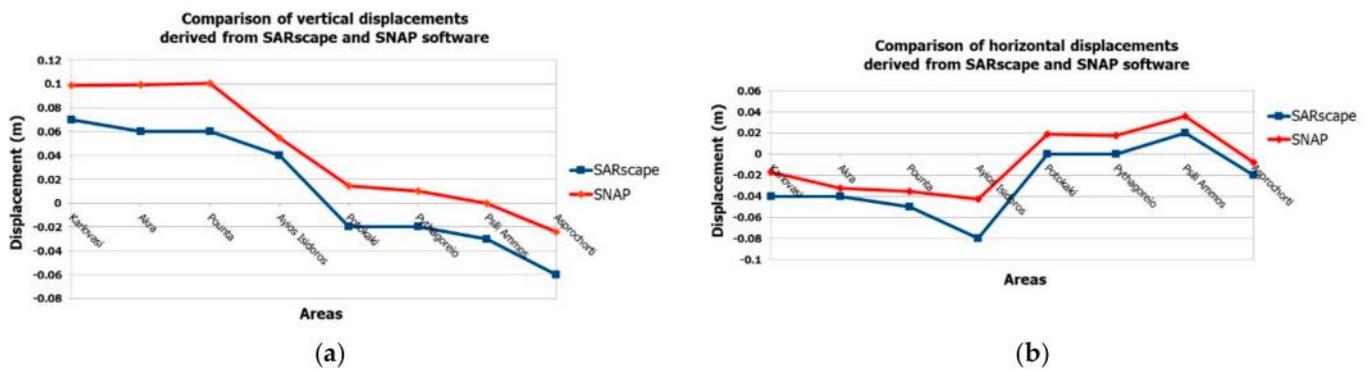
Comparing the vertical displacement obtained by the two different softwares, the results seem to agree in general, having a deviation of up to 2 cm. Horizontal deviations, however, are larger, especially in areas with high topography, which were not completely removed in the case of the SNAP software (Table 3 and Figure 29).

**Figure 29.** Comparative graphs of the (a) vertical and (b) horizontal displacements derived from the SARscape and SNAP softwares for selected sites on the earthquake-affected Samos Island.

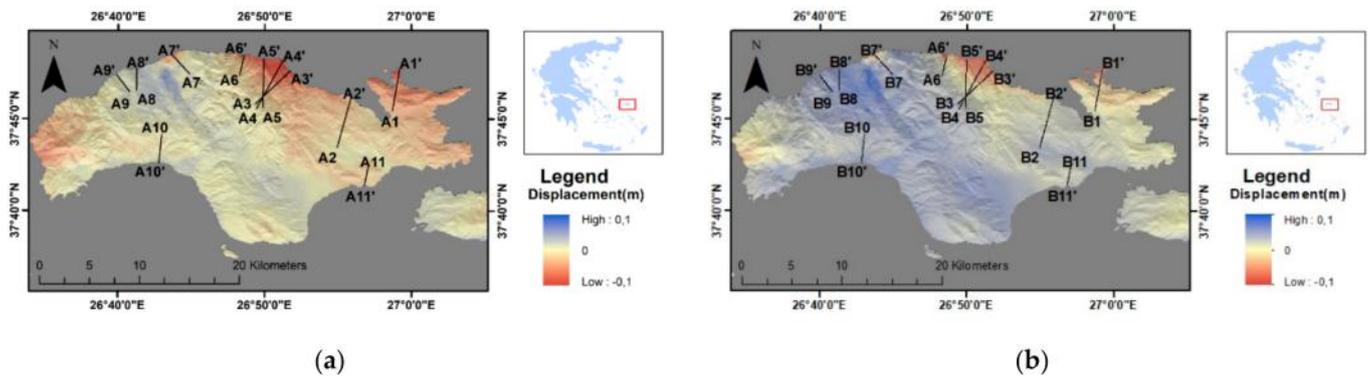
**Figure 30.** Displacement maps (descending) of Samos Island by using the SARscape (a) and SNAP (b) softwares. The presented sections were constructed at sites affected by environmental effects induced by the 2020 Samos earthquake. More specifically, the A1-A1', B1-B1', A2-A2', B2-B2', A5-A5', B5-B5', A6-A6', B6-B6', A7-A7', B7-B7', A9-A9', B9-B9', A10-A10', B10-B10', A11-A11', and B11-B11' sections refer to sites affected by primary effects, comprising coseismic uplifts and surface ruptures, while the others refer to sites affected by secondary effects, including slope failures.

The sections and their respective profile graphs were created for various sites on the earthquake-affected Samos Island, where primary and secondary earthquake environmental effects were generated. They were created for areas with permanent coseismic uplift, coseismic subsidence, coseismic surface ruptures, and slope failures; more specifically, the sections A8-A8' and B8-B8' for the uplifted Karlovasi coastal area, the sections A9-A9' and B9-B9' for the uplifted Potami coastal area, the sections A10-A10' and B10-B10' for the uplifted Marathokampos area, the sections A11-A11' and B11-B11' for the uplifted Pythagoreio area, the sections A1-A1' and B1-B1' for the uplifted Asprochorti area, and the sections A2-A2' and B2-B2' for the Kokkari area (Figure 30). Moreover, the sections A7-A7' and B7-B7' were created for the Ayios Nikolaos–Kontakaeika–Vrysses area, the sections A6-A6' and B6-B6' for the Ampelos area, and the sections A5-A5' and B5-B5' for the Ano Ayios Konstantinos area (Figure 30), all characterized by extended surface ruptures.

In addition to the above created for sites affected by primary effects, more sections and graphs were created for areas affected by secondary earthquake environmental effects; more specifically, the sections A9-A9' and B9-B9' for the Potami coastal area affected by slope failures associated with uplift and the sections A3-A3', A4-A4', A5-A5', B3-B3', B3-B3', and B3-B3' for the Avlakia coastal area also affected by slope failures associated with subsidence (Figure 30).

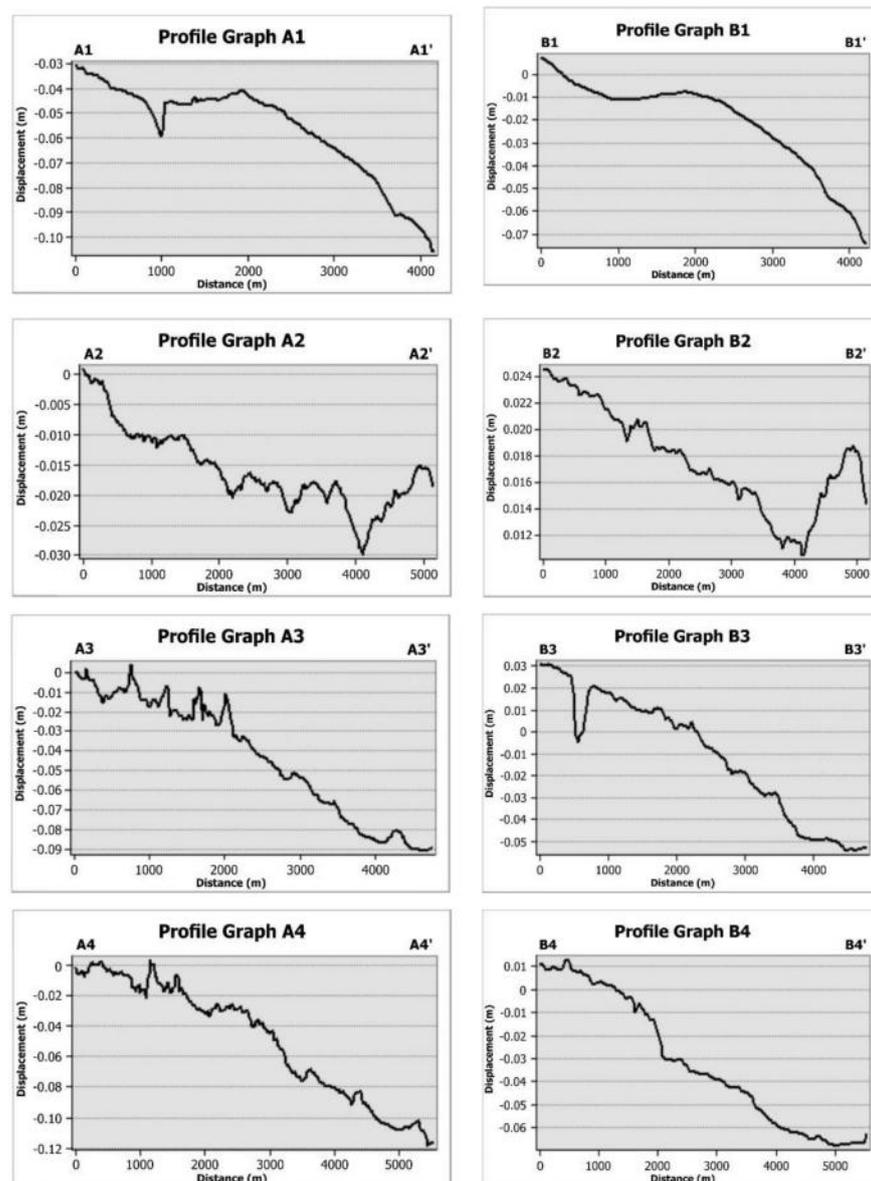
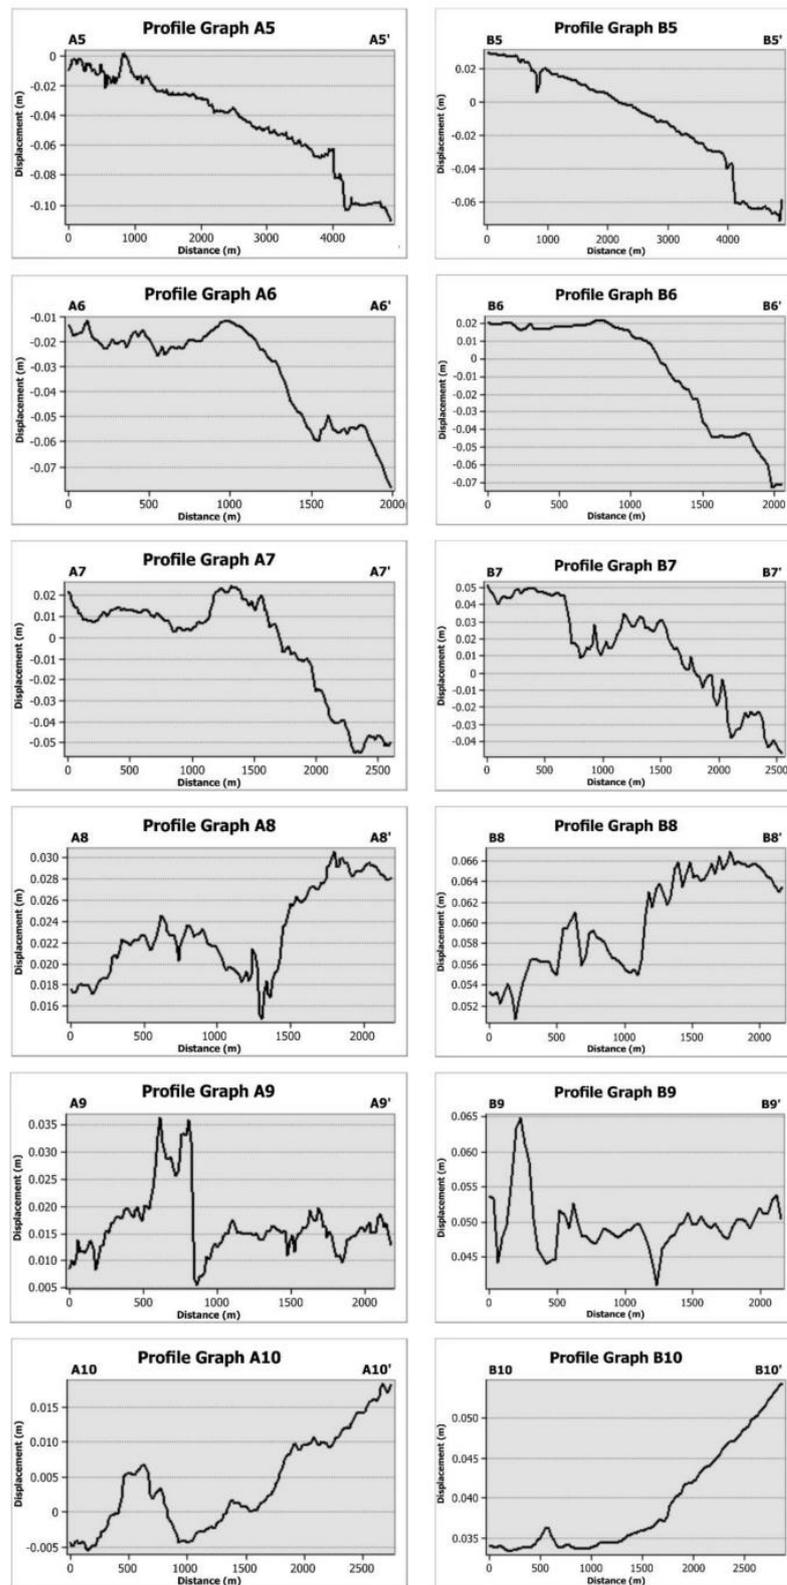
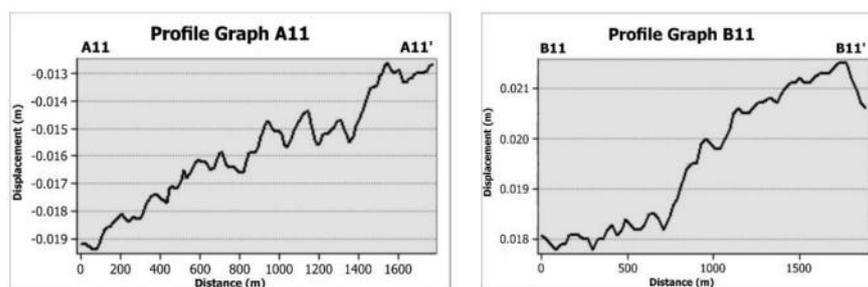
As regards the sections and the respective d-displacement profile graphs and the comparison of the displacement values from the DInSAR analysis with the corresponding field observations, large differences were observed. Typical examples of these large differences are the following (Figure 31 and Table 4):

- (a) The uplift detected in the field at the Asprochorti site in the northeastern part of Samos was 10 cm, while the InSAR analysis showed a small subsidence or relative stability (sections and profile graphs A1-A1' and B1-B1' in Figures 30 and 31).
- (b) The uplift detected in the field at the Kokkari site in the northeastern part of Samos was 22 cm [15], while the InSAR analysis showed a subsidence of 2 cm from the

- SARscape software and an uplift of 1.4 cm from the SNAP software (sections and profile graphs A2-A2' and B2-B2' in Figures 30 and 31).
- (c) The uplift detected in the field at the Karlovasi vessel shelter site was 24 cm, while the InSAR analysis showed a smaller uplift of 2.8 cm from the SARscape software and 6.3 cm from the SNAP software (sections and profile graphs A8-A8' and B8-B8' in Figures 30 and 31).

- (d) The uplift detected at the Potami coastal area with the Akra and Pounta promontories was 20–22 cm, while the InSAR analysis showed a smaller uplift of 1.3 cm from the SARscape software and 5 cm from the SNAP software (sections and profile graphs A9-A9' and B9-B9' in Figures 30 and 31).

- (e) The uplift detected at the Marathokambos coastal area was 10 cm, while the InSAR analysis showed a smaller uplift of 2 cm from the SARscape software and 5.5 cm from the SNAP software (sections and profile graphs A10-A10' and B10-B10' in Figures 30 and 31).

**Figure 31.** Surface displacement profile graphs resulting from the sections in the displacement map (descending) of Figure 30. Profile graphs (A1–A11) resulted from the SARscape software and the profile graphs (B1–B11) from the SNAP software.

As regards the studied areas affected by coseismic surface ruptures, a change in the surface deformation on both sides of the ruptures was observed. A typical example is the section and the corresponding graphs A7-A7' and B7-B7' (Figure 31) in the area of Ayios Konstantinos-Kontakaeika-Vrysses, where the southeastern fault block (the southeastern part of the section) is characterized by uplift and the northwestern fault block (northwestern part of the section) by subsidence. The type of the surface deformation detected by the InSAR analysis is qualitatively identical to the field observations since, as determined, the offset along the ruptures was normal with subsidence of the northwestern fault block and uplift of the southeastern one. Similar observations can be made and similar conclusions can be drawn for the sections and the respective graphs in the areas of Ano Ayios Konstantinos (A5-A5' and B5-B5') and Ampelos (A6-A6' and B6-B6') (Figure 31).

As regards the sites where slope failures occurred, it was found from the displacement map and the respective sections and graphs that in the Avlakia area (A3-A3' and B3-B3') (Figure 31) the slope failures occurred in an area that suffered a subsidence of  $-9$  cm (SARscape) and  $-5$  cm (SNAP). Similarly, for the slope failures that occurred at the Tsambou Vourliotes beach (A4-A4' and B4-B4') (Figure 31), the area suffered the maximum detected subsidence on the affected island; more specifically,  $-12$  cm from the SARscape software and  $-6$  cm from the SNAP software.

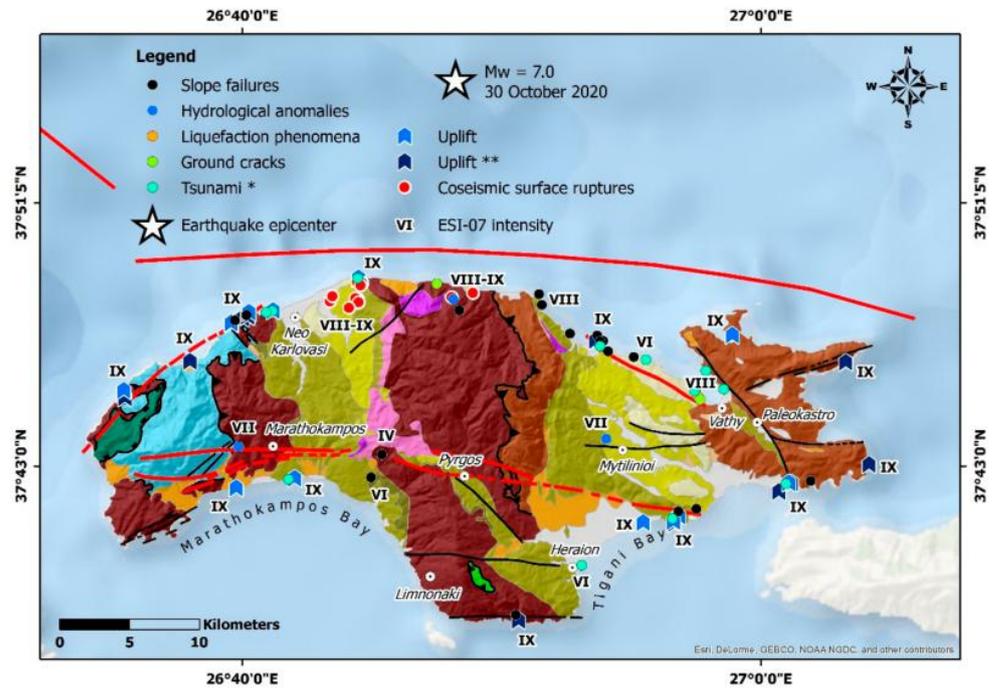
Based on the spatial distribution of the assigned ESI-07 intensities on Samos Island (Figure 32), it was concluded that the maximum intensity is  $IX_{ESI-07}$ , assigned to sites affected by a coseismic uplift larger than 10 cm in northwestern, northern, northeastern, southeastern, southern, and southwestern Samos.  $VIII-IX_{ESI-07}$  intensities were assigned to sites with smaller amounts of uplift induced by the January 2021 aftershock in southwestern Samos and to sites with surface ruptures in northern Samos.  $VIII_{ESI-07}$  intensities were assigned to sites affected by surface ruptures with a length of several hundred meters, by landslides with large volumes of mobilized materials, by extensive liquefaction phenomena, and by tsunami with large run-up and run-in distances and a large impact on objects. Sites affected by slope failures were characterized by intensities varying from  $IV_{ESI-07}$  to  $VIII_{ESI-07}$ .  $VI_{ESI-07}$  and  $VIII_{ESI-07}$  were assigned to sites affected by liquefaction phenomena.  $VI-VII_{ESI-07}$  was assigned to sites with ground cracks.  $VI_{ESI-07}$  and  $VII_{ESI-07}$  were assigned to springs suffered from hydrological anomalies. The tsunami-affected areas are characterized by intensities varying from  $VI_{ESI-07}$  to  $VIII_{ESI-07}$ .

**Figure 32.** Map of Environmental Seismic Intensity (ESI-07) scale intensities for sites affected by primary and secondary earthquake environmental effects triggered by the 30 October 2020, Mw = 7.0, Samos earthquake. \* Tsunami sites from [16] and \*\* uplift sites with the dark blue symbol from [15].

As regards the distribution of the effects on the fault blocks of Samos Island, it was found that effects were generated and distributed to all fault blocks (Figure 32). Particularly, coseismic uplift, slope failures, and hydrological anomalies were generated in the fault block of western Samos, coseismic uplift, surface ruptures, and slope failures in the Karlovasi basin, surface ruptures, slope failures, hydrological anomalies, and ground cracks in the fault block of central Samos, coseismic uplift and slope failures in the fault block of southern Samos, coseismic uplift and subsidence, slope failures, hydrological anomalies, liquefaction, and ground cracks in the Mytilinii Basin, and coseismic uplift and slope failures in the fault block of eastern Samos. The subsequent tsunami also affected the coastal areas of Samos [16], with its maximum intensity along the northern coasts.
