# Old Timber Reinforcement with FRPs

**Abstract:** The tests included the determination of the reinforcement effectiveness of old larch timber originating from a building built in 1860 with the use of carbon-fibre and aramid-fibre mats and strips, BFRPs and GFRPs. The test results showed that in old solid timber pieces from European larch (*Larix decidua* Mill.), the highest mean flexural bending capacity occurred in samples reinforced with carbon-fibre mats (increase in flexural bending capacity was 60.66% in relation to non-reinforced elements), while the lowest flexural bending capacity of the tested components occurred with reinforcement with GFRP (10 mm in diameter) (increase by only 19.04% in relation to non-reinforced elements). Additionally, bending tests of repaired 130-year-old pine (*Pinus sylvestris* L.) beams were shown (real-size scale) using CFRP strips and mats. The problems associated with the delamination of the CFRP strip due to uneven deformation of the damaged timber surface and the effectiveness of these repairs are also shown.

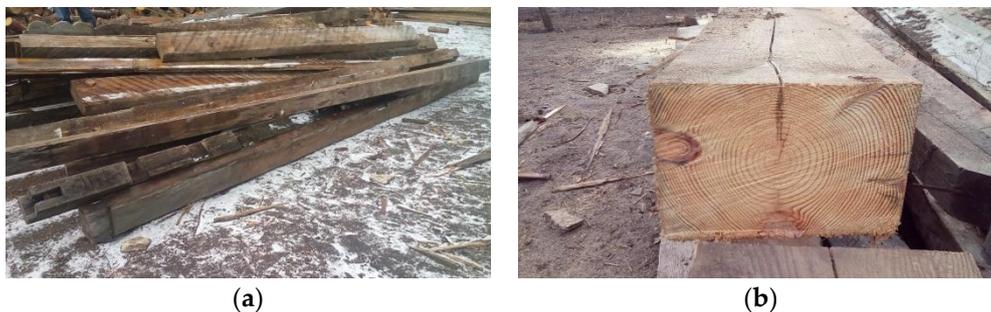
**Figure 1.** Timber components (photo by A. Wdowiak-Postulak): (a) floor beams; (b) the cross-section of the European larch (*Larix decidua* Mill.) from which the test samples were cut.

The tests included the determination of the physical and mechanical properties of the European larch (*Larix decidua* Mill.) originating from a building built in 1860. The test components were cut from the old floor beams located in a brickyard in Machory, Poland (see Figure 1).

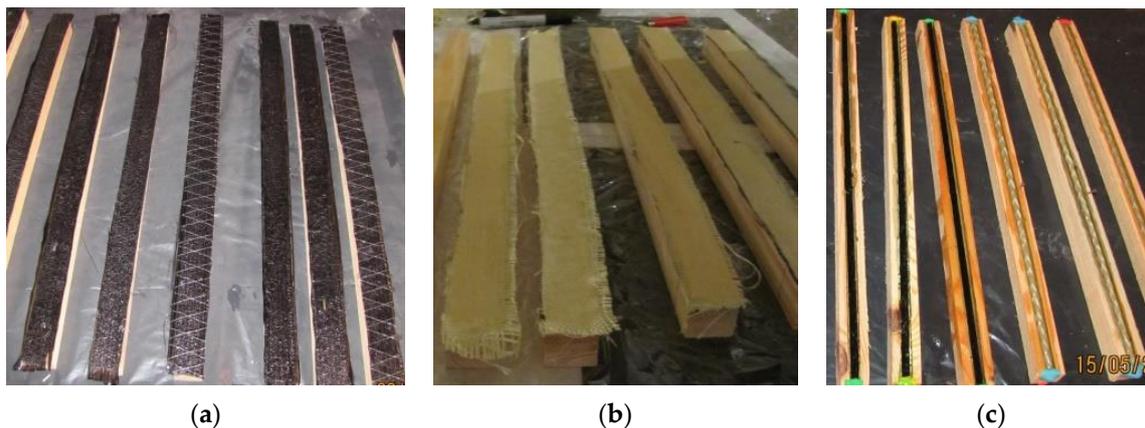
**Figure 2.** Tested pieces (photo by A. Wdowiak-Postulak): (a) reinforced with carbon-fibre mats; (b) reinforced with aramid-fibre mats; (c) reinforced with BFRPs and GFRPs.

Figure 2 illustrates the old pieces reinforced with carbon-fibre and aramid-fibre mats, as well as BFRP and GFRP (10 mm in diameter) ( $30 \times 30 \times 600 \text{ mm}$ ).

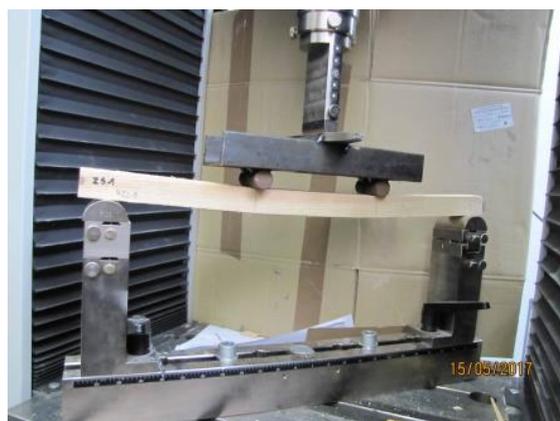
**Figure 3.** Bending strength test of timber pieces (photo by A. Wdowiak-Postulak).

The bending strength test was assessed on the basis of PN-EN 408+A1:2012 [17] using  $\pm 250 \text{ kN}$  electromechanical testing machine (Zwick, Wrocław, Poland) (see Figure 3). The tested samples were symmetrically loaded with two concentrated forces, with a span equal to 18 times the cross-sectional height of the beam. In the test, the span between the supports was 540 mm. The load was applied at a constant speed of travel so that the maximum load was reached after  $(300 \pm 120) \text{ s}$ . The load speed of the sample was determined by preliminary tests. The optimum time to reach  $F_{\text{max}}$  was 300 s.

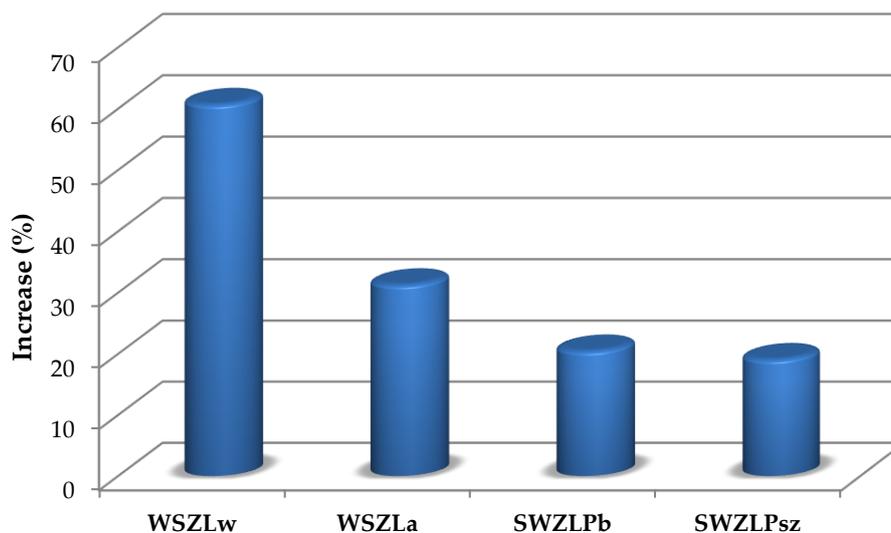
**Figure 4.** Comparison of the increase in bending strength of solid timber pieces with defects, European larch (*Larix decidua* Mill.) originating from a building erected in 1860 reinforced with carbon-fibre mats (WSZLw), aramid-fibre mats (WSZLa), BFRP (10 mm in diameter) (SWZLPb), GFRP (SWZLPsz) (10 mm in diameter) in relation to non-reinforced pieces (SZL).

Reinforcement effectiveness of timber pieces with defects of the European larch (*Larix decidua* Mill.) originating from a building built in 1860 (30 × 30 × 600 mm) using carbon-fibre and aramid-fibre mats, BFRPs and GFRPs (10 mm in diameter), is shown in Figure 4.

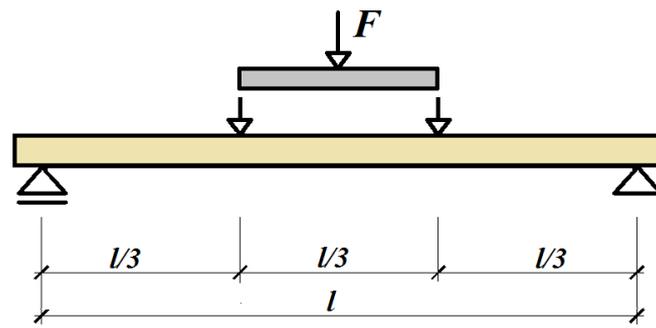
Figure 5. General scheme of testing.

The bending tests were performed at a support spacing of  $l = 4.5$  m. The test diagram and a view of the test stand are shown in Figure 5. Force, deflection and deformation on the bottom and top of the beam were measured during the tests.

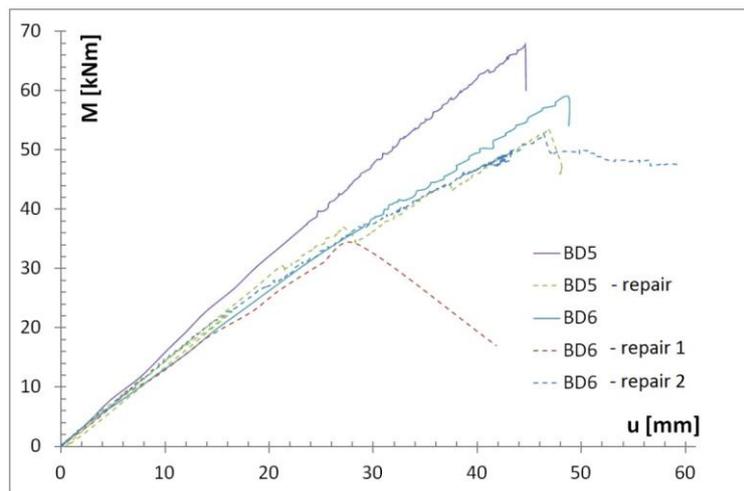
**Figure 6.** Moment—deflection dependency of tested timber beams in destructive tests and after repairing with the use of CFRP.

The results are shown in Table 5 and Figure 6, and are described in more detail below. The BD5 beam was repaired with a S512 strip by gluing it to the lower surface of the beam over its entire length (Figure 7). The reason for reinforcement over the entire length was the minor damage to the fibres in the range from 1/3 to 2/3 of the beam span. The main damage to the BD5 beam, on the other hand, occurred close to the centre of the beam span and consisted of a rupture of the lower timber fibres. This solution enabled restoration to 80% of the original load-bearing capacity of the beams, simultaneously maintaining the stiffness of the original beam. With regard to the permissible deflections of 1/300, the rigidity practically remained unchanged. Only when the deflection values were higher did the original damage to the beam become apparent. The strip was damaged by loosening in the anchorage zone (Figure 8).

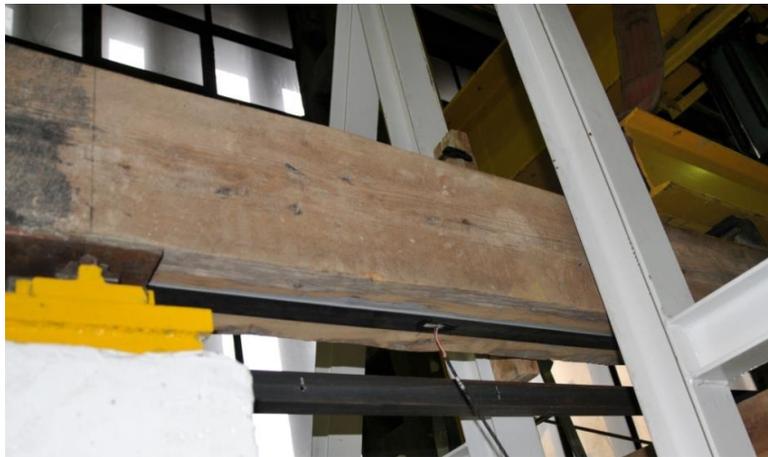
**Figure 7.** View of the beam repaired with the use of CFRP strip S512 (photo by J. Brol).

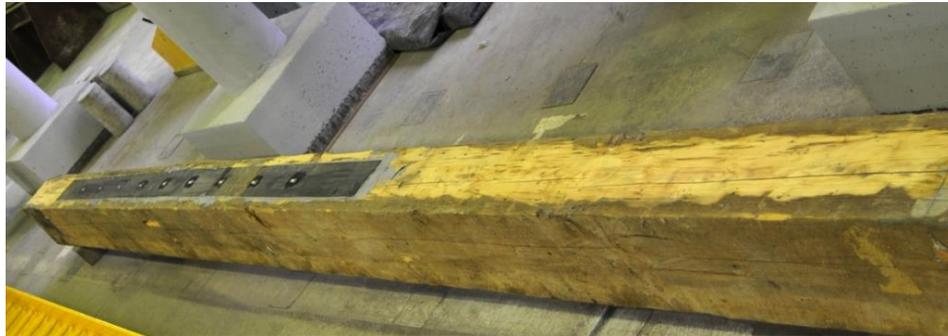
**Figure 9.** Timber beam repair with the use of CFRP strip M1214 (photo by J. Brol).

In case of the BD6 beam, it was decided to glue an M1214 strip with a 240 MPa module for 1/3 to 3/3 of the beam length (Figure 9) due to the nature of the damage to the beam. In this beam, the damage

was deeper, and occurred at around 2/3 of the beam span (under a concentrated force from earlier tests) and covered half of the section height with a simultaneous longitudinal crack.

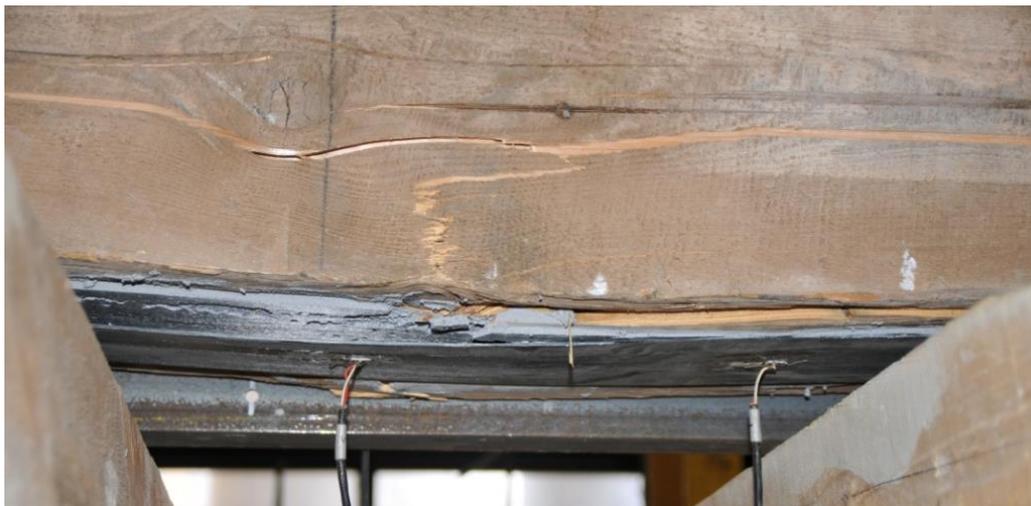
**Figure 10.** The form of destruction of the timber beam BD6 (photo by J. Brol).

Due to longitudinal cracks in the middle of the beam height, uneven displacements at the adjacent edges of the cracks were visible during the test (Figure 10), and fast delamination occurred at the timber-CFRP strip joint. As a result, only about 58% of the primary load capacity was achieved while maintaining the beam stiffness. With regard to the permissible deflections  $l/300$ , only a small loss of stiffness was observed.

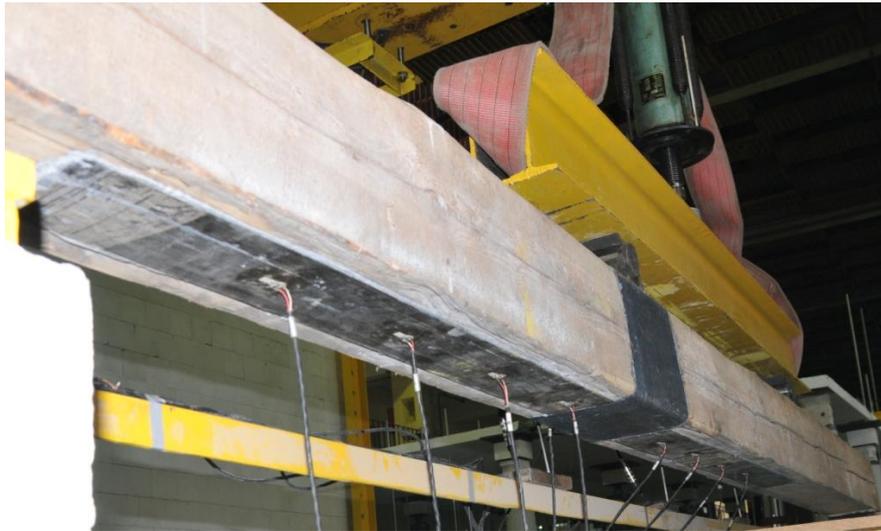
**Figure 11.** Re-repair of the timber beam with the use of CFRP strip M1214 (photo by J. Brol).

Due to the destruction form of the timber-M1214 strip joint as a result of delamination, it was decided to repeat this test on the same beam while the joint was reinforced at the site of the damage to the beam by additional wrapping of the spot with a carbon-fibre mat (Figures 11 and 12). Wrapping the beam in the damaged area with the mat was intended to prevent independent vertical movements on both sides of the contact, and thus to prevent delamination. As shown in Figure 6, this solution significantly improved the repair result and recreated 90% of the original load capacity. With regard to the permissible deflections  $l/300$ , a small loss of stiffness was also observed.

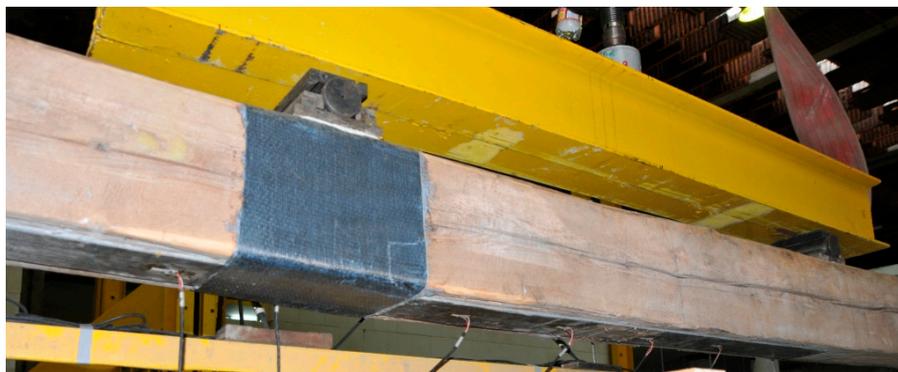
**Figure 12.** View of the additional strengthening with the use of CFRP mat (photo by J. Brol).
