A Study of Early-Stage Corrosion Behavior of AZ91 Alloy and MAO-Coated Alloy in 3.5% NaCl Solutions

Abstract: The early-stage (1 h) corrosion behavior of AZ91 alloy before and after microarc oxidation treatment in a 3.5% NaCl solution was revealed using open circuit potential, potentiodynamic polarization, electrochemical impedance spectroscopy, and the observations of corroded surfaces at different immersion time (5, 25 and 45 min). The coating offers excellent corrosion resistance for the substrate for 1 h immersion corrosion by serving as a physical barrier. For the alloy, pitting corrosion initiates easily, but propagates difficultly, due to the formation of oxides/hydroxides in the pits. By comparison, the localized corrosion of the coated alloy proceeds continuously via the through pores, and the newly formed corrosion products inside the pores are easily damaged. Based on the electrochemical results, the alloy exhibits quasi-uniform corrosion, and the coated alloy reveals localized corrosion, both of which are under cathodic control.

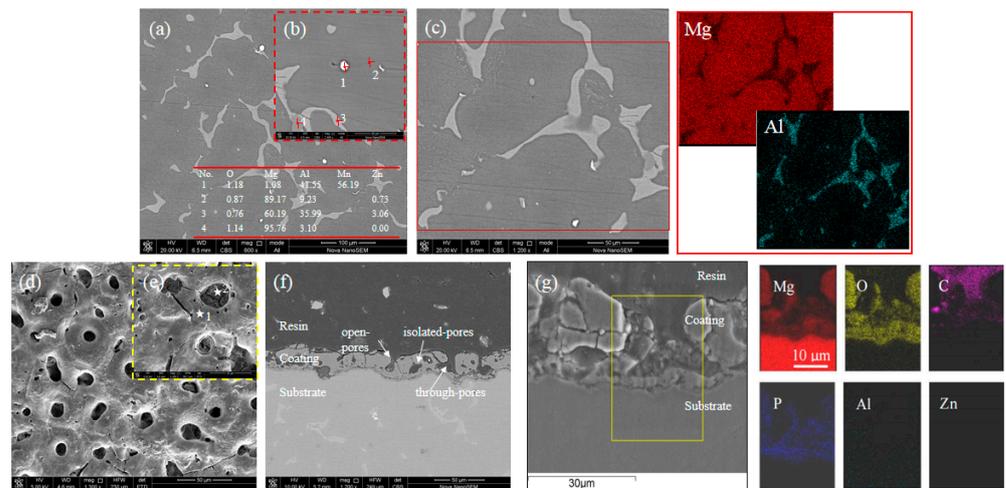
Figure 1 shows the SEM images and EDS elemental distribution of the AZ91 alloy before and after MAO treatment. Figure 1a,b show that the as-received alloy is mainly composed of the α -Mg phase and the discontinuous β phase. In addition, the Al-Mn phase (41.55 wt.% Al, and 56.19 wt.% Mn at point 1 in Figure 1b) exists, and it appears white in the SEM images. The EDS point spectra confirm the β phase comprising 60.19 Mg, 35.99 Al, 3.06 Zn, and 0.76 O in wt.% (point 3). From the EDS mapping results in Figure 1c, Zn is absent because of its low amount, and the appearance of O indicates the oxidation of the alloy in the air. Oxidation also occurs on β phases and the amount of O of α phase and β phase approximates about 1 wt.%. Figure 1d,e show that the coating surface is characterized by pores with an average size of 10 μ m and microcracks that always originate from the edge of pores and go through the adjacent pores. The average chemical compositions of the smooth surface (point 1 in Figure 1e) are 48.20 O, 16.41 P, 31.45 Mg, and 3.94 Al, indicating that Mg oxides/hydroxides and phosphates are the main constituents. The microstructure inside the pores is unlike the surface, which can be attributed to the formation of more Mg oxides (56.90 O, 1.22 P, 35.84 Mg, and 6.03 Al, see point 2 in Figure 1e), when intensive discharges took place in the pores [24,25]. Figure 1f,g show the cross-section images of the coated alloy, exhibiting a good coating/substrate adhesion. The overall thickness of the coating is 25–30 μ m. Three types of pores can be observed: isolated, open, and through pores [10]. Figure 1g shows the morphology of a through pore that has been reported to be the vulnerable site where localized corrosion can be easily triggered. EDS elemental mapping images show that O and P are the main elements that constitute the oxides/hydroxides and phosphates.

Figure 1. SEM images showing the microstructure of the AZ91 alloy before and after MAO treatment. (a) SEM image and (b,c) magnified SEM images for the as-received alloy; (d,e) Coating surface image; (f,g) Interface images for the coated alloy. The EDS mapping images correspond to the SEM images of (c,g).

Figure 2 shows the XRD spectra of the AZ91 alloy and the MAO-coated alloy. The two main phases can be identified for the as-received alloy: Mg and Mg₁₇Al₁₂. The oxide (MgO) phase is detected, but the Al-Mn phase cannot be detected, possibly because the latter one has a very small fraction and volume. By comparison, the Mg₁₇Al₁₂ phase is concealed by the coating materials that are composed of MgO and Mg₃(PO₄)₂. The XRD results are consistent with the EDS results in Figure 1.

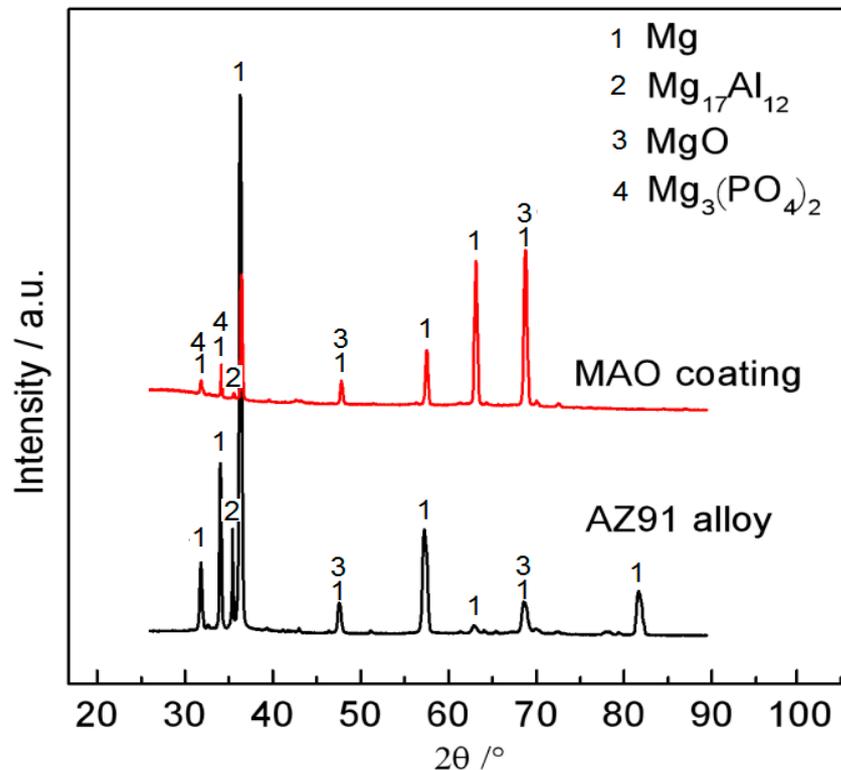
Figure 2. XRD patterns of the alloy and the coating.

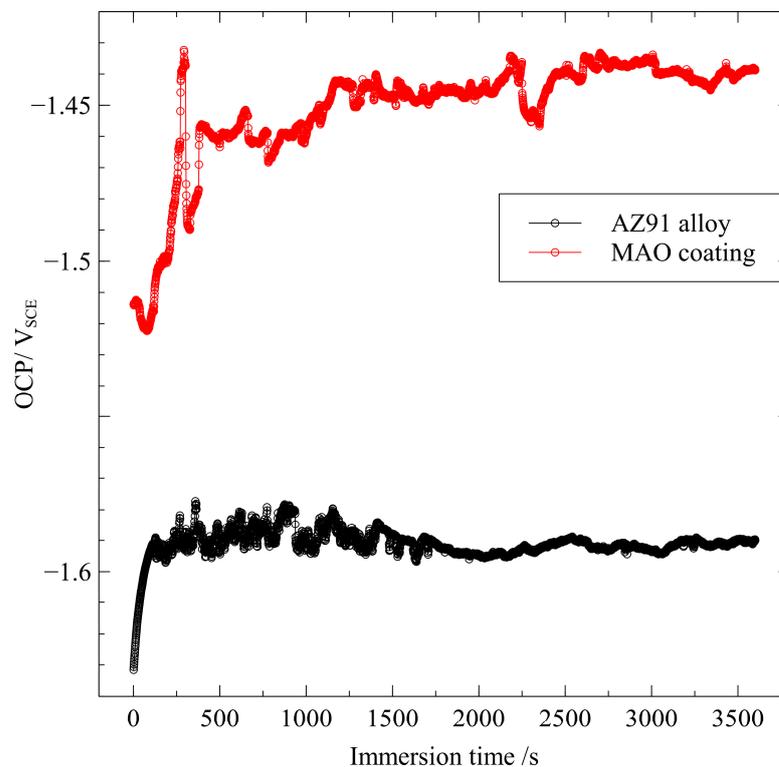
The open-circuit potentials (OCP), as a function of immersion time in Figure 3, show a similar evolution tendency for AZ91 alloy and MAO-coated alloy. The potential increases rapidly for 150 s and then fluctuates intensively from 150 to 1800 s. Finally, it reaches a relatively stable value after 1800 s. After 1 h immersion, the final potential for the MAO-coating alloy reaches a nobler value ($-1.44 \text{ V}_{\text{SCE}}$) with respect to the AZ91 alloy ($-1.59 \text{ V}_{\text{SCE}}$). Notably, the coated alloy always exhibits nobler OCP values than the alloy in the 3.5% NaCl solution. For the MAO-coated alloy, the coating can offer good protection for the underlying alloy before the coating's breakdown. In such a case, the electrochemical reactions on the alloy are stifled. However, once the coating ruptures, the galvanic corrosion between the coating and the alloy is triggered and the underlying alloy serves as the anode due to its lower potential, aggravating the metal dissolution at the moment.

Figure 3. Time-dependent corrosion potential of the AZ91 alloy before and after MAO treatment for 1 h immersion in a 3.5% NaCl solution.

The time evolution of the corrosion rate can be evaluated by the resistances (R_{CT} and R_{ZF}) extracted by EIS responses, as shown in Figure 9. The corrosion resistances of MAO-coated alloy far outweigh that of the alloy, consistent with the PDP results in Figure 4. For the alloy in Figure 9, the R_{CT} slightly increases with immersion time, indicating a decreasing electron transfer rate from alloy to solution as corrosion proceeds. The thin oxides/hydroxides film (Figure 7(a.1),d), formed continuously with time on the corroded surface, serves as a barrier to slow down the electron transfer rate. However, R_{ZF} experiences a decrease from 5 to 25 min, followed by an increase from 25 to 45 min. The smallest R_{ZF} at 25 min can be attributed to the rapid dissolution of Mg metal and oxide/hydroxide film (Figure 7b). The dissolution is also responsible for the fluctuation of OCP from 150 to 1800 s (Figure 3). The R_{ZF} at 45 min is smaller than that at 5 min, attributing to the presence

of inductive behavior (Figure 5c). The inductive behavior is related to Mg metal oxidation at a rapid Cl^- adsorption rate, triggering pitting corrosion (Figure 7b). Although the pitting corrosion is more significant after 45 min immersion (Figure 7c) than after 25 min, R_{ZF} is bigger due to the thickening corrosion product's film (Figure 7d) on the corroded surface. Meanwhile, the continuous deposition of corrosion products brings about a relatively stable OCP in Figure 3.

In the presence of Cl^- , the coated alloy is initially subjected to a chemical attack (Figure 8a). For 5 min immersion, OCP that experiences an instant decrease and subsequent rebound (Figure 3) is indicative of the chemical dissolution of the coating materials. However, Mg^{2+} in the bulk solution after 1 h immersion cannot be detected by ICP–OES measurements in this study and the pH experiences no changes with immersion time, meaning that the chemical decomposition is inappreciable. The MAO-coated alloy shares the same electrochemical reactions (3–5) with respect to AZ91 alloy, so the evolution and profile of OCP and PDP are similar except for the values. The thermodynamic similarity decides the same cathodic control ($\gamma = C_a/C_c < 1$ in Figure 10) for the coating in the early-stage immersion corrosion.

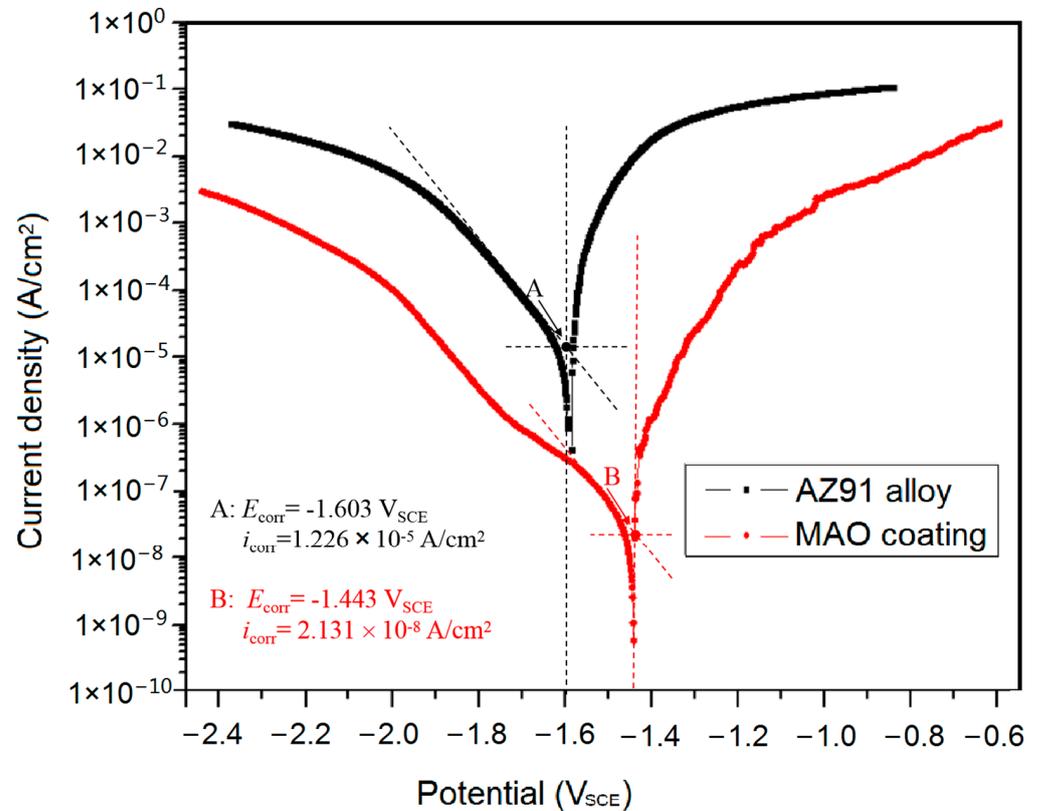
Figure 4 shows potentiodynamic polarization (PDP) curves for AZ91 alloy before and after MAO treatment after 1 h immersion in the 3.5% NaCl solution. Generally, corrosion potential and corrosion current density extracted from Tafel curves can be used to assess a metal's corrosion rate. However, such a method is unreliable for Mg alloys since the surface state of Mg alloys changes rapidly and hydrogen evolves quickly when anodic polarization is applied. Studies [26,27] showed that corrosion current density is underestimated when Tafel extrapolation for Mg alloys is performed because of anodic superfluous hydrogen evolution. However, the corrosion current density can be obtained by extrapolating the cathodic region of PDP curves in Figure 4. Compared with AZ91 alloy ($1.226 \times 10^{-5} \text{ A/cm}^2$), the corrosion current density (i_{corr}) of the coating ($2.131 \times 10^{-8} \text{ A/cm}^2$) is three orders of magnitude smaller, and the corrosion potential (E_{corr}) of the coating is 0.16 V nobler, consistent with the OCP measurements. Importantly, the anodic polarization curves for the alloy and the coating exhibit a similar evolution with applying anodic potentials, especially at a small anodic polarization. This similarity originates from the same anodic reaction (i.e., Mg metal is oxidized to Mg^{2+}) on the alloy and coated alloy. Thus, it can be deduced that

the electrons released by Mg dissolution can be easily captured by the water molecules, or the potentiostat along the passageways of the porous coating under an anodic potential, confirming the high possibility of localized corrosion of the MAO-coated alloy.

Figure 4. Polarization curves of AZ91 alloy, before and after MAO treatment after 1 h immersion in a 3.5% NaCl solution.

From Table 2, R_{ZF}^{MAO} is far bigger than R_{ZF}^{Sub} , consistent with the results in Figures 4 and 5.

The through-pores-induced localized corrosion makes a decisive contribution to the corrosion current density for the coating in Figure 4. Before coating ruptures in a large area, these isolated pores can be treated as the existing pits, where Cl^- ions and water molecules can infiltrate easily. As a result, decompositions of the oxides/phosphates in the pores bring about the direct contact of the underlying alloy with the aggressive solution and the subsequent pitting corrosion initiation. Thus, electrochemical reactions occur, forming high $[\text{Mg}^{2+}]$ and pH in the micro sized pores. Then, the formation of Mg oxides/hydroxides is ready, theoretically slowing down the further electrochemical corrosion of the underlying alloy. However, the corrosion resistance (Figure 9) of the coating decreases with time because the newly formed oxides/hydroxides (corrosion products) inside the pores are not compact (as shown by the large cracks in Figure 8(b.1,c.1)). Additionally, in the deep pores (deeper than the pits for the uncoated alloy), the local concentration of Cl^- ions may be much bigger than in the bulk solution, leading to the rapidly-forward chemical reaction (7). Thus, more and more pits initiate under the isolated through-pores. With time, pits inside these isolated pores propagate without resistance from the corrosion products, leading to the amalgamation of isolated pores and finally the large-area breakdown of the coating, as we have observed in our previous study [8].

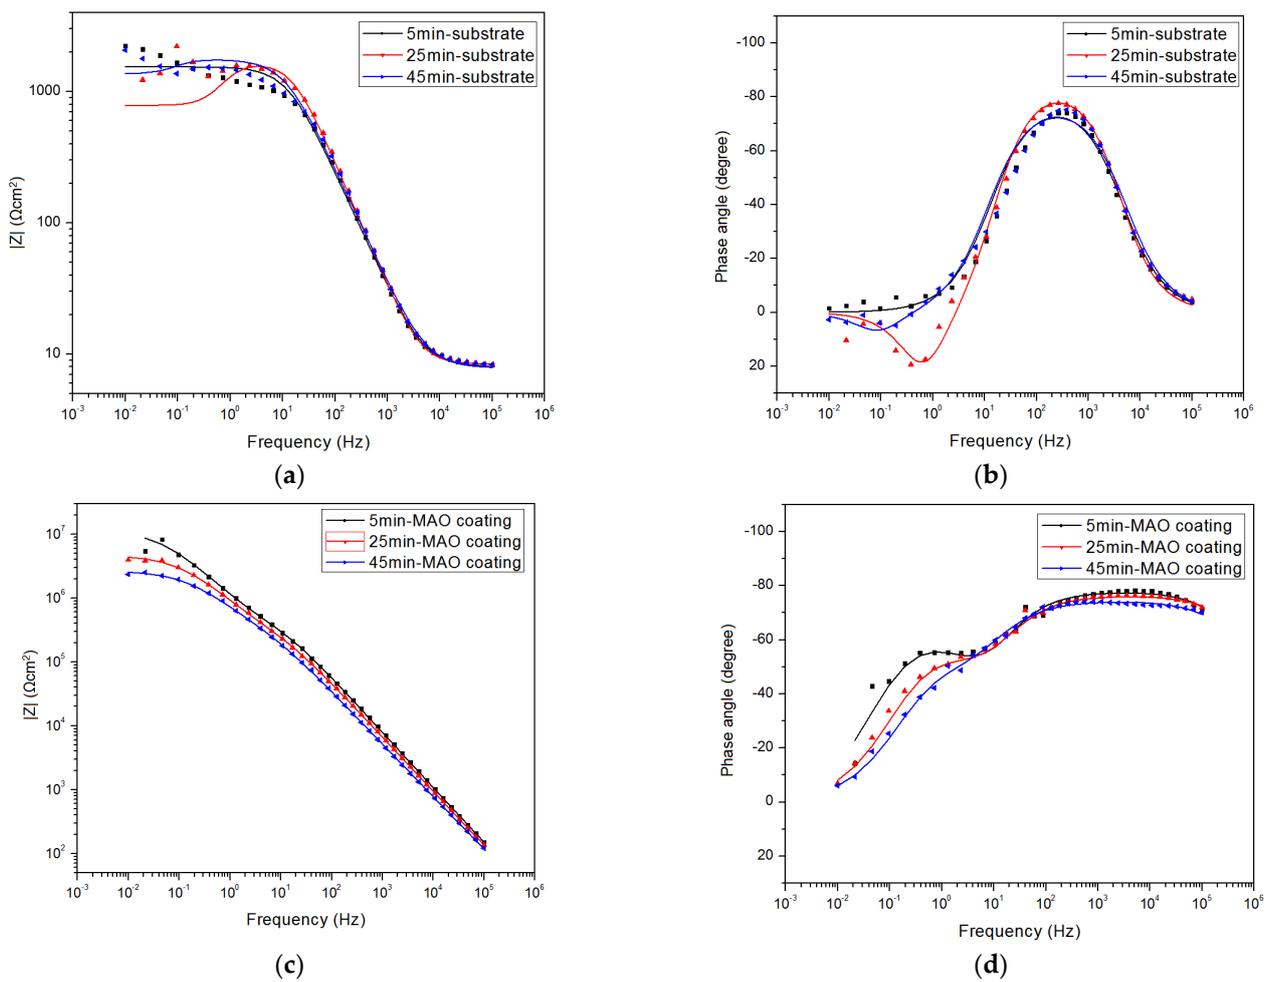
Figure 5 shows time-dependent EIS Bode plots for AZ91 alloy and MAO-coated alloy. The scattered points represent raw data, and the solid lines are plotted by fitting data using Zview software (version 3.5). The AZ91 alloy exhibits a different EIS response compared with the coated alloy. Specifically, the EIS response of AZ91 alloy is characterized by a well-defined capacitive loop at high frequency and an inconspicuous inductive loop at low frequency, especially for EIS response after 25 min immersion. The capacitive loop at high frequency represents a single time constant and is generally associated with forming the oxides/hydroxides layer and double electric layer. The apparent inductive loop at low frequency suggests that Mg oxidation occurs due to a rapid Cl^- adsorption rate. By comparison, two ill-defined capacitive loops at the high and medium frequencies, and no inductive loop at low frequency, are present in the EIS responses for the MAO-coated alloy. The two capacitive loops represent two time constants, and they are related to the MAO layer and double electric layer. The absence of the inductive loop for the MAO-coated alloy indicates that the adsorption of Cl^- is slow due to the thick coating.

Figure 5. EIS measurements (scattered points) and fitting results (solid lines) of the as-received alloy and the MAO-coated alloy at different immersion times at OCP. (a,c) Bode plots of impedance vs. frequency and (b,d) bode plots of phase angle vs. frequency.

The corrosion protection performance can be statistically estimated by low-frequency impedance modulus ($|Z|$). In Figure 5a,c, the $|Z|$ values decrease with increasing immersion time for both the alloy and the coated alloy. Notably, $|Z|$ values of the alloy are three orders of magnitude smaller than that of the coated alloy, consistent with the PDP results in Figure 4. The biggest $|Z|$ value for AZ91 alloy is only $2.0 \times 10^3 \Omega \text{ cm}^2$, whereas the biggest $|Z|$ for the coating reaches $9.3 \times 10^6 \Omega \text{ cm}^2$ after 5 min immersion. Such a big $|Z|$ of the coating is indicative of excellent corrosion protection for the substrate for 1 h free corrosion.

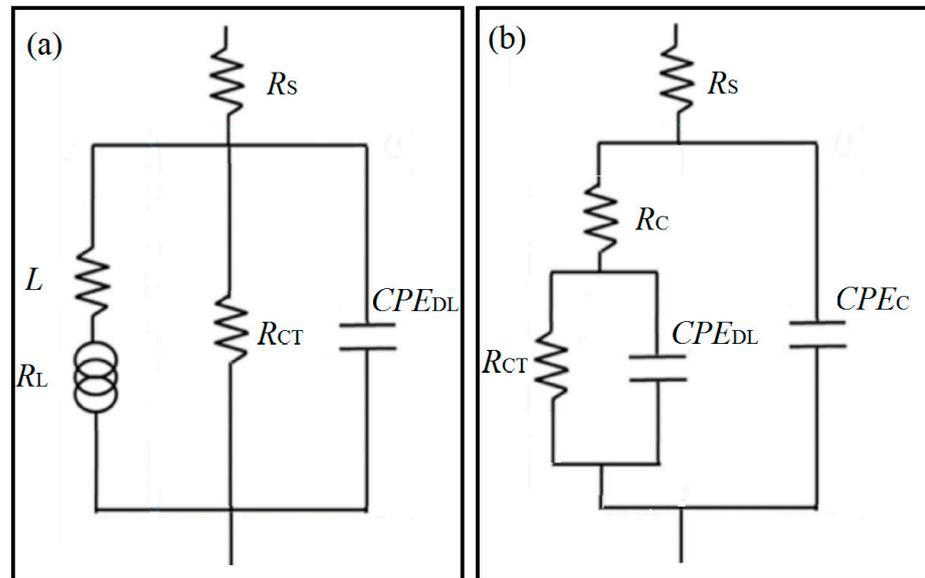
Figure 6 shows the equivalent electrical circuits used to fit EIS responses. The different profile of EIS responses for the alloy and the coating is the reason for using different equivalent circuits. In the equivalent circuits proposed, constant phase elements (CPE) are used as a substitute for a perfect capacitor since the most negative phase angle in EIS response is not -90° . Besides, R_S is solution resistance, and R_{CT} and CPE_{DL} represent charge transfer resistance and double-layer capacitance at the solid/liquid interface, respectively. R_L and L stand for the inductance and resistance associated with inductive loops for AZ91 alloy. R_C and CPE_C represent the capacitance and resistance of the MAO-barrier layer. The numerical fitting results of R_{CT} , R_C , and R_L are provided in Table 2 (the fitting values of all components are given in Table S1). R_{ZF} in Table 2 represents zero-frequency resistance ($f \rightarrow 0$). It is used to estimate the corrosion rate of AZ91 alloy due to the presence of inductive behavior. The zero-frequency resistance of AZ91 alloy (R_{ZF}^{Sub}) and MAO coating (R_{ZF}^{MAO}) can be estimated:

$$R_{ZF}^{Sub} = \frac{1}{\frac{1}{R_{CT}} + \frac{1}{R_L}} \quad (1)$$

$$R_{ZF}^{MAO} = R_C + R_{CT} \quad (2)$$

Figure 6. Equivalent electrical circuit proposed to fit the EIS responses of the corrosion systems. (a) For alloy and (b) for MAO coating.

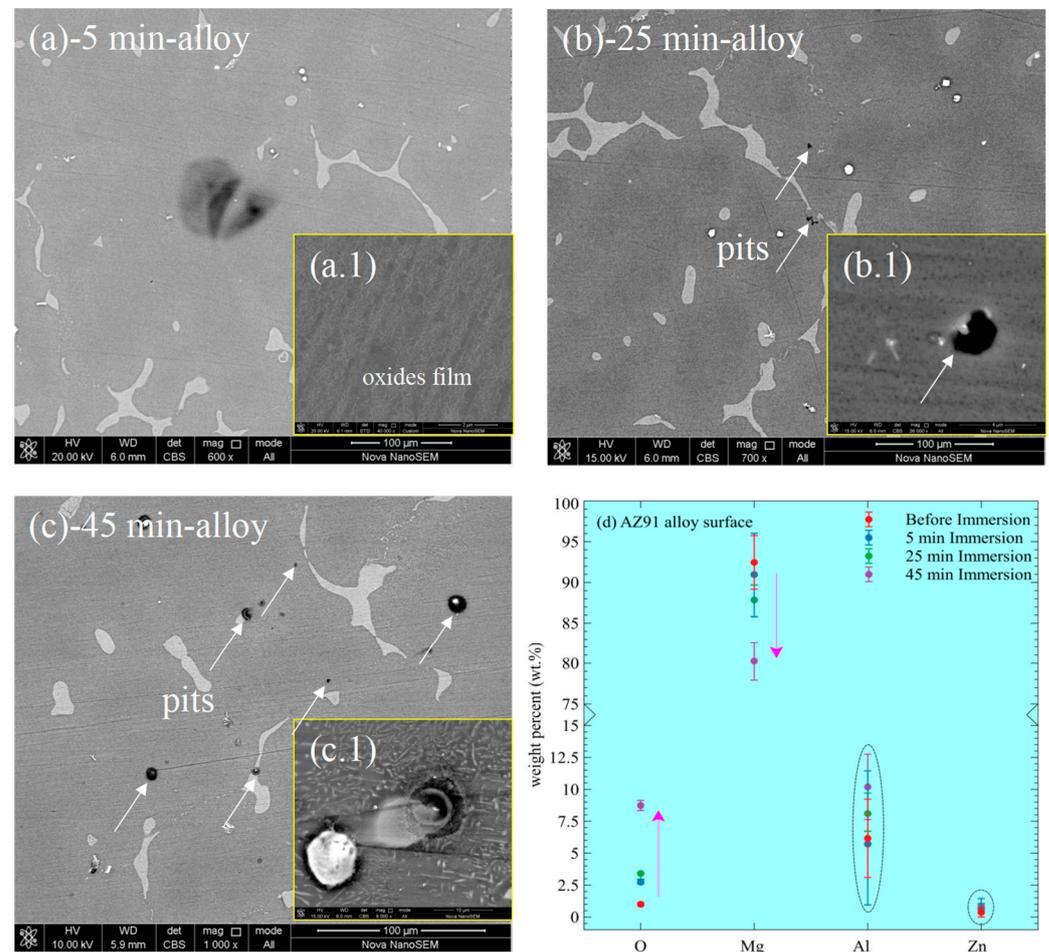
Figure 7 shows the corroded surface of AZ91 alloys before and after MAO treatment at different immersion times in the 3.5% NaCl solution. For AZ91 alloy, there are no evident corrosion features after 5 min immersion in Figure 7a. However, an oxide/hydroxide film forms (Figure 7(a.1)), but the film covers a part of the corroded surface. After 25 min, pits initiate randomly on the corroded surface (Figure 7b). The dissolution of the film and Mg metals is severe on the black corroded sites in Figure 7(b.1). At this moment, corrosion dissolution slightly outweighs the formation of corrosion products (Mg oxides/hydroxides). After 45 min, the number of pits increases with time (Figure 7c), indicating the corrosion aggravates the localized breakdown of the alloy substrate. On some pits, the corrosion products deposit and develop a volcano-like structure in a size of 10–20 μm (Figure 7(c.1)). The elemental compositions (O, Mg, Al, and Zn) of the alloy, before and after corrosion for different immersion times, are compared in Figure 7d. The variation of Al and Zn is small and irrelevant to the occurrence of corrosion. Notably, the alloy exhibits an increasing amount of O and a decreasing amount of Mg with immersion time. The tendency of Mg and O indicates the continuous formation of Mg oxides/hydroxides. However, the

amount of O after 25 min approximates that after 5 min, confirming the relatively severe film/alloy dissolution.

Figure 7. Corrosion morphology of AZ91 alloy and MAO-coated alloy for different immersion times in 3.5% NaCl solution. (a–c) the alloy surface morphology after 5, 25, and 45 min immersion; (a.1–c.1) the localized corrosion morphology, and (d) the weight percent (wt.%) of the elements on the corroded surfaces.

According to equation six, the formation of an $\text{Mg}(\text{OH})_2$ film is impossible at the macroscopic level using the data of $[\text{Mg}^{2+}]$, and pH in Table 3. This is the essential reason for the large area of the exposed alloy without covering by oxides/hydroxides after immersion in Figure 7. On the other hand, the dissolution of the metal and oxides/hydroxides prevail due to the presence of the Cl^- ions by reaction (7):

The Cl^- ions also contribute to the pitting corrosion of the alloy in Figure 7b,c after 25 and 45 min immersion.

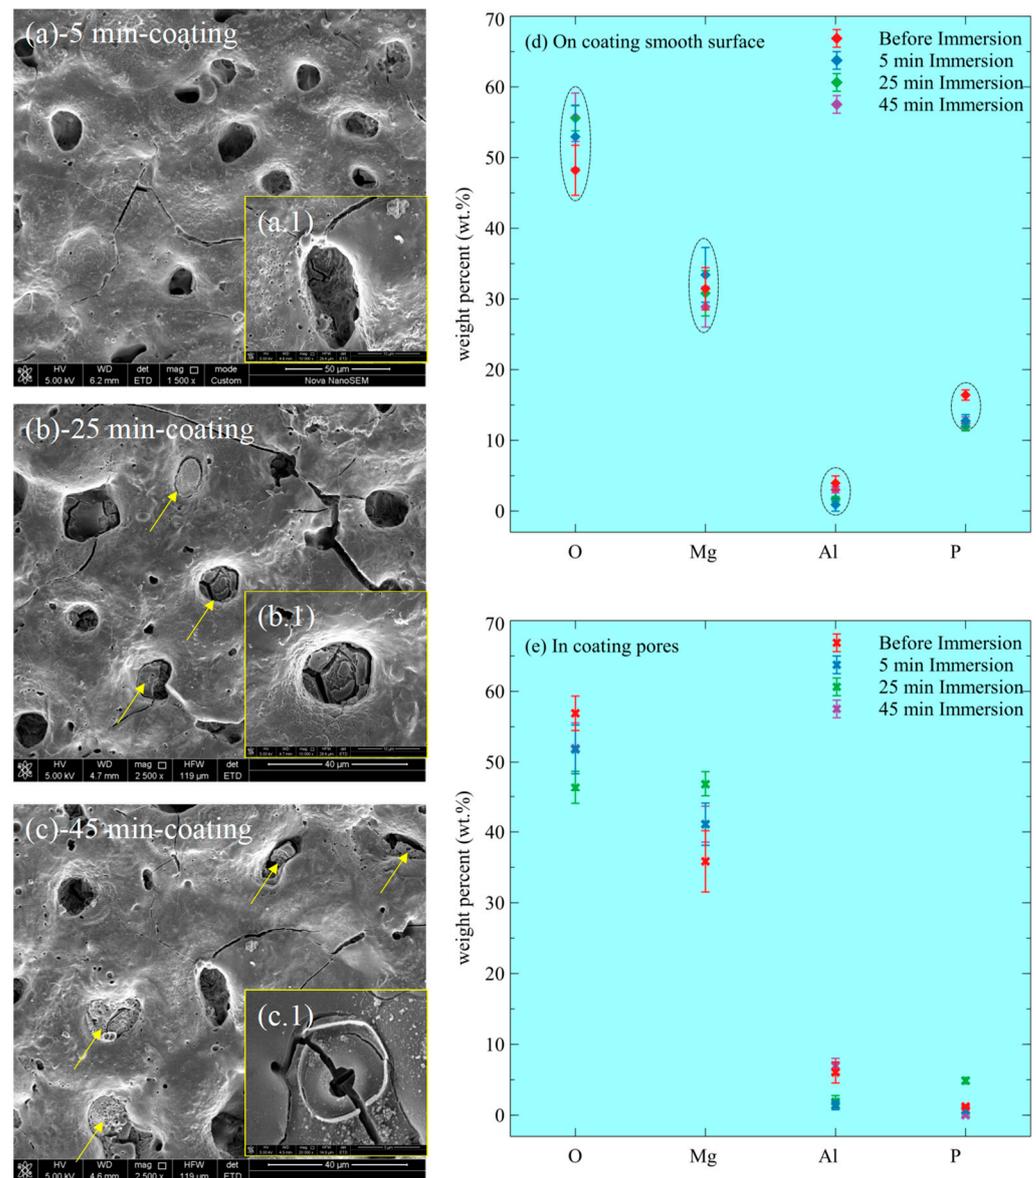
The corroded surface of the coating after 5 min immersion is characterized by slight chemical damage of oxides/phosphates, resulting in small holes in Figure 8(a.1). After 25 min, some pores are filled with corrosion products (Figure 8b), indicating localized corrosion occurs inside these pores. After 45 min, an increasing amount of corrosion products filled the initial pores in Figure 8c, developing volcano-like structures (Figure 8(c.1)). The coating after immersion shows intact surfaces (the smooth regions), without apparent corrosion morphology, supported by the elemental compositions in Figure 8d that the elements (O, Mg, Al, and P) vary insignificantly. By comparison, the materials inside the pores are under corrosion by the SEM observations and the elemental compositions in Figure 8e. For the corrosion products inside the pores, the amount of Mg increases, indicating the dissolution of the underlying Mg metal and the formation of corrosion products inside the pores. The new-formed corrosion products are mainly Mg oxides/hydroxides because the amount of P is a trifle in Figure 8e.

Figure 8. Elemental compositions of corrosion products of AZ91 alloy and MAO-coated alloy at different immersion times in a 3.5% NaCl solution. (a–c) the coating surface morphology after 5, 25, and 45 min immersion; (a.1–c.1) the localized corrosion morphology; (d) the weight percent (wt.%) of the elements on the smooth corroded surface; (e) the weight percent (wt.%) of the elements in coating pores.

For the coated alloy, it is interesting that the MAO-coated alloy exhibits high resistance in the case that the coating has considerable pores and cracks. Firstly, the 25–30 μm thick phosphate/oxide ceramic composites stifle uniform chemical dissolution. Secondly, at the early-stage immersion, although corrosion of the underlying Mg alloy proceeds through the through-pores, the electron transfer rate from alloy to solution is limited spatially due to the thick coating, and thus, the charge transfer resistance is very big. Moreover, the through-pores are isolated before coating ruptures in a large area at the early-stage immersion. From Figure 9, R_{CT} and R_{ZF} decrease with immersion time, indicating an increased corrosion rate. The isolated through-pores offer passageways for corrosive media penetrating the underlying alloy. As a result, corrosion occurs inside the pores to deteriorate the protection of the coating (Figure 8(b.1,c.1)). Accordingly, the localized corrosion of the underlying alloy accelerates with time, but the overall corrosion rate of the coating is relatively small, and the coating is still intact from the surface appearance (the smooth regions in Figure 8).

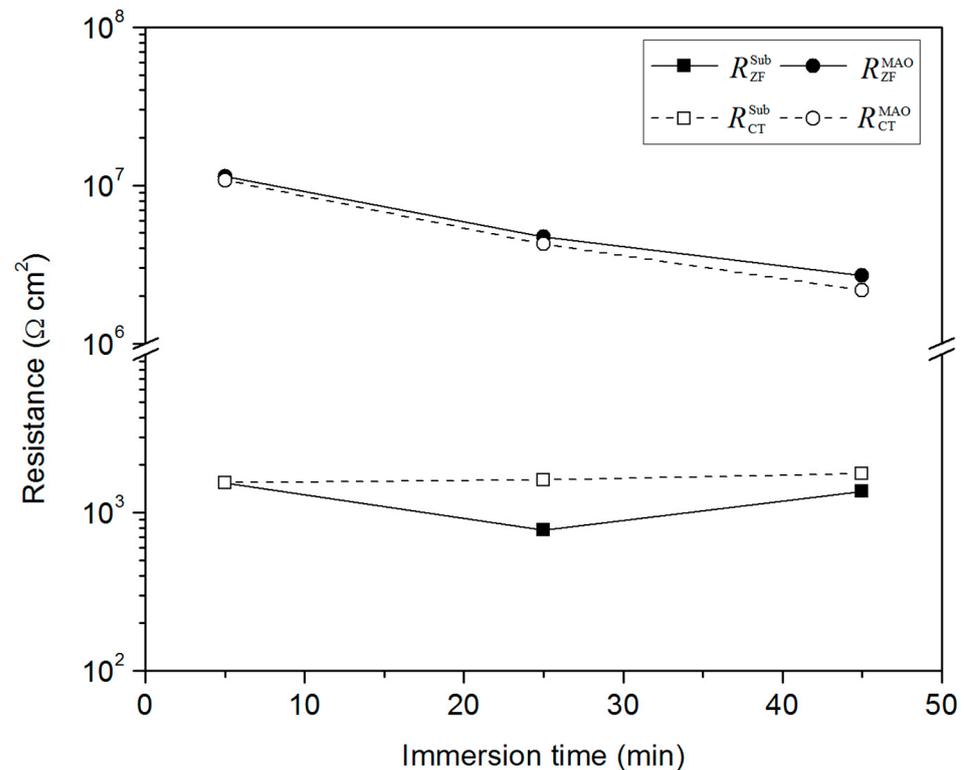
Figure 9. Comparison of R_{CT} and R_{ZF} of AZ91 alloy and MAO-coated alloy from fitted EIS results at different immersion times in a 3.5% NaCl solution.

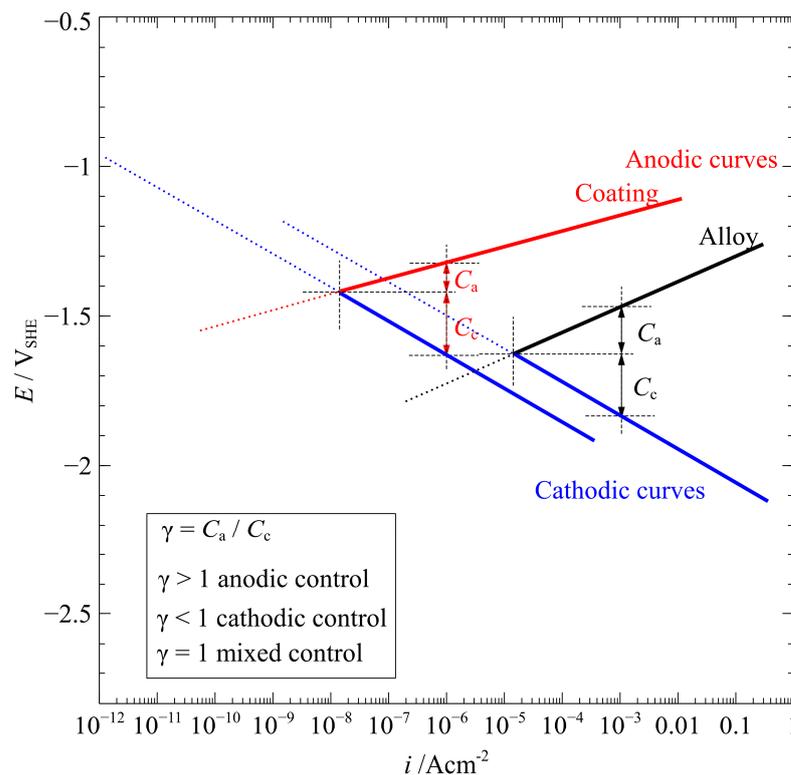
Theoretically, metal corrosion can be classified as being under anodic, cathodic, or mixed control. If the metal is under cathodic control, small changes in current density result in larger changes in cathodic potential than in anodic potential [6]. In order to evaluate the corrosion-control reaction, an ideal schematic mechanism of anodic and cathodic curves for the alloy after 1 h corrosion is shown in Figure 10. At the macroscopic level, it is revealed that corrosion of the AZ91 alloy is under cathodic control ($\gamma = C_a/C_c < 1$) for the 1 h immersion corrosion in a 3.5 % NaCl solution. However, at the microscopic level, pit corrosion initiates due to the attack of Cl^- on the bared Mg metal. Subsequently, oxides/hydroxides form on the pits, developing volcanic-like structures. The deposition of oxides/hydroxides indicates the locally high $[\text{Mg}^{2+}]$ and pH on the corroded area. In this case, the Mg oxidization reaction controls the electrochemical corrosion, suggesting an anodic control. Moreover, the volcanic-like structures slow down the propagation rate of pitting corrosion, possibly because the chemical reaction (7) proceeds from products to reactants at a very high pH.

Overall, the corrosion of the AZ91 alloy in a 3.5% NaCl solution is generally under cathodic control since the Mg oxidation reaction proceeds freely without obstruction from oxides/hydroxides film, leading to quasi-uniform corrosion. Although pitting corrosion initiates and propagates with time, the local formation of corrosion products makes the pitting corrosion seem insignificant to the overall damage.

Figure 10. An ideal schematic mechanism of anodic and cathodic curves for AZ91 alloy and MAO-coated alloy after 1 h immersion in a 3.5% NaCl.
