Concept Paper

Non-Destructive Thermography Analysis of Impact Damage on Large-Scale CFRP Automotive Parts

Keywords: non-destructive testing; thermography analysis; impact damage behavior; impact test; structural automotive parts

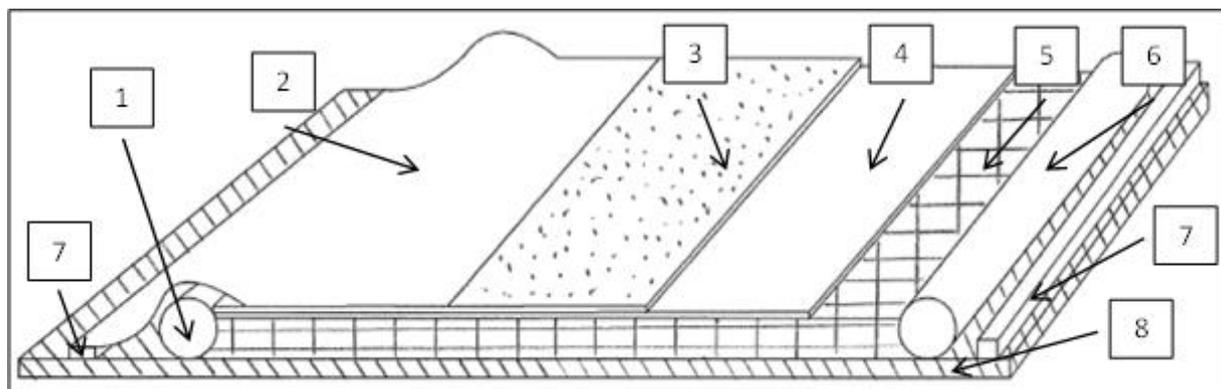
Figure 1. Schematic drawing of a typical vacuum infusion construction; mold assembly: 1, inlet; 2, vacuum bag; 3, distribution medium; 4, peel ply; 5, reinforcement; 6, outlet; 7, vacuum seal; 8, mold die; referring to Correia N.C. *et al.* (2005) [12].

The basic requirement for vacuum infusion is to guarantee that the mold used and the vacuum infusion structure are as airtight as possible. If this precondition of generating an effective vacuum is not fulfilled, the result will be shown in poorly manufactured parts, e.g., parts that include dry spots and/or entrapped air. Inside that area, the reinforcements are placed in order of the possible variety of loadings that they have to resist. In some cases, to improve the laying down of the enforcement parts, it is possible to use a binder to fix the dry reinforcements on the contour of the mold or to use other preform techniques, for example, like stitching and cutting, net-shape preforming or direct fiber. Normally, with vacuum infusion, composite parts with a fiber percentage up to 60% are possible [11]. As the next step, a resin feed wire and a suction wire have to be placed correctly in the mold to guarantee quick and proper resin infusion and impregnation. As an additional chance to improve the results of the vacuum infusion, simulating the infusion process provides extra information and a possible chance to rethink the whole procedure. On top of this construction, a peel ply, flowing agents, resin absorption material for spare resin and the vacuum bag are the last applied components. After finishing the construction, a vacuum test is necessary to check if the whole mold is airtight, and in the case that the test is positive, completing the impregnation can be started by filling the part with resin by using the suction power of the vacuum. Subsequent to the filling and impregnation process, the resin has to cure, and the manufacturing is done [12]. In the following a schematic drawing, a typical vacuum infusion construction is shown (Figure 1).

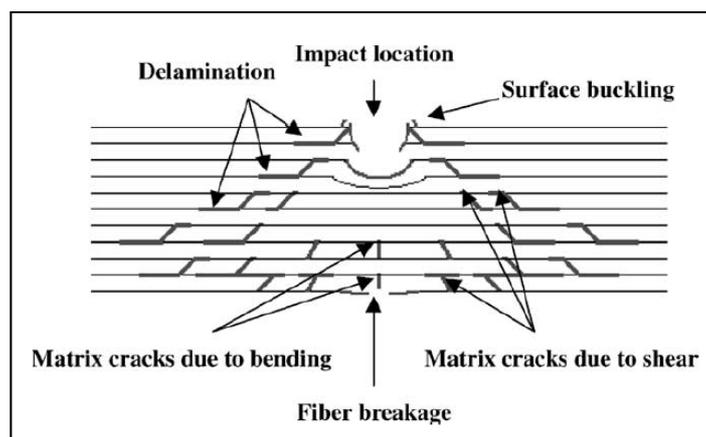
Figure 2. Schematic representation showing a typical impact damage mode for a composite laminate; referring to Tien-Wei S., Yu-Hao P. (2003) [26].

Impact energies can induce complicated forms of damage, for example, as shown in Figure 2. Damage in composites often begins on the non-impact surface or in the form of an internal delamination, and often, the detection and characterization of impact damages are difficult. The impact damage mechanism in a laminate constitutes a very complex process. It is a combination of matrix cracking, surface buckling, delamination, fiber shear-out and fiber fracture, *etc.*, which usually all interact with each other. The delamination caused by the mismatching of the bending stiffness was propagated and aligned along the direction of the fibers [1,13,14]. The delamination pattern is dependent upon the structure of the fabric. It requires an understanding of the basic mechanics and the damage mechanism [15]. As a matter of fact, composites can fail in a wide variety of modes, because nearly every impact damage mechanism reduces the structural integrity of the component. Even barely visible impact damage can cause fatal destruction to the composite parts, because most composite parts are brittle and, therefore, can only absorb energy in an elastic mechanism or damage mechanism [16]. Impact behavior is even more difficult to understand in applications where hybrid composites are used. In many advanced engineering applications, such as the automotive and aviation industries, hybrid composites have been extensively used due to their high strength, low weight, good fatigue life and corrosion resistance. In addition, their behavior under impact loading has been of significant concern in engineering. There are many studies in the literature [17–22] of the impact response of composite materials and structures. For example, Ying [23] has investigated the damage resistance of three types of carbon laminates and fabric reinforced composites and used finite element analysis coupled with a failure technique to predict the impact threshold energy of the laminates. Low velocity impact damage to composite parts, most of the time, are due to both operational and maintenance activities. In the operational environment, there are typically few incidents of low velocity impact damage, and most can be attributed to hailstone strikes and foreign object damage, such as runway debris, e.g., stone thrown by the tires. The major source of low velocity impact damage for structural composite parts is due to mishandling and maintenance mishaps that include part transportation, handling and storage, and incidental tool drops. However, the impact energy is initially absorbed through elastic deformation till a threshold energy value. Beyond this value, impact energy is absorbed through both elastic deformation and the creation of damage through various failure modes. The type of failure depends on the material and geometric properties of both the impactor and target materials. It has been documented by several investigators that damage initiation is manifested in the load-time history as a sudden load drop due to the loss of stiffness from unstable damage development. Subsequently, damage growth will arrest; the composite laminate will reload, and a cycle of damage propagation and arrest occurs until the impactor begins to rebound and the laminate is unloaded [24,25]. However, damage in composites often begins on the non-impacted surface or in the form of an internal delamination. To gather more information about the damage profile caused by an impact test, many testing procedures are used. Several inspection techniques (acoustic emission, thermography, dye penetrant, stereo X-ray radiography, ultrasonic), with different sensitivity levels, can be used for the non-destructive evaluation of composite materials. All these testing procedures are divided mainly into area detection, e.g., thermography analysis and single-point detection, e.g., ultrasonic analysis. Many investigators have studied the empirical relationship between the initial kinetic energy of the

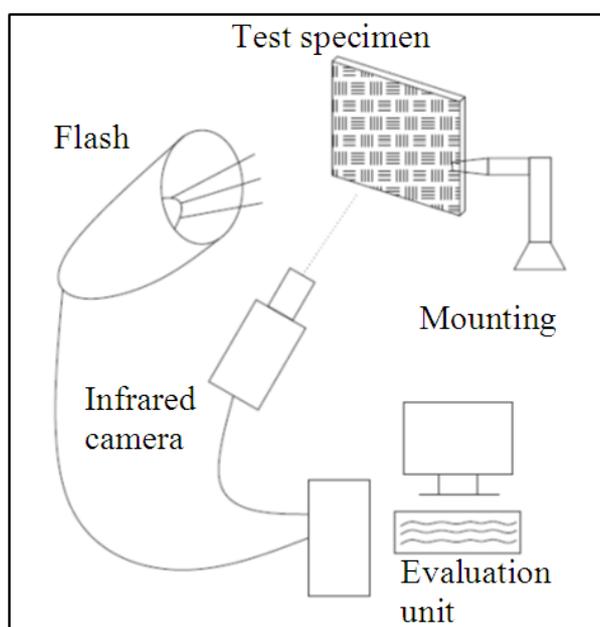
Figure 3. Thermography analysis testing setup.

In our experiments, a flash lamp was used with a 1 ms (full-width half-maximum) heating pulse with an energy of 6 kJ from one xenon flash lamp at a distance of 60 cm from the specimen. The heated side of the CFRP samples was imaged with a commercially available cooled 320×256 pixel InSb (indium-antimony detectors) camera, operating at 385 Hz in the $1.5\text{--}5 \mu\text{m}$ spectral range (Figure 3).

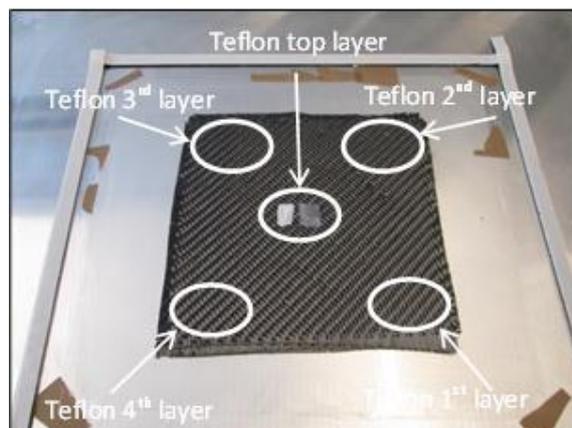
Figure 4. Test specimen, first thermography analysis.

For the first thermography analysis, the testing specimens were produced with dimensions of $400 \text{ mm} \times 400 \text{ mm}$, 5 layers, and between each layer, small Teflon pieces of $10 \text{ mm} \times 10 \text{ mm}$ were positioned to simulate delamination (Figure 4). Due to this stacking, a thickness of the testing specimen of 3.2 mm was reached.

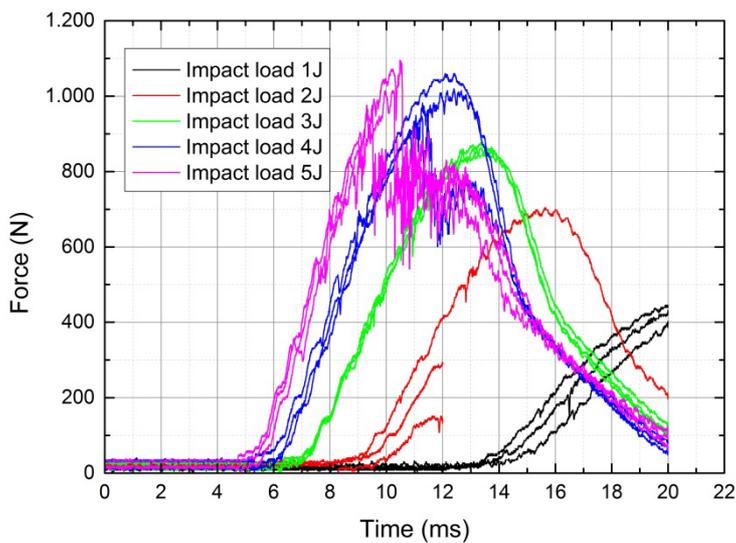
Figure 5. Impact result on the carbon test specimen for 1 J to 5 J.

As shown in Figure 5, it was not possible to detect matrix cracking, surface buckling, fiber shear-out and fiber fracture from the impact results for the impact loads of 1 J to 2 J. The test series under a 1 J and 2 J impact load showed no typical impact response. As a reason for these responses, we found out that the resolution of the testing machine was not great enough for measuring the impact at such low impact energies. Therefore, for the impact tests of 1 J and 2 J, no further evaluations were possible, and the testing series were not used for further analysis. For the impact results for the impact

load of 3 J, it was not possible to detect matrix cracking, surface buckling, fiber shear-out and fiber fracture either, but the testing resolution was high enough, and therefore, we decided to use the impact results for further analysis. For all tests at 4 J and 5 J, at least one aforementioned mechanics failure was detected. For all of the impact tests from 3 J to 5 J, delamination between any of the layers was possible, and therefore, the thermography analysis came in handy. The capabilities of this non-destructive testing method are shown in this work.

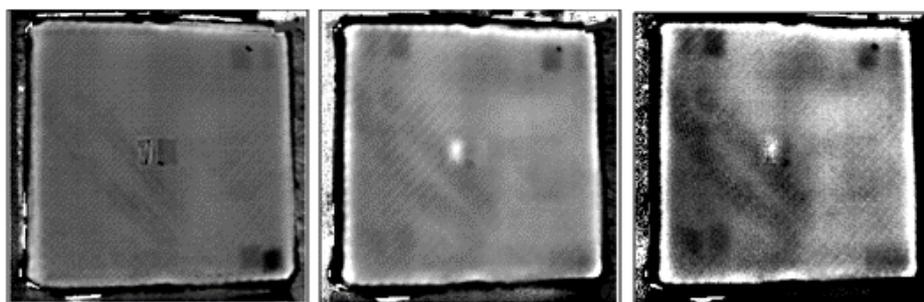
Figure 6. Phase images, after using Thermographic Signal Reconstruction (TSR), of the sample with Teflon inserts, shown in Figure 4. The frequencies of the images are 0.1 Hz (left), 0.15 Hz (middle) and 0.18 Hz (right).

The advantages of the thermography testing are that not only the subsurface defects can be made visible, but also, according to the delay of the response, their depths can be estimated. Teflon inserts are often used in CFRP structures to create artificial delaminations. A specimen, as shown in Figure 3, has been prepared with five layers and with Teflon inserts between them. The temperature response to a flash pulse heating has been evaluated by the PPT technique, following a TSR step, to increase the signal-to-noise ratio of the images. Figure 6 shows the results, and the figures from left to right demonstrate that with the evaluation of different frequencies, it is possible to make deeper and deeper images of the delaminations.

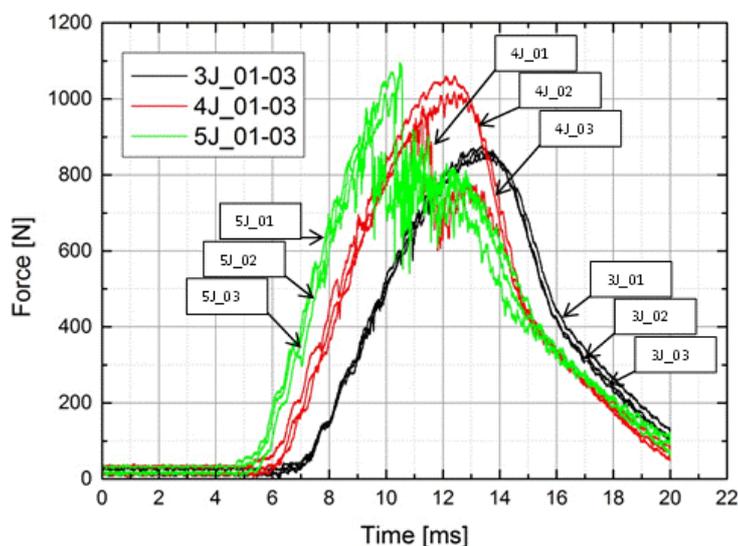
Figure 7. Load/time (F/t) curves of the carbon specimen for thermography analysis.

Figure 7 shows the Load-time (F/t) curves of the carbon testing specimens for thermography analysis at different levels of impact energy as an extract of Figure 5, because in this study, the results will be based on these impact energies. Individually, each curve has an ascending section of loading, reached a maximum load value and has a descending section of unloading. The ascending section of the Load/time curve is called the bending stiffness, due to the resistance of the composite to impact loading, and at this section, the maximum load value reached the highest maximum load; this value is called the peak force.

Typical Load/time curves of composite plates subjected to impact loading have three situations, including rebounding, penetration and perforation. Furthermore, load-time curves, in general, can be classified as closed-type curve and open-type curve. The rebounding case results in closed curves, indicating the rebounding of the impactor from the specimen surface. The closed-type curves return back from the maximum load or the peak force value towards the axis of abscissas means to 0 N force without a sudden load drop due to the loss of stiffness from unstable damage development. These curves are all curves with 3 J impact energy (3J_01–03), and, at an impact energy of 4 J, the second and the third one (4J_02, 03) are as seen in Figure 7.

When the impact energy increases, closed-type curves bound larger areas, and deflection increases while the rebounding section becomes smaller. As seen from Figure 7, at an impact energy of 4 J, there are closed-type (4J_02, 03) curves, but also open-type curves (4J_01). From that point on, as the impact energy continuously increases, the curve type changes from the closed-type to the open one. If a curve is of an open type, the specimen is either penetrated or perforated by the impactor. Therefore, the testing specimen at 5 J (5J_01–03) represents the penetrated case, while the others represent the perforated case, as seen in Figure 7.

At the highest impact energy during this work (5J_01-03), penetration and perforation started to take place for the carbon testing specimen, as shown in Figure 7. The penetration threshold can be defined as the energy level when the impactor gets stuck in the specimen for the first time and does not rebound from the specimen surface any more. The perforation threshold can be defined as the energy level at which the impactor passes through the thickness of the specimen for the first time resulting in permanent catastrophic damage to the specimen. As seen in the visual inspection (Figure 8), all carbon fibers are damaged through the thickness, but compared to the F/t curves, the energy was not enough for the impactor to get stuck in the specimen; a short rebound is seen in Figure 7 for the 5 J tests. Due to the visual inspection, the perforation process started at this point, but a complete perforation (catastrophic damage) was not seen. These results from the impact test and the visual detection are congruent with the result given by the thermography analysis, as seen in Figure 9. As additional information, the bottom pictures in Figure 9 showed two horizontal line marks on the specimen, which refer to the placement of the flowing agent during the vacuum manufacturing. These marks came from the vacuum under pressure and are due to the compaction of the rims of the flowing agent being marked on the composite plates. That result is not a part of this study and, therefore, not evaluated further. The same applies to Figures 11 and 12. However, the thermography analysis displays the damage section (fiber breakage, penetration, lamination, *etc.*) perfectly as a cross in the center of the impact zone. The four pictures at different times show the damage profile through the specimen thickness and gives a good overview that the impact damage goes through the whole testing piece, and as a conclusion, the thermography analysis is comparable with the F/t curves from the impact tests, therefore, for this stage of damage, the possibility for non-destructive damage detection.

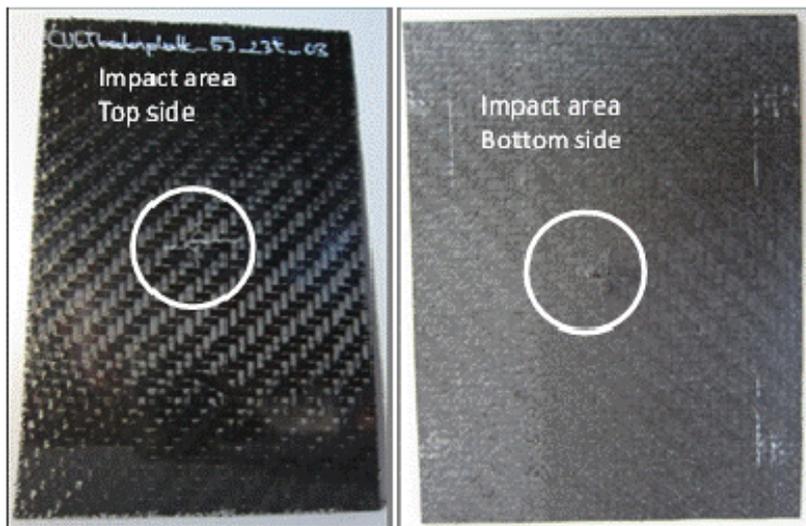
Figure 8. Visual failure detection for an impact energy of 5 J; (left) top side up; and (right) bottom side up.

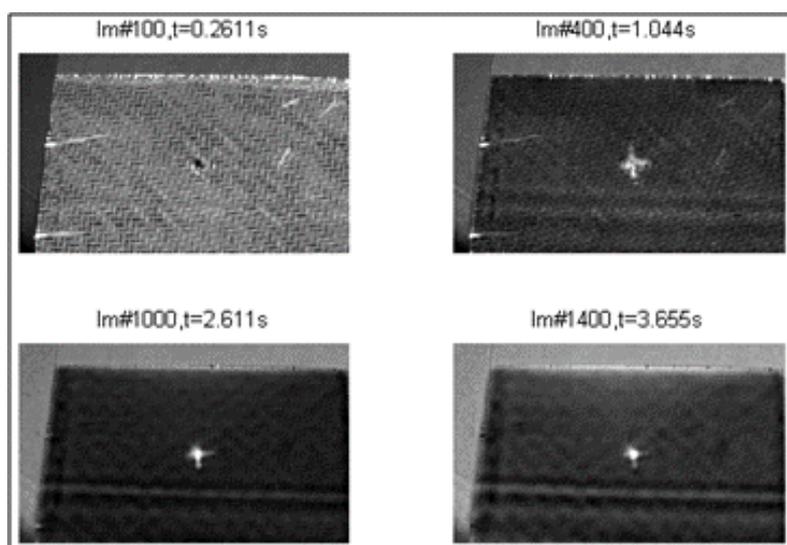
Figure 9. Catastrophic damage of the specimen shown by the thermography analysis after impact testing at 5 J, the second derivative of TSR.

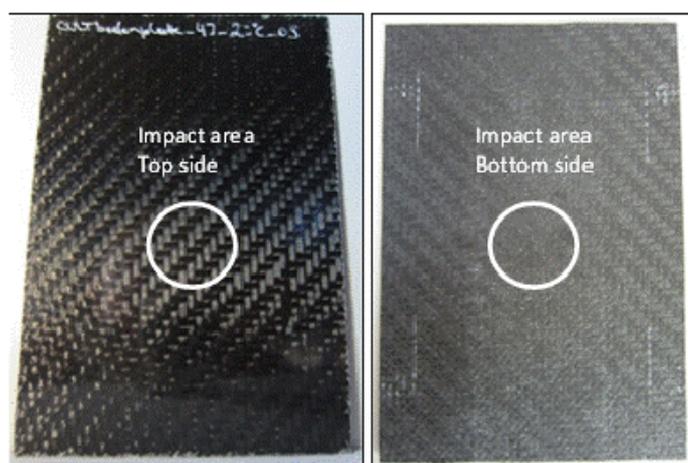
Figure 10. Visual failure detection for an impact energy of 4 J; **(left)** top side up; **(right)** bottom side up.

As the impact energy decreases (4 J), the F/t curves of composites shrink in the negative direction of the horizontal axis, and due to the fact that the damaged composites had to absorb less impact energy, the damage profile of the catastrophic damage picture does not immediately show failure, as expected. F/t curves for 4 J compared with the visual inspection show the same tendency of lesser damage at lower impact energies, except for the testing specimen, 4J_03. These impact tests showed an open F/t curve, and therefore, the beginning of penetration and perforation would be expected. In Figure 10, as seen in the sectioning of the damage, there are no fiber breakages or penetration through the thickness of the carbon layers. The visual inspection of the other 4 J test specimen (4J_01, 02) showed the same result as the specimen, 4J_03. There are only small scratches, and on closer examination, matrix cracking and impact signs (small dots) of the impactor were shown, as seen in Figure 10. Regarding the F/t curves, it seemed that around an impact energy of 4 J, the damage profile

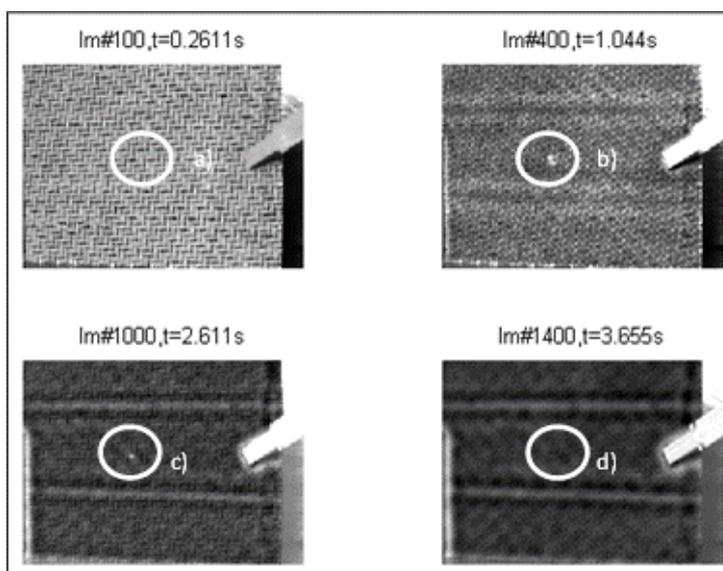
Figure 11. Thermography analysis after impact testing at 4 J, the second derivative of TSR.

is in a transition area between catastrophic damage and possible hidden damage inside the carbon layers. Therefore, heavy damage inside the specimen is possible, but with the F/t curves and the visual inspection, not verified. In part (a) of Figure 11, the thermography analysis showed no damage sign, and due to that very first image, it seemed like the same result as the F/t curves and the visual inspection. Analysis through the thickness of the test specimen thermography pictures (b) and (c) (more time leads to the inner carbon layer) showed damage, seen in Figure 11, as a highlighted spot. That spot means that between the layers, there is delamination caused by the impact test before. In that case, the non-destructive thermography analysis gave the possibility of detecting existing damages inside the specimen, which were not detectable with conventional testing methods. Going on to the last part (d), the thermography did not detect damage at all, and as a conclusion, and compared to the visual detection, the test specimen had no damaged top or bottom layer; only delamination between layers occurred.

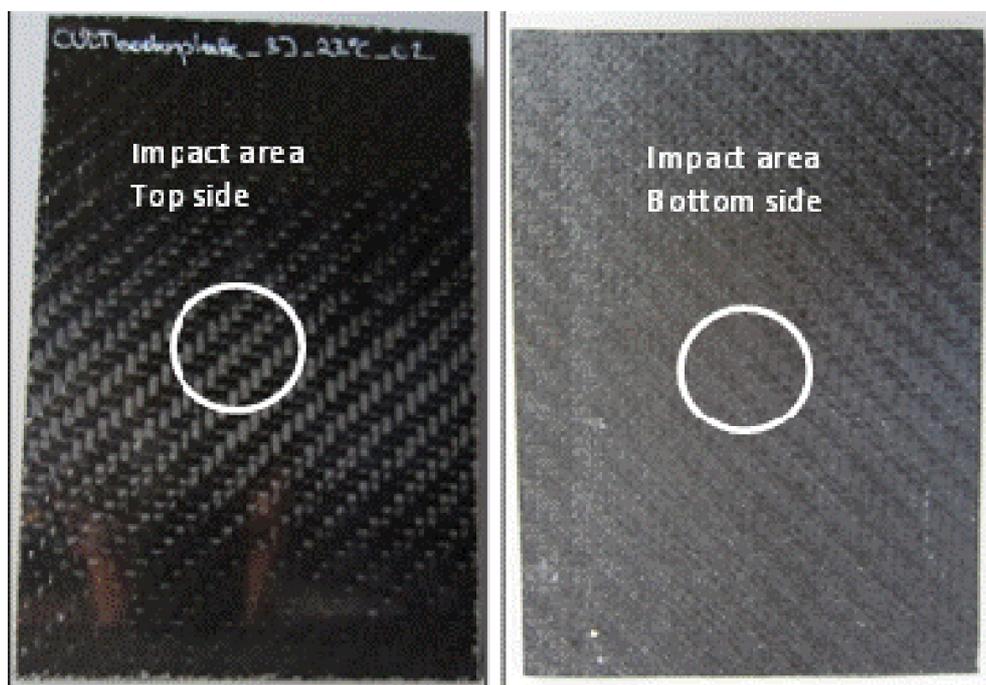
Figure 12. Visual failure detection for an impact energy of 3 J; **(left)** top side up; and **(right)** bottom side up.

For lower impact energies (less than approximately 3 J), the primary damage mode was indentation-induced matrix cracking on impacted surfaces. There were minor matrix cracks on the bottom side of the test specimen, and some delamination could be possible between the inner layers (Figure 12). As shown in Figure 7 (3J_01–03), the impact curve is a closed one, and compared with the visual detection of the top side up or the bottom side up (Figure 12), there is no penetration and/or perforation. As a result of these analyses, there are no failures detected. Nevertheless, interior layer delamination could be possible, but was not detected with the mentioned methods.

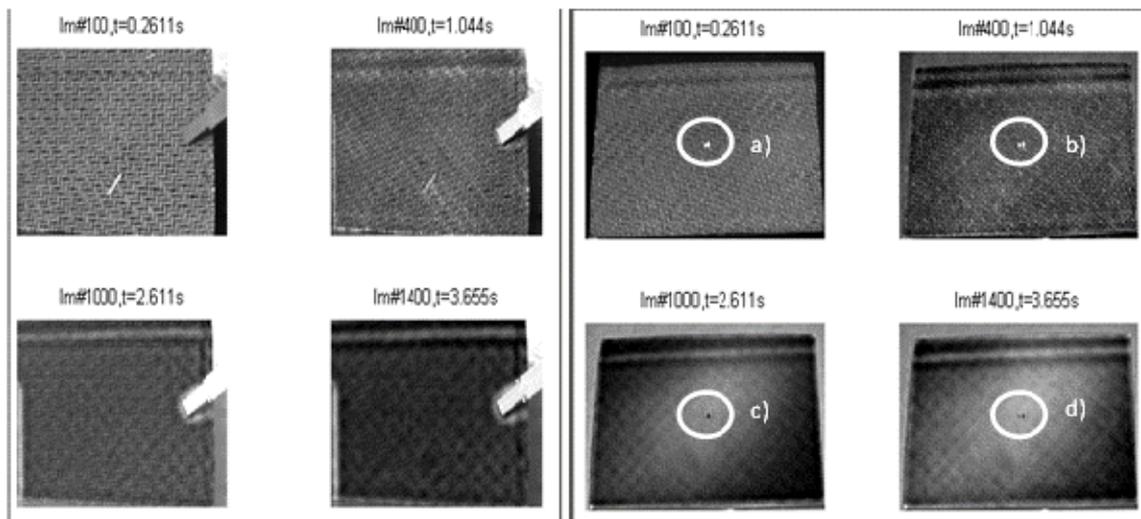
Figure 13. Thermography analysis after impact testing at 3 J; **(left)** top side up; and **(right)** bottom side up; the second derivative of TSR.

At that point, the degree of resolution of the thermography analysis provides, once again, further information of the failure profile of this testing specimen, shown in Figure 13. With the thermography analysis, a small failure crack at the bottom side of specimen was found. In fact, that there is no sudden drop in the F/t curve from the impact test right after peak force, which would detect fiber breakage in interior layers or perforation/penetration, none of these failures were expected. Referring to the visual inspection, the little black dot shown in the right pictures of Figure 13, there is no matrix cracking. One possibility was that this failure could be a delamination between the layers. In Figure 13, the right side, the different parts (a–d) show images along time, and therefore, it could be possible to provide information about the horizontal failure spread. However, for this impact energy, separated from the other analysis results, the non-destructive thermography analysis showed that there is a failure mark due to the impact. If this specimen were a real carbon composite part in a car, as the next step, the impact area, especially, and the area around it should be further inspected, and based on that, a statement about whether this part could be used further on could be made.
