Corrosion Behavior of 30 ppi TAD_{3D}/5A05Al Composite in Neutral Salt Spray Corrosion

Abstract: This study created ceramic preforms with a 3D network structure (TAD_{3D}) by using treated aluminum dross (TAD) and kaolin slurry, with 30 ppi polyurethane foam as a template via the sacrificial template method. TAD_{3D}/5A05Al composites were then produced via pressureless infiltration of 5A05Al aluminum alloy into TAD_{3D}. The corrosion behavior and resistance of TAD_{3D}/5A05Al in salt spray were assessed via neutral salt spray corrosion (NSS), scanning electron microscopy (SEM), potentiodynamic polarization (PDP), and electrochemical impedance spectroscopy (EIS) tests. The results showed that after 24 to 360 h of NSS corrosion, the corrosion of the 5A05 matrix was primarily pitting, with pits expanding and deepening over time, and showing a tendency to interconnect. The main corrosion products were MgAl₂O₄, Al(OH)₃, and Al₂O₃. As corrosion progressed, these products increased and filled cracks, pits, and grooves at the composite interface on the material's surface. Corrosion products transferred to the grooves at the composite interface and grew on the ceramic surface. Corrosion

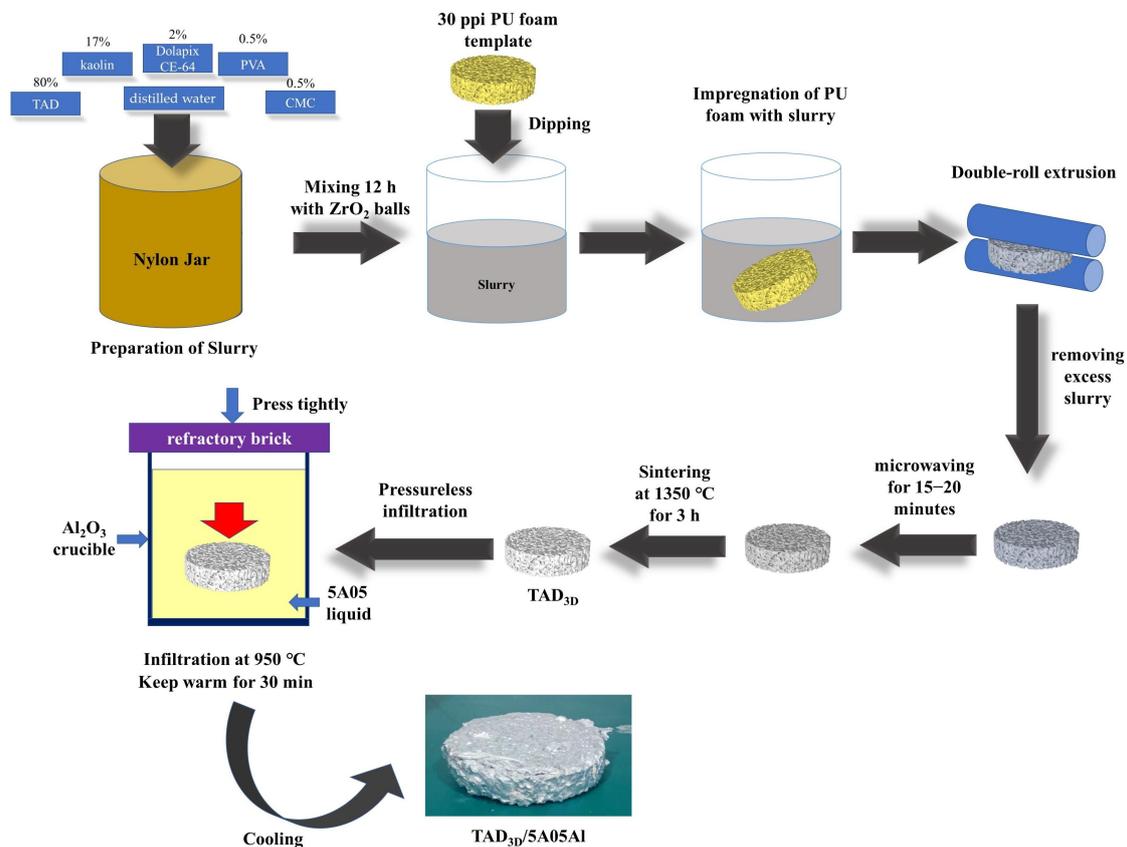
Figure 1. Manufacturing process of the TAD_{3D}/5A05Al composite material.

This study used the polyurethane foam template method to manufacture TAD_{3D} [21]. Figure 1 shows the manufacturing process of the TAD_{3D}/5A05Al composite material. The process involved mixing treated aluminum dross (Inner Mongolia Hengsheng Environmental Protection Technology Co., Ltd., Tongliao, China) and kaolin powders (Lingshou County Huayao Mineral Products Processing Factory, Shijiazhuang, China) with Dolapix CE-64 (dispersant) (Zschimmer-Schwarz (China) Ltd., Foshan, China), Polyvinyl alcohol (PVA) (binder) (Changchun Chemical (Jiangsu) Co., Ltd., Changshu, China), and carboxymethyl cellulose (CMC) (thickener) (Shanghai Shengguang Edible Chemicals Co., Ltd., Shanghai, China) in ratios of 80, 17, 2, 0.5, and 0.5 wt.%, respectively. The compositions of TAD and kaolin are shown in Table 1. This mixture was then added to distilled water and milled with ZrO₂ balls in a nylon jar for 12 h to create a 70% solid slurry and adjusted to pH 9.1–9.8 with ammonia water. A polyurethane sponge template (Changzhou Mukun

Sponge Technology Co., Ltd., Changzhou, China) was dipped into the slurry, the excess was removed via double-roll extrusion (Yiwu Juandu Crafts Factory, Jinhua, China), and air-dried to reveal a coated sponge. This sponge was microwaved (Xuzhou Zhongneng Drying Equipment Co., Ltd., Xuzhou, China) for 15 to 20 min, then sintered in a furnace (KSL1700X, Hefei Kejing Material Technology Co., Ltd., Hefei, China) at 5 °C/min to 1350 °C for 3 h, producing TAD_{3D}.

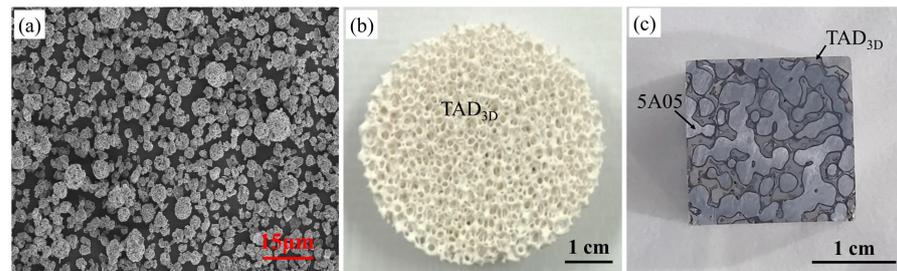
Figure 2. The raw materials, process, and samples for preparing TAD_{3D}/5A05Al composite materials: (a) SEM of treated aluminum dross; (b) TAD_{3D}; (c) TAD_{3D}/5A05Al.

Figure 2 illustrates the raw materials, TAD_{3D}, and sample photographs for the fabrication of TAD_{3D}/5A05Al composite materials. Figure 2a displays the SEM image of processed aluminum dross, revealing its spherical shape. The sintered TAD_{3D} framework, shown

in Figure 2b, transformed into ceramic through body sintering, appearing white with a shrinkage rate of approximately 19%. The compressive strength of the framework was about 2–5 MPa, and the porosity was around 30 ppi. Figure 2c shows a photograph of the cut TAD_{3D}/5A05Al sample, displaying a defect-free appearance. The black striped pattern on the surface represents the TAD_{3D} framework, with approximately 23–26 pores formed per square centimeter. The pore diameter ranged from 1.7 to 2.0 mm and was filled with the 5A05Al alloy exhibiting a silver-white metallic luster. The wetting property between the TAD_{3D} framework and 5A05Al alloy was excellent, resulting in a dense interface between TAD_{3D} and 5A05Al.

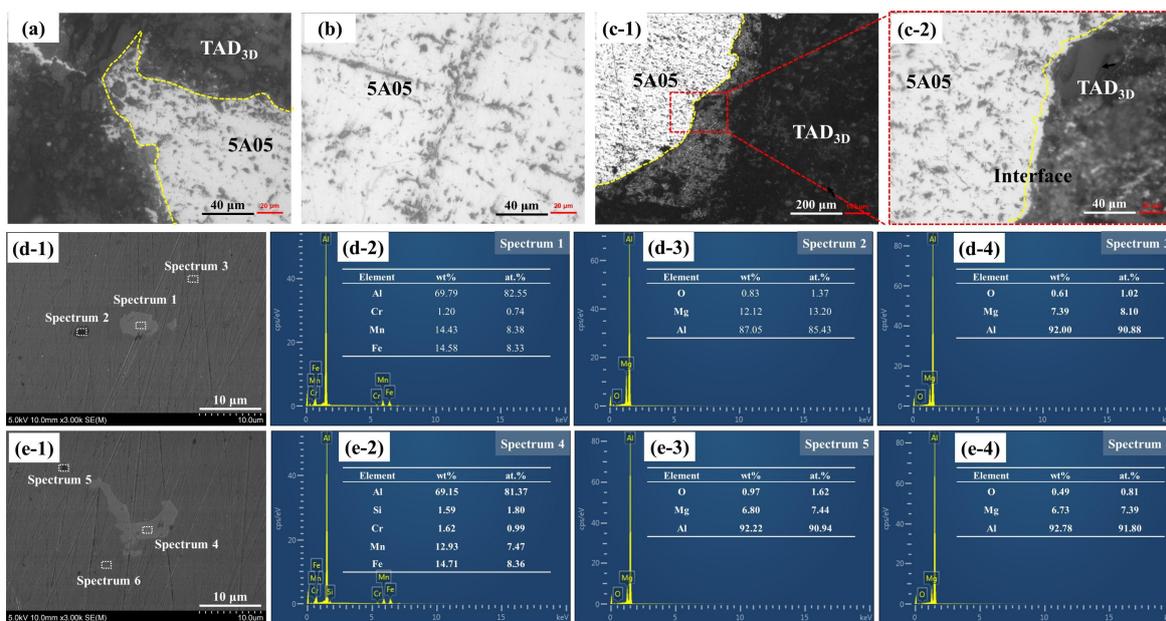
Figure 3. OM and SEM image of TAD_{3D}/5A05Al: (a) OM image of TAD_{3D}; (b) OM image of 5A05Al; (c-1,c-2) OM image of composite interface; (d-1,e-1) SEM image of β-phase; (d-2–d-4,e-2–e-4) EDS point scan spectrum.

Figure 3 shows the microstructure of the uncorroded TAD_{3D}/5A05Al composite. Figure 3a shows that the pores of the ceramic phase were completely filled with 5A05 aluminum alloy. TAD_{3D} was manufactured using the polyurethane foam template method, and it contained triangular voids left by the combustion of the polyurethane foam. In this study, the pressureless melt infiltration method was employed to completely fill the triangular voids of TAD_{3D} with the solution of 5A05Al, achieving a dense IPC structure between 5A05Al alloy and TAD_{3D}. This structure is also referred to as a co-continuous structure, wherein the 5A05 aluminum alloy not only fills the macroscopic large pores with a diameter of 1.7 to 2.0 mm but also completely fills the small voids in TAD_{3D}. The 5A05 aluminum alloy formed a fully interconnected three-dimensional network structure in the composite material, compensating for the hollow defects in the TAD_{3D} framework pillars and significantly enhancing the mechanical and corrosion resistance properties of TAD_{3D}/5A05Al [24]. Figure 3b shows the microstructure of 5A05Al, which revealed that there were a large number of second-phase particles distributed in 5A05Al. Figure 3(c-1,c-2) shows the microstructure of the interface between TAD_{3D} and 5A05Al. It can be seen that the interface between 5A05Al and TAD_{3D} was clear, with a tight bond.

Figure 3(d-1,e-1) show the micromorphology of the second-phase particles in the 5A05 matrix. Figure 3(d-2–d-4,e-2–e-4) show the results of the EDS point scan. Figure 3(d-4,e-3,e-4) show the composition of α -Al phase. In Al-Mg alloys, the α -Al matrix is mainly solid-soluted with Mg and generally does not contain other solutes (Mn, Fe, Cr, or Si) [25]. It can be seen that the α -Al phase was Al-Mg7.4. The results of Figure 3(d-2,e-2) show that the blocky and dendritic precipitates on the aluminum matrix may be (FeMn)Al₆, with a grain size of over 10 to 13 μ m. The results of Figure 3(d-3) show that the precipitates with a grain size of about 2 μ m and darker color in the aluminum matrix may be Mg₂Al₃ [26–28].

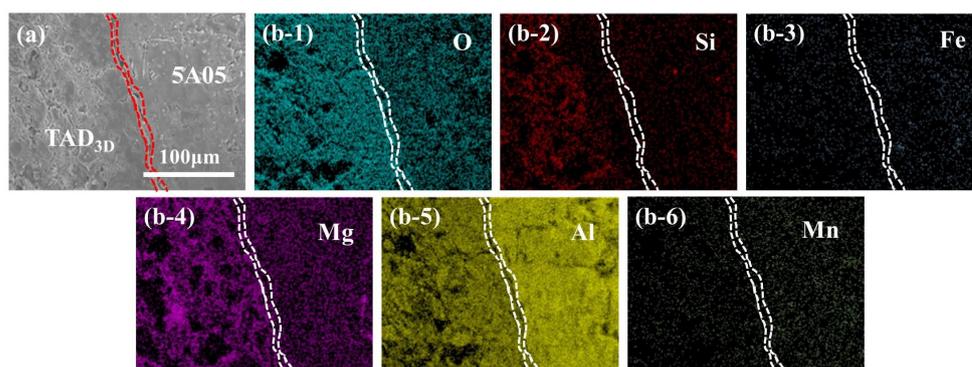
Figure 4. SEM and EDS of TAD_{3D}/5A05Al: (a) SEM of composite interface; (b-1) O; (b-2) Si; (b-3) Fe; (b-4) Mg; (b-5) Al; (b-6) Mn.

Figure 4 shows the SEM and EDS surface scanning images of the composite material. A clear deep crack can be seen between 5A05Al and TAD_{3D}, which is the interface of the composite material. The bonding between 5A05Al and TAD_{3D} is a physical bonding, which can be observed more clearly at the interface after etching with Keller's reagent. EDS showed that 5A05Al alloy was mainly composed of Al, Mn, Mg, Si, and Fe elements, which was consistent with its alloy composition. A Si–Mg enrichment band can be observed on the right side of the element distribution map, which may be the precipitated phase Mg₂Si, which was not observed in Figure 3 [29]. Al, O, Si, and Mg elements were enriched in TAD_{3D}, because TAD_{3D} was prepared from Al₂O₃, MgAl₂O₄, and MgO in TAD and Al₂O₃,

SiO₂ in kaolin. For the same reason, there was almost no Fe and Mn element in TAD_{3D}. It is worth noting that the silicon element in TAD_{3D} decreased significantly near the interface. It can be seen from Figure 4a that the ceramic surface near the interface was dense, while TAD_{3D} had more pores away from the interface. The silicon element in TAD_{3D} was mainly distributed in the porous area. The dense ceramic layer at the interface may be due to the fact that during the composite process, the aluminum melt reacted with SiO₂ in TAD_{3D} to reduce SiO₂ near the interface to the Si, and the Si diffused into the aluminum melt [30]. It may also be caused by the unevenness of the ceramic itself.

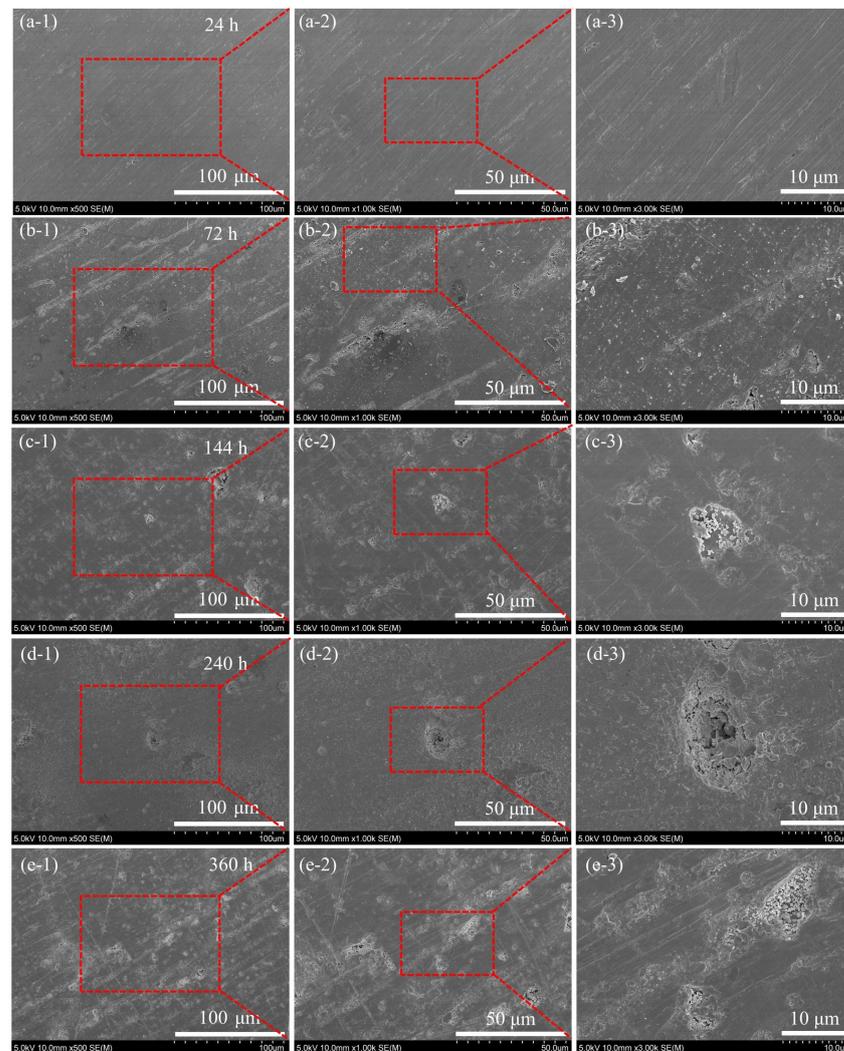
Figure 5. SEM images of 5A05Al matrix in TAD_{3D}/5A05Al after removing corrosion products at different NSS corrosion durations: (a-1–a-3) 24 h; (b-1–b-3) 72 h; (c-1–c-3) 144 h; (d-1–d-3) 240 h; (e-1–e-3) 360 h.

Figure 5 illustrates the microstructure of 5A05Al after the removal of corrosion products. Figure 5(a-1–a-3) show the microstructure after 24 h of NSS corrosion, with few micron-sized pits observed on the surface of the 5A05Al alloy. Figure 5(b-1–b-3) reveal the microstructure after 72 h of NSS corrosion. Compared with the 24 h samples, deep pits with several microns in diameter can be observed. The corrosion behavior was mainly mild pitting. This phenomenon was likely caused by galvanic corrosion in the β-phase Mg₂Al₃. The potential difference between phases plays a significant role, with a larger difference

increasing the likelihood of corrosion. In the 5A05 aluminum alloy, the potential of α -Al was around -800 mV, while the β -phase Mg_2Al_3 was around -900 mV. This made the β -phase more negatively charged and therefore more susceptible to anodic dissolution. Microstructures in Figure 5(c-1–c-3) reveal the surface of 5A05Al after 144 h of NSS corrosion. Larger pitting pits with diameters of 10 to 20 μm were observed on the sample surface. This proved that extending the NSS time further promoted the occurrence and development of pitting. The depth of pitting corrosion increased, leading to exfoliation corrosion and a decrease in the corrosion resistance of the material. Microstructures in Figure 5(d-1–d-3) depict the surface of 5A05Al after 240 h of NSS corrosion. Compared to the 144 h mark, the areas of pitting corrosion continued to increase and take on an elliptical shape. This indicated the presence of localized corrosion features with corrosion areas predominantly appearing as punctate or cellular. Notably, the edges of the pitting corrosion pits on the surface of 5A05Al were covered by a small amount of aluminum oxide. It is worth mentioning that some metastable pitting pores continued to grow, leading to diameters exceeding 20 μm in certain cases. Figure 5(e-1–e-3) show the microstructure after 360 h of NSS corrosion. Compared with the previous corrosion characteristics, it can be seen that the corrosion was further intensified, the pitting pits on the surface were enlarged, and there was a tendency to connect with each other.

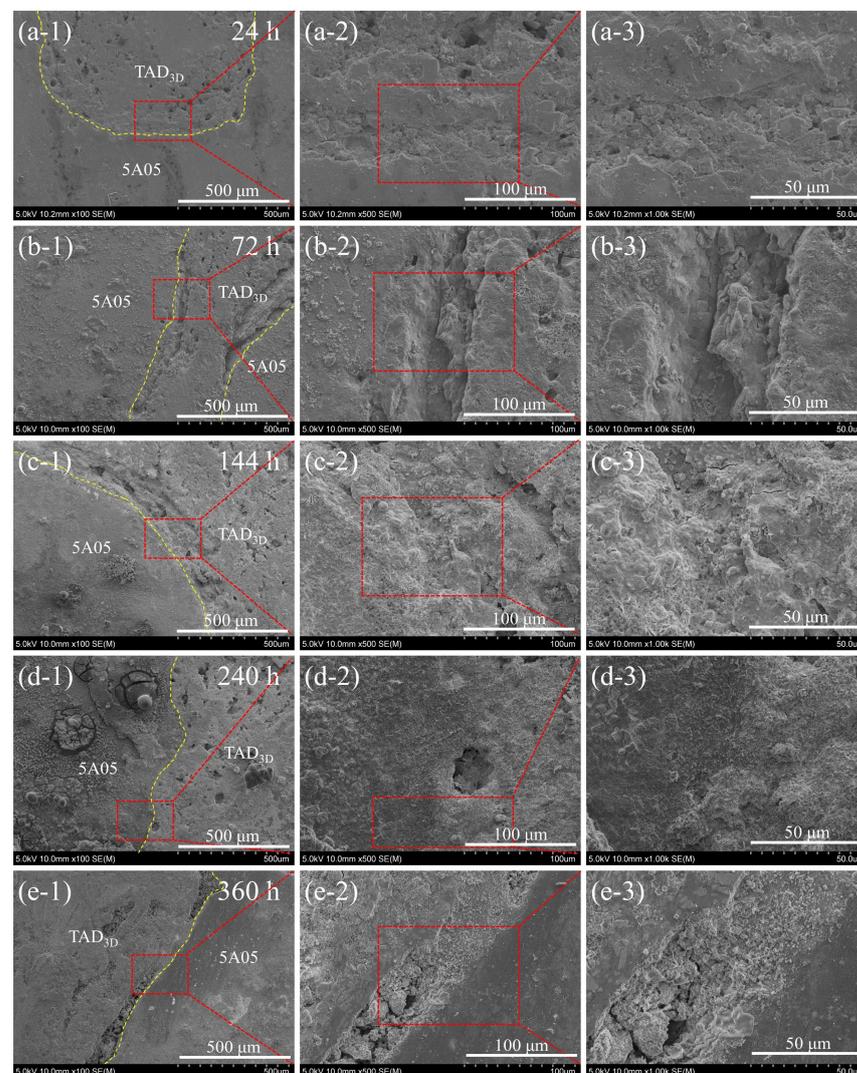
Figure 6. SEM images of the interface in TAD_{3D}/5A05Al with corrosion products after NSS corrosion for different durations: (a-1–a-3) 24 h; (b-1–b-3) 72 h; (c-1–c-3) 144 h; (d-1–d-3) 240 h; (e-1–e-3) 360 h.

Figure 6 shows the SEM images of the corrosion products at the interface of TAD_{3D} and 5A05Al after NSS corrosion for 24, 72, 144, 240, and 360 h, respectively. Figure 6(a-1–a-3) show that after 24 h of NSS corrosion, the interface was intact. Pores can be seen on the TAD_{3D}, which were defects left by incomplete densification of TAD sintering. No obvious pitting was observed on the 5A05Al side. Figure 6(b-1–b-3) show that after 72 h of NSS corrosion, a small amount of spot-like agglomerated corrosion products were generated on the 5A05Al side. The pores on the TAD_{3D} were reduced and filled with corrosion products. Figure 6(c-1–c-3) show that after 144 h of NSS corrosion, cluster-like corrosion products with a diameter of about 200 μm appeared on the 5A05Al side. The TAD_{3D}, especially the composite interface, was covered by corrosion products. Figure 6(d-1–d-3) show that after 240 h of NSS corrosion, there were still large spherical protruding corrosion products on the 5A05 substrate, and severe pitting may have occurred below them. There was no obvious interface in the composite material. Figure 6(e-1–e-3) show that after 360 h of NSS corrosion, there were deep grooves at the interface between 5A05 and TAD_{3D}, which were filled with corrosion products, but still contained deep holes and grooves with loose structures. These types of defect are very dangerous because local corrosion can reach deep into the composite and destroy the material.

penetrate into the groove and remain there for a long time, leading to serious corrosion. Overall, combined with the analysis of Figures 6 and 7, it can be seen that although the corrosion products filled the grooves of the composite interface, the TAD_{3D} and 5A05Al jointly produced continuous corrosion products. However, the interface of the composite material was still the weak link of corrosion.

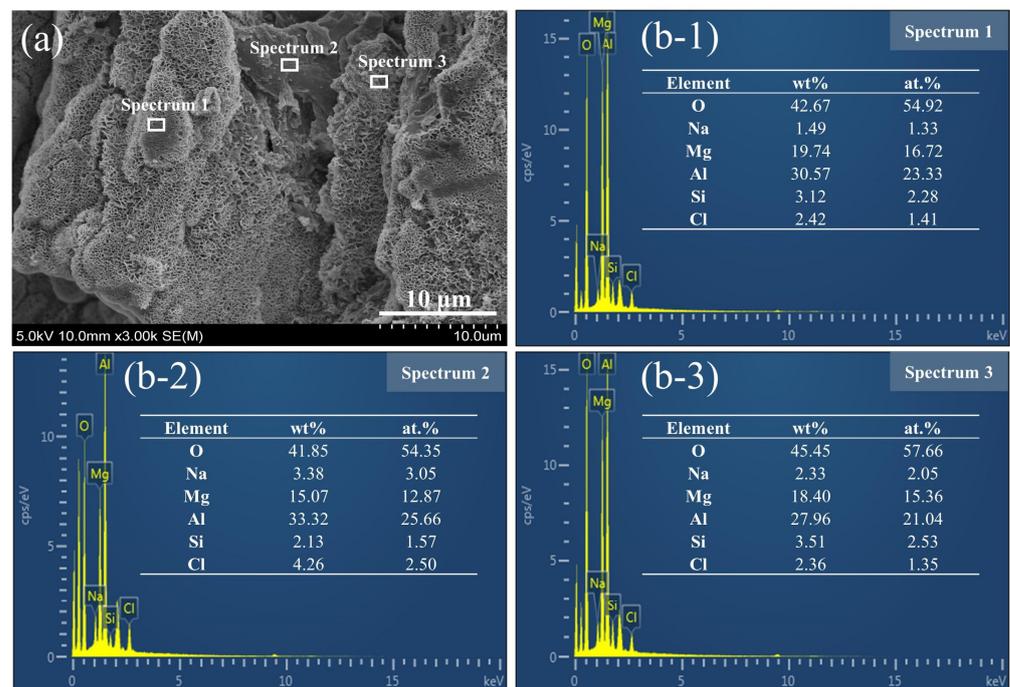
Figure 7. EDS point scan images of corrosion products at the interface in TAD_{3D}/5A05 after 72 h of NSS corrosion: (a) SEM image; (b-1–b-3) energy spectrum and composition.

To further investigate the composition of the corrosion products at the interface of the TAD_{3D}/5A05 composite material after 72 h of NSS, the interface was magnified. Figure 7 shows the EDS point scanning image of the corrosion products at the interface. As can be seen in Figure 7a, the ceramic skeleton at the interface groove was covered with a large amount of lamellar structure material. These substances may be formed by the deposition of substances that were dissolved after the 5A05 matrix was corroded and transferred with the corrosive liquid during the corrosion process. According to the point scanning results of Figure 7(b-1–b-3), the main components of the corrosion products were O, Al, and Mg. Therefore, the corrosion products may be composed of MgAl₂O₄, Al(OH)₃, and Al₂O₃. Based on Figures 6 and 7, it can be seen that the TAD_{3D} skeleton easily adsorbed and grew corrosion products, so that the composite interface was filled with corrosion products. The corrosion products generated by the 5A05 matrix were combined with the corrosion products on the TAD_{3D} to form a continuous passivation layer, which had some corrosion protection effect.

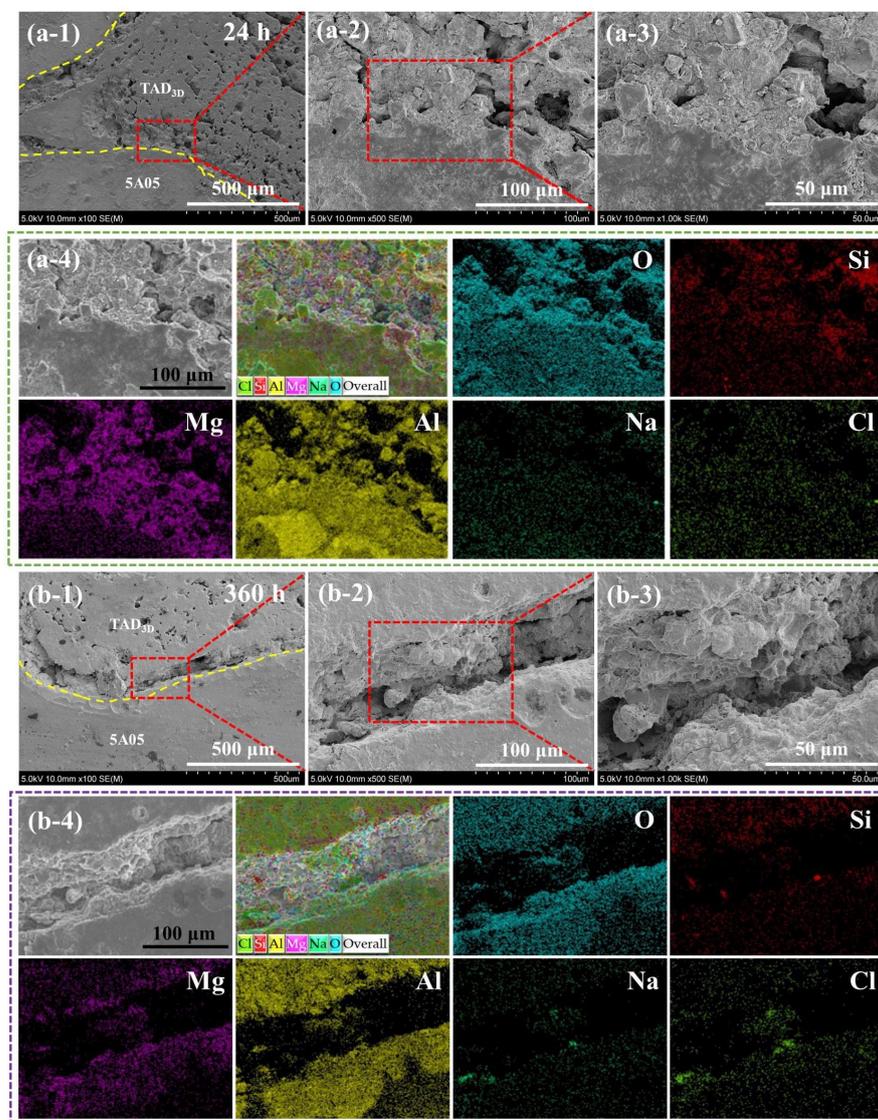
Figure 8. SEM images and EDS of the interface in TAD_{3D}/5A05Al after removing corrosion products at different NSS corrosion durations: (a-1–a-3) SEM of 24 h sample; (a-4) EDS of 24 h sample; (b-1–b-3) SEM of 240 h sample; (b-4) EDS of 240 h sample.

To better understand the microstructure of the 5A05Al/TAD_{3D} interface after NSS, SEM and EDS analysis were performed after removing the corrosion products. Figure 8 shows the SEM images of the composite interface after removing the corrosion products from the 24 and 360 h samples, as well as the EDS analysis images. Figure 8(a-1–a-3) show the morphology of the composite interface after removing the corrosion products from the 24 h sample. It can be seen that although there were more pores on the TAD_{3D}, the TAD_{3D} and 5A05 matrix were relatively tight. As can be seen from the element distribution map in Figure 8(a-4), although the corrosion products were removed, there were still Na and Cl enrichment points. Figure 8(b-1–b-3) show the morphology of the composite interface after removing the corrosion products from the 360 h sample. Compared with 24 h, it can be clearly seen that a large gap formed between the TAD_{3D} and the 5A05 matrix. This gap may have been caused by local corrosion at the interface of the two phases during the corrosion process. It can be seen that the gap was deep and the internal structure was loose. As can be seen from the element distribution map in Figure 8(b-4), some NaCl remained in the groove, indicating that the loose structure in the groove made it easy for Cl⁻ to

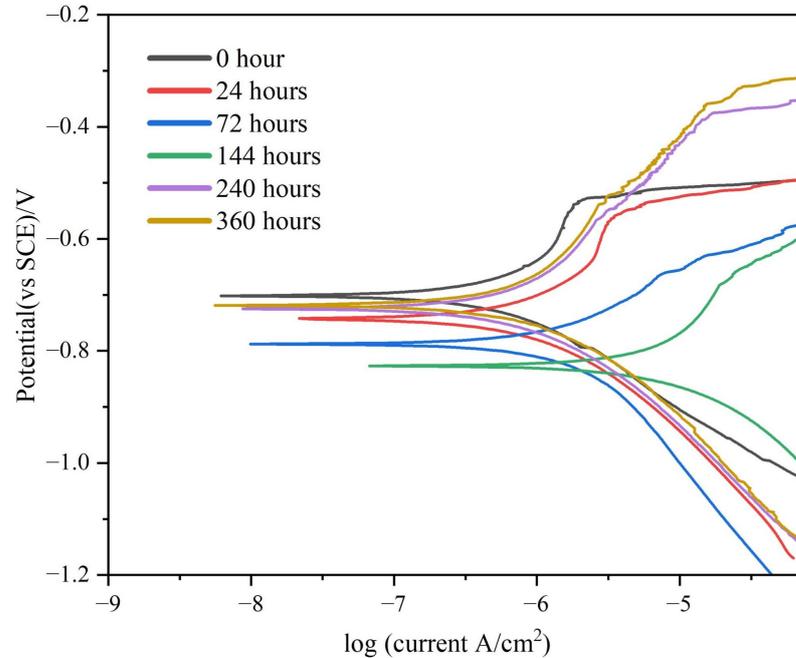
Figure 9. PDP of TAD_{3D}/5A05Al with corrosion products after different NSS durations in 3.5% NaCl.

To investigate the corrosion resistance of samples after different NSS times, PDP tests were conducted on specimens with corrosion products. Figure 9 presents the PDP polarization curves of TAD_{3D}/5A05Al with corrosion products after different NSS durations. The polarization curve trends of TAD_{3D}/5A05Al were similar at different NSS times. Table 3 provides the E_{corr} and I_{corr} values of TAD_{3D}/5A05Al at various NSS corrosion times. It is evident from the table that, during the NSS corrosion period from 0 to 144 h, the E_{corr} value decreased. After 144 h of NSS corrosion, E_{corr} decreased to a minimum of -0.932 V, indicating the breakdown of the passive film and a reduction in corrosion resistance. As NSS corrosion progressed from 240 to 360 h, the E_{corr} value increased, reaching -0.712 V

after 360 h of NSS corrosion, slightly lower than the E_{corr} value of the uncorroded sample (-0.710 V). This suggested that, after 240 h of NSS corrosion, a significant amount of corrosion products formed on the surface of the composite material, protecting it and leading to an increase in corrosion voltage, a decrease in corrosion rate, and enhanced corrosion resistance. By 360 h of NSS corrosion, a complete corrosion product film formed on the surface, continuing to elevate the corrosion voltage, exerting inhibitory effects on corrosion, further reducing the corrosion rate, and enhancing corrosion resistance.

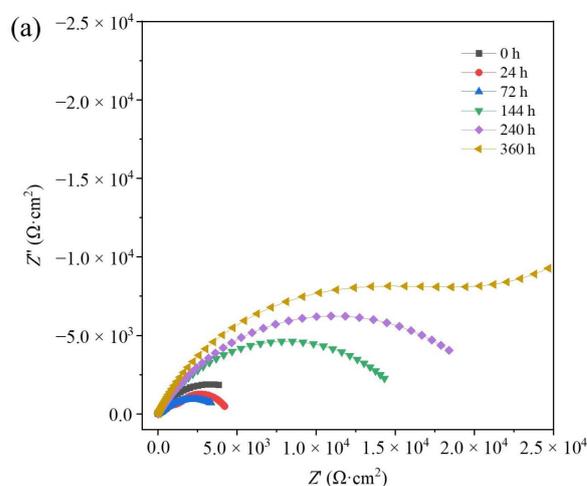
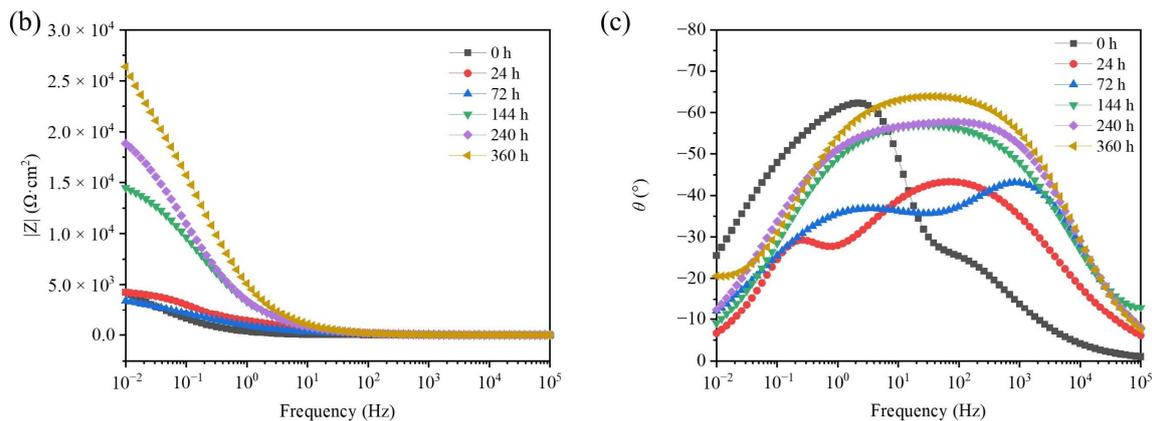
Figure 10. EIS of TAD_{3D}/5A05Al with corrosion products after different NSS durations: (a) Nyquist diagram; (b) Bode diagram ($|Z|-F$); (c) Bode diagram ($\theta-F$).

Figure 10 depicts the EIS of TAD_{3D}/5A05Al with corrosion products. The Nyquist plot comprises capacitive arcs (Figure 10a). The high-frequency capacitive arc corresponds to the corrosion products on the surface of TAD_{3D}/5A05Al, representing the resistance of the corrosion products and the surface passive film. The radius of the high-frequency capacitive arc was directly proportional to corrosion resistance. The low-frequency capacitive arc corresponds to electrochemical corrosion reactions on the electrode surface. With the increase in NSS time, the capacitance resistance arc in the high-frequency region initially decreased and then increased, indicating the slow formation of corrosion products on the surface of TAD_{3D}/5A05Al. From Figure 10b, it can be observed that $|Z|$ showed a trend of first decreasing and then increasing with the increase in NSS time, and the peaks of the high-frequency and mid-frequency θ shifted towards the low-frequency direction. From Figure 10c, it can be observed that in the Bode plot, the separation degree of the two-phase angle peaks at 24 h was slight. This was because the pit corrosion extended laterally and longitudinally, and when the pitting had just developed into intergranular corrosion of precipitated phases and α -Al, the intergranular corrosion was not yet apparent. However, after NSS 72 h, the radius of the capacitive arc in the low-frequency region in the Nyquist plot was smaller compared to NSS 24 h, indicating a decrease in corrosion resistance. In the Bode plot, it can be seen that compared to the two-phase angles at 24 h, the separation degree of the two-phase angles at 72 h was more pronounced. This was because when corrosion reached the interface of TAD_{3D}/5A05Al, there were tiny cracks caused by thermal expansion at the TAD_{3D} and 5A05Al interface. Underneath the cracks, a new interface was formed, leading to the appearance of a low-frequency phase angle peak. As the NSS corrosion time increased, the corrosion severity between grains and interfaces intensified, and the gap at the interface between TAD_{3D} and 5A05Al widened, resulting in a clear separation of the two-phase angle peaks. After NSS 144 h, the radius of the capacitive arc in the Nyquist plot decreased compared to NSS 72 h, while the phase angle in the low-frequency region began to increase, and the impedance modulus increased, indicating the initiation of corrosion product formation. Following NSS 240 h, the capacitive arc radius increased, and the impedance modulus at low frequency significantly rose. The peak values of the phase angle in the low-, medium-, and high-frequency regions all increased, suggesting an increase in corrosion products and an enhancement in material corrosion resistance. After NSS 360 h, the capacitive arc radius significantly increased compared to NSS 240 h, and the impedance modulus at low frequency markedly rose. The low-frequency phase angle region became wider, and the peak values of the phase angle were close to those at NSS 240 h. According to the morphology of the corrosion products, the corrosion product layer at this stage was most dense, resulting in an improved corrosion resistance.
