Foulant Analysis of Three RO Membranes Used in Treating Simulated Brackish Water of the Iraqi Marshes

Abstract: In this work, three different types of Reverse Osmosis (RO) (Thin-Film Composite (SE), Cellulose Acetate (CE), and Polyamide (AD)) were used to perform foulant analysis (autopsy) study on the deposited materials from three different simulated brackish surface feed waters. The brackish surface water qualities represented the water quality in Iraqi marshes. The main foulants from the simulated feed waters were characterized by using Scanning Electron Microscope (SEM) images and Energy-Dispersive X-ray Spectroscopy (EDXS) spectra. The effect of feed water temperatures (37 °C and 11 °C) on the formation of the fouled material deposited on the membrane surface was examined in this study. Also, pretreatment by a 0.1 micron microfiltration (MF) membrane of the simulated feed water in advance of the RO membrane on the precipitated material on the membrane surface was investigated. Finally, Fourier Transform Infrared Spectroscopy (FTIR) analysis was used to identify the functional groups of the organic matter deposited on the RO membrane surfaces. The SEM images and EDSX spectra

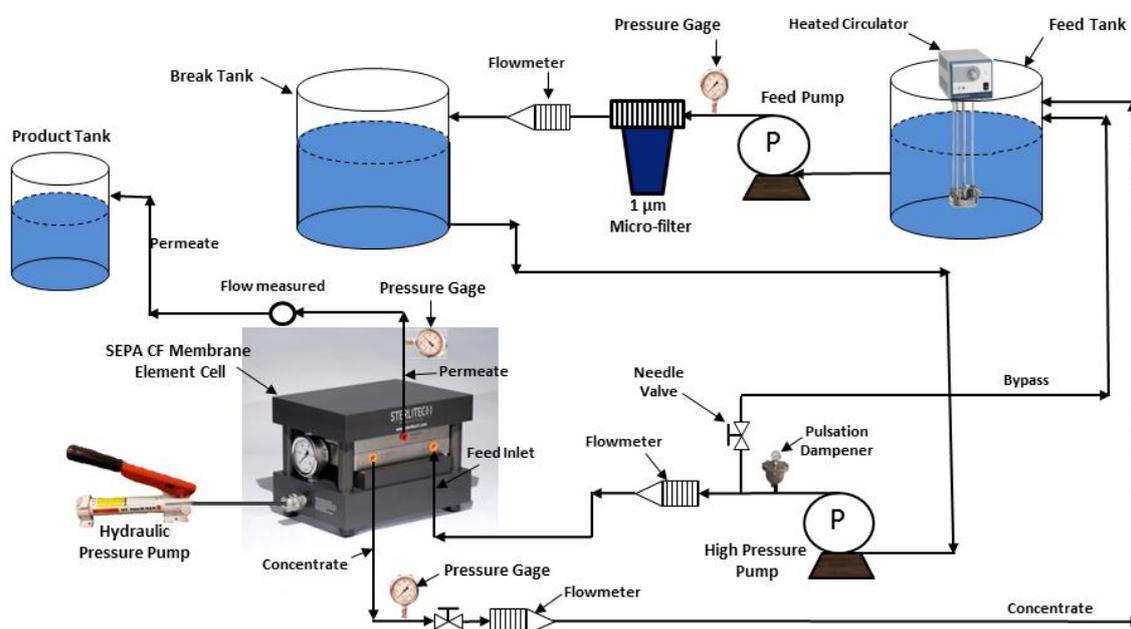
Experiments were conducted in a commercial bench-scale cross-flow filtration unit, a stainless steel SEPA CF Membrane Element Cell (Sterlitech Corporation, Kent, WA, USA). The SEPA CF Membrane Cell is designed to handle a maximum pressure of 6895 kPa and to accommodate a 19.1 cm × 14 cm flat sheet membrane. A 48-L batch of prepared brackish surface feed water was pumped at a constant flow rate of 2.27 Lpm from the feed tank through a 1-µm filter cartridge to the break tank using low pressure feed pumps (MasterFlex, Cole-Parmer Instrument Co., Chicago, IL, USA). Then the feed water was pumped at the same flow rate through the RO membrane filtration cell using a high-pressure pump (M-03S Hydracell CC Pump, Wanner Engineering, Inc., Minneapolis, MN, USA). The system pressure was kept in the range of 2620–2757 kPa using two high pressure needle valves. A schematic diagram of the experimental system is shown in Figure 1. Additional information on experimental systems setup is described elsewhere [19].

Figure 1. Schematic diagram of the experimental RO system.

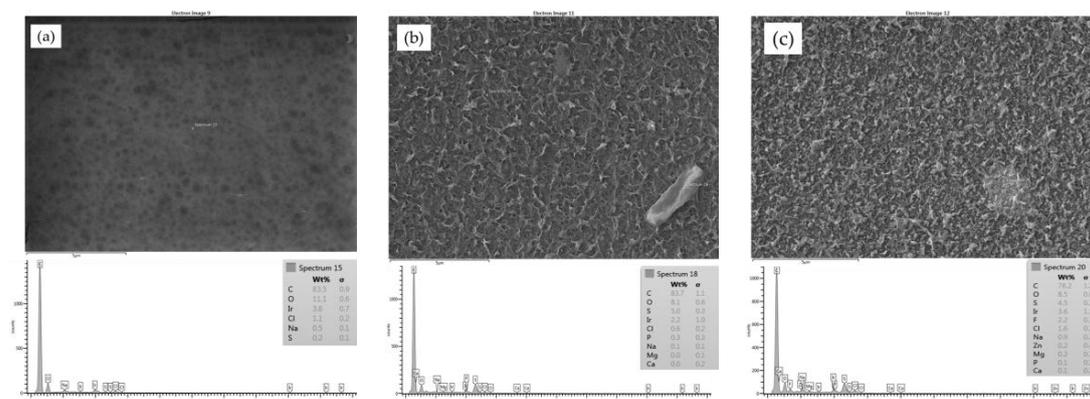
Initially, samples from the clean CE, SE and AD membranes were imaged by the SEM, and corresponding EDXS spectra were taken to reveal the morphology of the membrane surfaces and to also compare them to the fouled membranes surfaces. The SEM images of the unused membranes showed that the surface of the cellulose acetate (CE) membrane had a very smooth morphology, as shown in Figure 2a, compared to a rough surface morphology of the SE and AD membranes, as shown in Figure 2b,c, respectively. The EDXS spectra of the three membranes showed that all membranes had a high percentage of carbon which can be caused by the aliphatic functional groups in the cellulose acetate (CE) membrane, aromatic functional groups in the polyamide (AD) membrane, and aliphatic and aromatic functional groups in the thin film composite (SE) membrane [2,20]. A considerable percentage of sulfur is present in the spectra of both the SE and AD membranes as a result of the microporous substrate, which is typically polysulphone [2,21].

Figure 2. SEM image and EDXS spectrum of unused membrane: (a) CE; (b) SE and (c) AD.

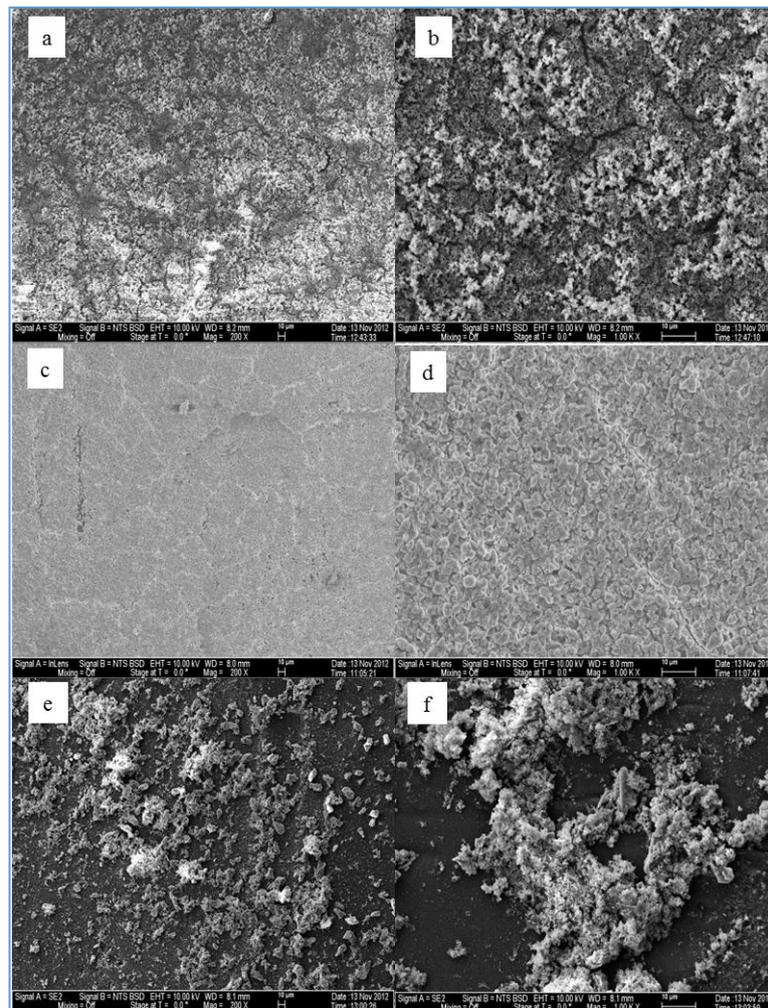
Figure 3 elucidates a comparison of the extent of scale formation across the SE membrane surface for the three feed waters at the temperature of $37\text{ }^{\circ}\text{C}$ using two levels of magnification ($200\times$ and $1000\times$). Figure 3a,b shows that a thick layer of the fouling material from the feed water of location 6 (run 1), where the highest TDS ($2569\text{--}2657\text{ mg/L}$) and the highest TOC ($4.6\text{--}4.8\text{ mg/L}$) existed, almost evenly covered the entire SE membrane surface. In addition, Figure 3c,d shows a thinner layer of the fouled material from the feed water of location 1 (run 13), where the TDS ranged between 1338 and 1428 mg/L and the TOC ranged between 1.4 and 2.3 mg/L , almost covering the entire surface of the

SE membrane. Moreover, Figure 3e,f shows that the fouled material from the feed water of location 5 (run 19), where the lowest TDS (679–742 mg/L) and the lowest TOC (1.2–1.4 mg/L) were present, partially covered the surface of the SE membrane. However, the results of additional SEM images of different runs revealed that the distribution and the morphology of the fouling materials deposited on the RO membrane surface depend not only on the feed water quality, but also on the type of the membrane and the operating conditions, such as the feed water temperature.

Figure 3. SEM images and EDSX spectra of (a) run 1 at a magnification of 200×; (b) run 1 at a magnification of 1000×; (c) run 13 at a magnification of 200×; (d) run 13 at a magnification of 1000×; (e) run 19 at a magnification of 200×; (f) run 19 at a magnification of 1000×.

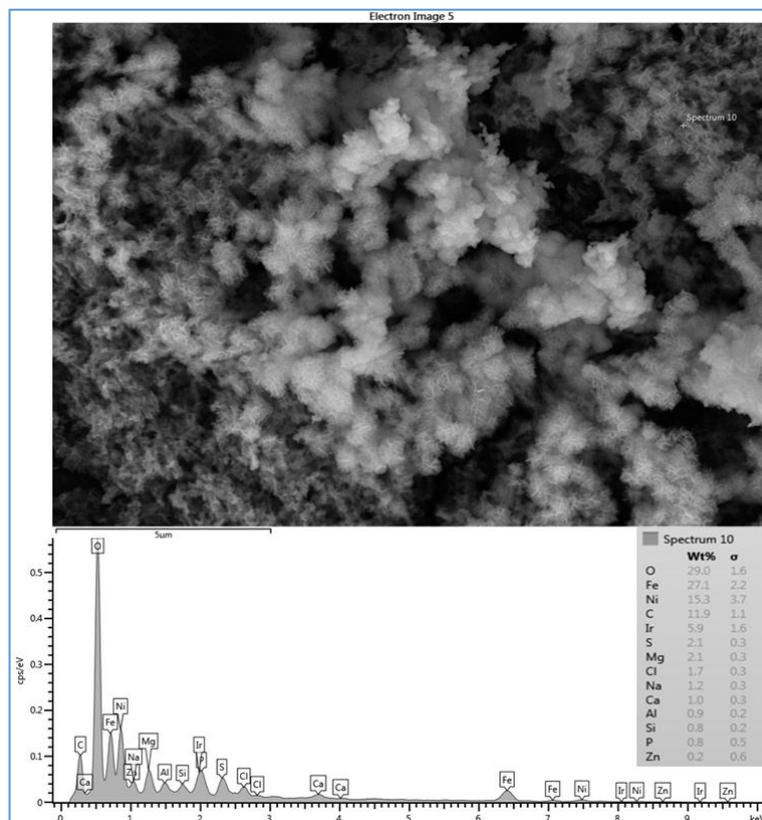
To investigate the difference in the scale morphology among the three types of the membranes (SE, CE and AD), three SEM images of these membranes were taken after the membranes were operated under identical conditions (i.e., feed water quality of location 6, temperature of 37 °C, feed pressure of 2620–2757 kPa, and feed flow rate of 2.27 Lpm). First, Figure 4 shows the SEM image and the EDSX spectrum of the fouled SE membrane (run 1). The EDSX analysis unexpectedly showed that the scale formation had high level of Ni and Fe which were not highly present in the feed water of location 6. As expected, O, C, Na⁺, Ca²⁺, Mg²⁺, and Cl⁻ were present in the spectrum. The data suggest that the fouling was due to a combination of organic matter and inorganic material. Although Fe was observed in the feed water in low quantity, it was probably due to a leaching from the system parts. For example,

some rust was seen on the submerged part of the heated immersion circulator indicating a leach of iron into the feed water. In addition, although it was not found in the feed water, Ni was also detected by the EDSX spectrum. It was apparently due to the rust as well. The part that was rusting was replaced with an aluminum part to minimize the corrosion during the rest of the experiment runs.

Figure 4. SEM image and EDSX spectrum of fouled SE membrane for location 6 (run 1). Run 1 was conducted at a feed flow rate of 2.27 Lpm, a temperature of 37 °C and a range of feed pressure of 2620–2757 kPa.

The flower crystals of CaCO_3 seen in Figure 5 and the large and elongated crystals seen in Figure 6 are probably due to the high TOC (4.6–4.8 mg/L) and carbonate (72–82.4 mg/L) concentrations of the feed water at location 6, and CaCO_3 is likely a calcite crystal form, as suggested by Koyuncu and Wiesner [13]. Furthermore, they reported that the ratio of the organic matter/calcium influences the shape of the CaCO_3 crystal in the cake formation. Moreover, Koyuncu [24] proposed that organic matter may play a role in reducing calcium diffusivity in the cake formation. In addition, Lee [25] reported that natural organic matter (NOM) can reduce free calcium ions by producing NOM-calcium complexes on the membrane surface. Also, they claimed that NOM-calcium complexes form a compressed layer on the membrane surface, which severely decreases the permeate flux. Therefore, some spectra did not show high peaks of calcium, particularly when the scale formation on the membrane surface was a more sludge-like deposit than a crystal formation, such as those of runs 1 (see Figures 4 and 7). The results of the various configurations of the scale formations deposited under

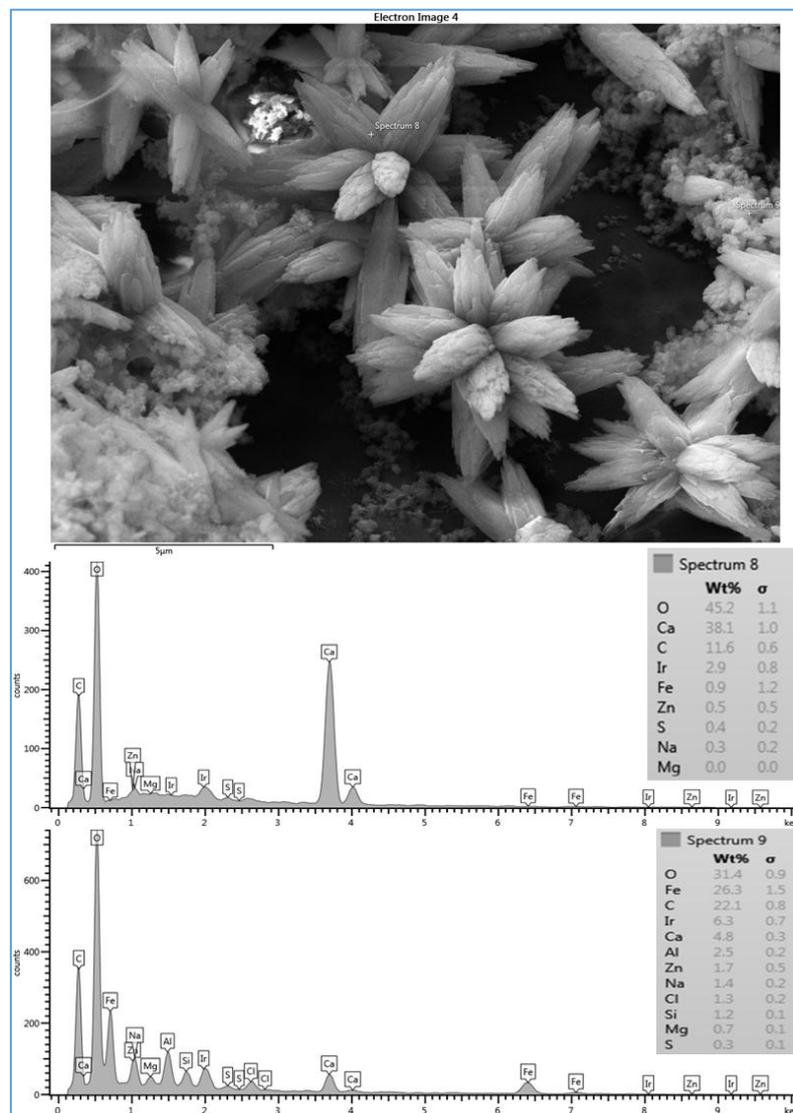
However, the deposited material on the CE membrane surface (run 3) mostly covered the membrane surface with a crystal structure (flowers) and lesser amounts of amorphous shapes, as illustrated in Figure 5. To investigate both structures, two spectra were taken in both places. Spectrum 8, which was located on the flower structure, shows that a high level of Ca^{2+} (38.1%) was present. Spectrum 9, which was located on the amorphous shape, shows that a lower level of Ca^{2+} (4.8%) was present. Both spectra show high levels of C and O. Moreover, spectrum 9 also shows a high level of Fe^{2+} (26.3%). The high peaks of O, C, and Ca^{2+} that exist in spectrum 8 suggest that the structure of the deposited material was calcium carbonate (CaCO_3), which is consistent with that observed by Tzotzi [22] on a thin film composite polyamide membrane surface. The data presented in spectra 8 and 9 on the CE membrane surface suggest that the crystal forms were accompanied by a small amount of a mixture of organic matter and inorganic materials. In addition, the smooth black spots on the SEM image in Figure 5 are parts of the CE membrane surface. Membrane fouling can be affected by the membrane surface characteristic. Smooth surface such as that of CE membrane is less susceptible to fouling. However, membrane with rough surface such as that of SE membrane is more susceptible to fouling by materials that can be accumulated in the valleys or channels of the surface [17]. Therefore, the fouled material of run 3 partially covers the CE membrane surface compared to that of run 1, which apparently covers the entire surface of the SE membrane, as illustrated in Figure 4. This provides one potential cause for the rapid decline in the permeate flux of run 1 compared to that of run 3.

Figure 5. SEM image and EDSX spectra of fouled CE membrane for location 6 (run 3). Run 3 was conducted at a feed flow rate of 2.27 Lpm, a temperature of 37 °C and a range of feed pressure of 2620–2757 kPa.

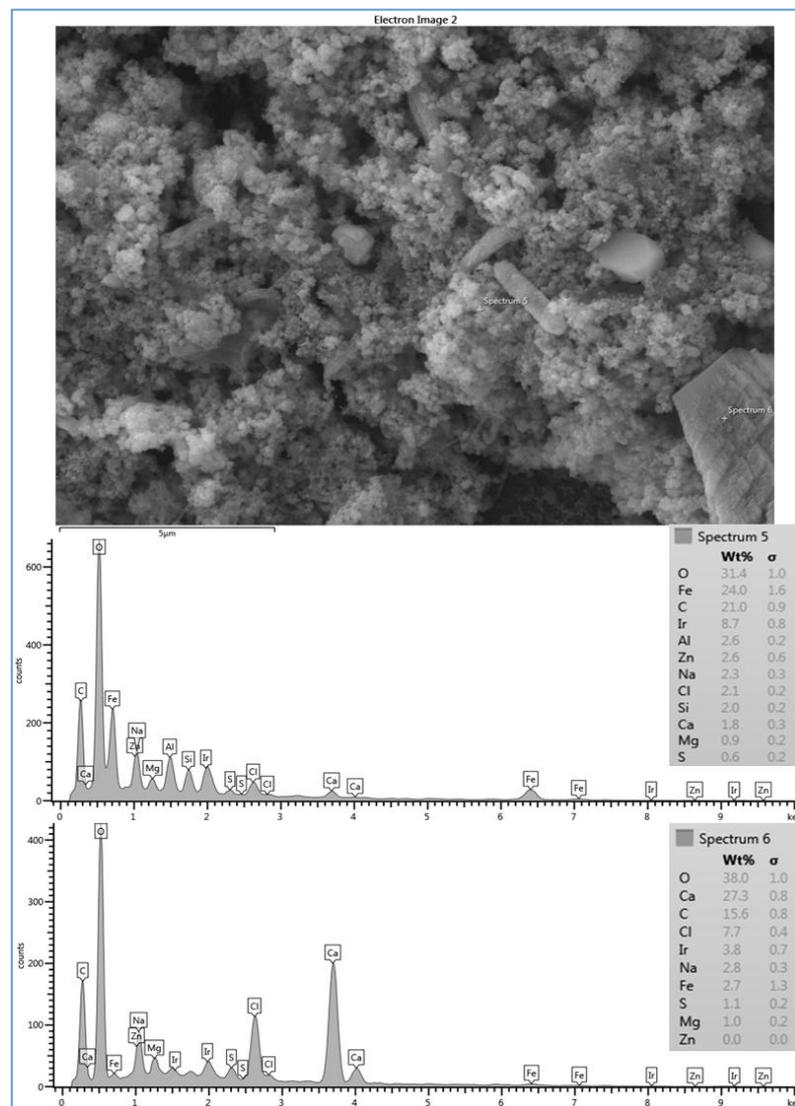
Figure 6 shows that the fouling layer deposited on the AD membrane surface (run 5) has different shapes. Some large crystal shapes exist as part of the scale formation on the membrane surface. Also, two spectra were taken to investigate the morphology of the two different shapes of the fouling material on the membrane surface. Like the observation in spectrum 8 of run 3, spectrum 6, which was taken on the crystal shape, shows a high level of Ca^{2+} (27.3%) compared to a lower level of Ca^{2+} (1.8%) on the amorphous shaped material, as shown by spectrum 5. Likewise, both spectra (5 and 9) show a high level of C and O as well as a high level of Fe^{2+} on the amorphous shaped material. In addition, spectrum 5 shows a low level of silica present in the deposited material, and spectrum 6 shows a high peak of Cl^- on the crystal shape. The SEM image and the data of spectra 5 and 6 suggest that the fouling materials deposited on the AD membrane surface have different configurations and composition. The fouling materials included different crystal shapes and a mixture of organic and inorganic matter. As a result of high levels of O, C and Ca^{2+} , the large crystal form is also possibly due

to the formation of CaCO_3 , which was reported as a common scale with all feed types by Greenlee [5], Kucera [2], and Antony [23].

Figure 6. SEM image and EDSX spectra of fouled AD membrane for location 6 (run 5). Run 5 was conducted at a feed flow rate of 2.27 Lpm, a temperature of 37 °C and a range of feed pressure of 2620–2757 kPa.

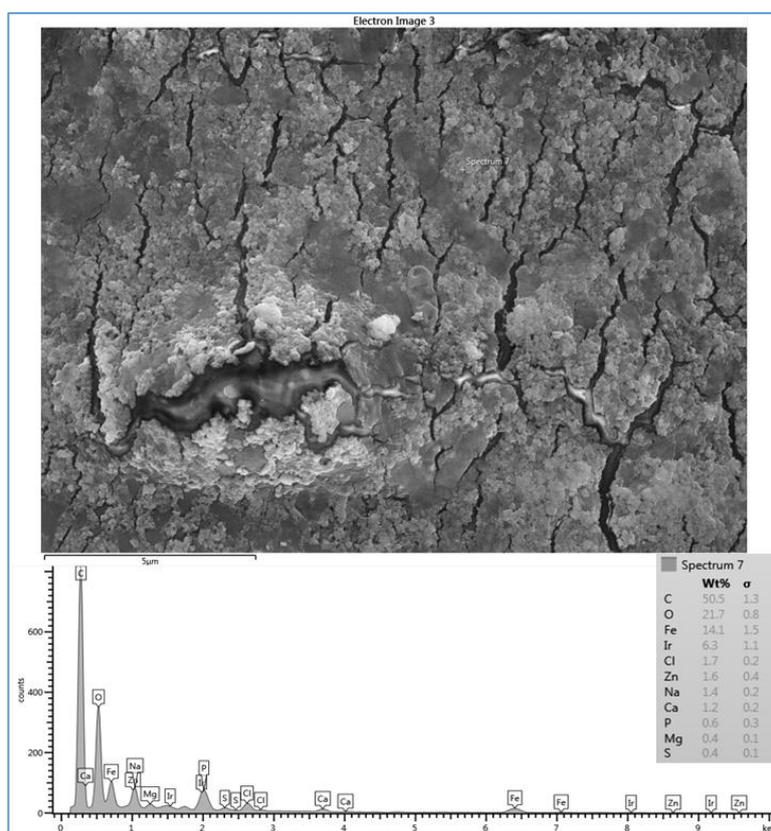
Figure 7. SEM image and EDSX spectrum of fouled CE membrane for location 6 (run 4).

The effect of feed water temperature on the formation of the fouling material deposited on the membrane surface was also examined in this study. The SEM images in Figure 8 shows a comparison between the scale formations on the surface of several RO membranes at high and low temperatures. The SEM images focus on the densest of accumulated materials on the selected RO membrane surfaces. The scale formation on the CE membrane at 11 °C (run 4) is quite different from that at 37 °C (run 3), as shown in Figure 8a,b. The morphology of the fouled material on the CE membrane surface of run 3, as previously mentioned, is in more of a crystalline shape, which is mostly CaCO₃, while the morphology is a sludge-like deposit on the membrane surface of run 4. It is obvious that low temperature (11 °C) affected the deposited material on the CE membrane and resulted in the sludge layer. Jawor and Hoek [27] reported that high temperature (25–35 °C) brackish feed water can enhance the crystal formation of the deposited material on the RO membrane surface, which agrees with what was observed in run 3. The EDSX spectrum of the fouled membrane of run 4, as shown in Figure 7,

shows that high levels of C and O, lesser amounts of Fe, Cl^- , Zn, Na^+ and Ca^{2+} , and a small amount of P, Mg^{2+} , and S were present in the scale formation. The results suggest that the scale formation on the CE membrane surface of run 4 is mostly organic or carbonaceous matter, which can be attributed to the high levels of TOC and carbonate of the feed water, and is accompanied by inorganic materials. It can be assumed that the higher total permeate flux drop of run 4 (42.8%), which was calculated after completion of the run, compared to that of run 3 (34.7%), is a consequence of the blockage of the CE membrane surface because of the sludge layer formation.

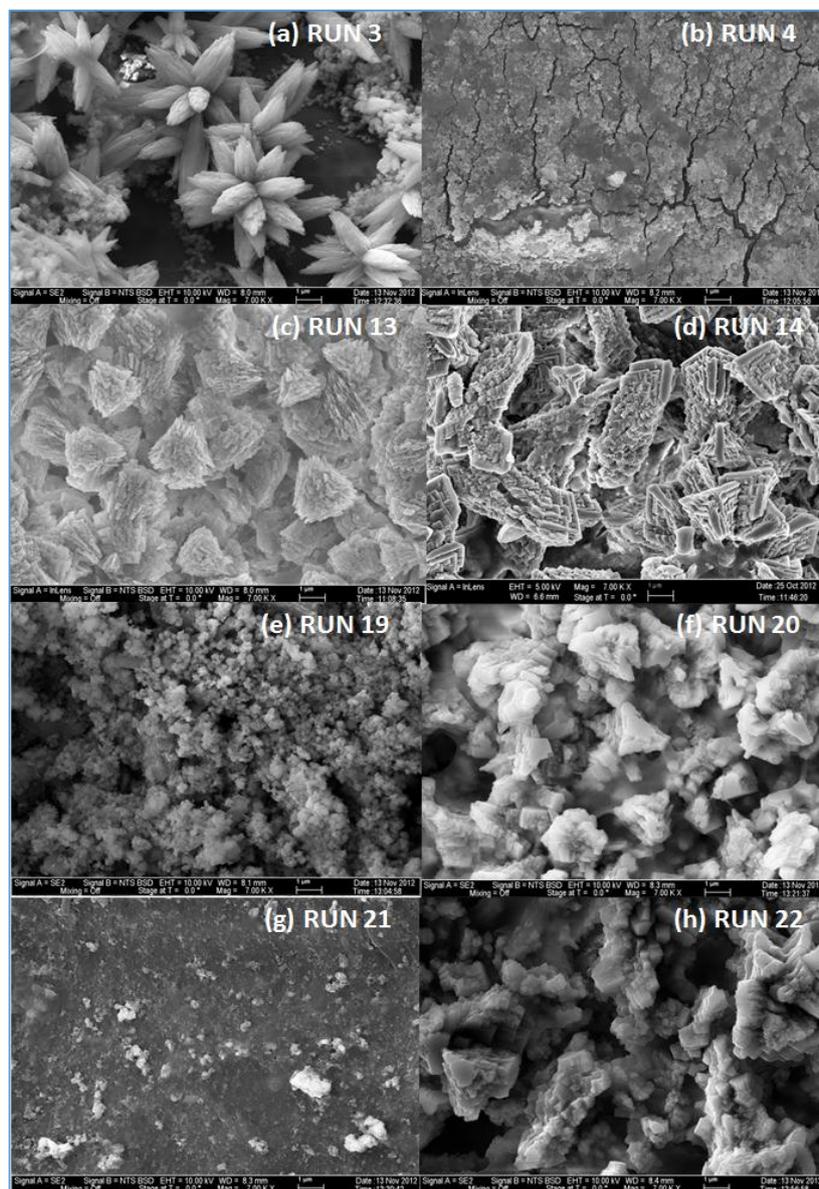
Figure 8. SEM images of fouled RO membranes: (a) CE membrane at 37 °C for location 6 (run 3); (b) CE membrane at 11 °C for location 6 (run 4); (c) SE membrane at 37 °C for location 1 (run 13); (d) SE membrane at 11 °C for location 1 (run 14); (e) SE membrane at 37 °C for location 5 (run 19); (f) SE membrane at 11 °C for location 5 (run 20); (g) CE membrane at 37 °C for location 5 (run 21) and (h) CE membrane at 11 °C for location 5 (run 22).

(4.6–4.8 mg/L). The SEM images of the fouled SE membrane of run 13 and run 14 shown in Figure 8c,d revealed that the formation of the fouled material from the feed water in location 1 deposited on the membranes surface is mostly in crystal shapes at both temperatures (37 and 11 °C). In addition, the results exhibited that the EDSX spectra of both fouled membranes, as displayed in Figure 9a,b, is nearly identical. Both spectra have high peaks of C, O, and Ca²⁺, indicating that the formed crystal on the membrane surface is likely CaCO₃. The relatively low TOC and high Ca²⁺ (77.4–82 mg/L) and carbonate (73–94.2 mg/L) concentrations in feed water in location 1 apparently resulted in the uniform crystal shapes of CaCO₃. This observation is consistent with the findings noted by Koyuncu and Wiesner [13].

Moreover, the SEM images of the deposited material from the feed water in location 5 at the temperature of 37 °C (run 19) and 11 °C (run 20), are shown in Figure 8e,f, respectively. Both images show that the fouling materials extend across the entire surface of the SE membranes with a more crystalline morphology of the fouling developed on the membrane surface of run 20 at a low temperature (11 °C). The EDSX spectra shown in Figure 9c and d revealed a high peak of Ca²⁺ in addition to the high peaks of O and C on the fouled membrane surface of run 20, which indicates that most of the crystal morphology is CaCO₃. Also, the EDSX spectra shows that the fouling of run 19 and run 20 have a combination of organic matter and inorganic material. In addition, Inductively Coupled Plasma (ICP) spectrometer analysis showed that the Ca²⁺ concentration of the permeate at low temperature (run 20) was higher than that at high temperature (run 19), as shown in Figure 10. The Ca²⁺ concentration is a consequence of more calcium deposits on the SE membrane surface, which resulted in forming more crystal morphology like CaCO₃.

In addition, Figure 8g,h shows the SEM images of the scale formation of the fouled material from feed water in location 5 deposited on the CE membrane surface at the temperatures of 37 °C (run 21) and 11 °C (run 22), respectively. Like those of run 19 and run 20, the scale formation also extended across the entire surface of the CE membrane of runs 21 and 22. The fouling form of the high feed water temperature is apparently a sludge-like deposit on the membrane surface, while the fouling form of low feed water temperature is a combination of both sludge and crystalline shapes. The EDSX spectrum in Figure 9e shows that the cake formation of run 21 has a carbon content of 79.1% and oxygen of 13.8%, suggesting that much of the fouling material is organic matter. However, the EDSX spectrum of Figure 9f exhibits a high level of calcium (59.1%), besides the high level of the oxygen (23.8%) and lower level of carbon (7.9%) in the fouled material of run 22, suggesting that the large particles of the cake formation are like those of run 20, which are CaCO₃. Again, the low TOC and high carbonate concentrations of the feed water in location 5 were likely the main reason behind the formation of the CaCO₃ crystals. This observation agrees with that found by Koyuncu and Wiesner [13]. Contradictory to the morphology observation of the high TOC and TDS feed water runs (for instance runs 3 and 4), the low temperature (11 °C) with the low TOC and TDS feed water (for instance runs 21 and 22) enhances the crystal formation of the deposited material on the RO membrane surface (see Figure 8).

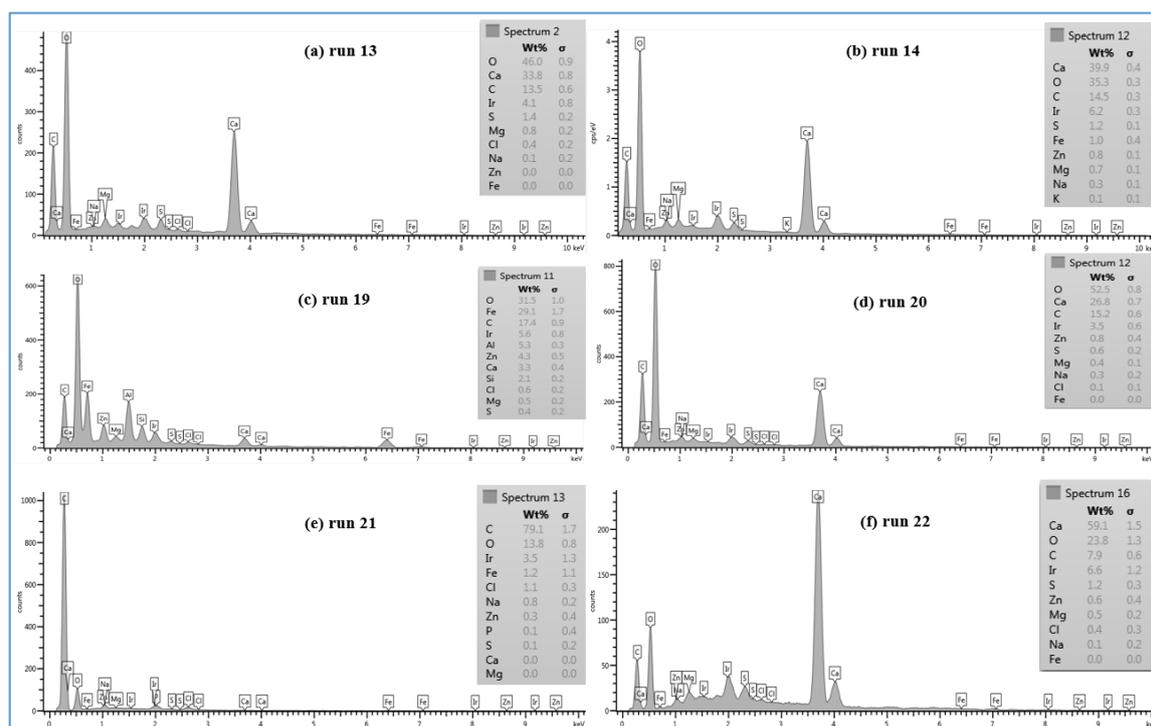
Figure 9. EDSX spectra of fouled RO membranes: (a) SE membrane at 37 °C for location 1 (run 13); (b) SE membrane at 11 °C for location 1 (run 14); (c) SE membrane at 37 °C for location 5 (run 19); (d) SE membrane at 11 °C for location 5 (run 20); (e) CE membrane at 37 °C for location 5 (run 21) and (f) CE membrane at 11 °C for location 5 (run 22).

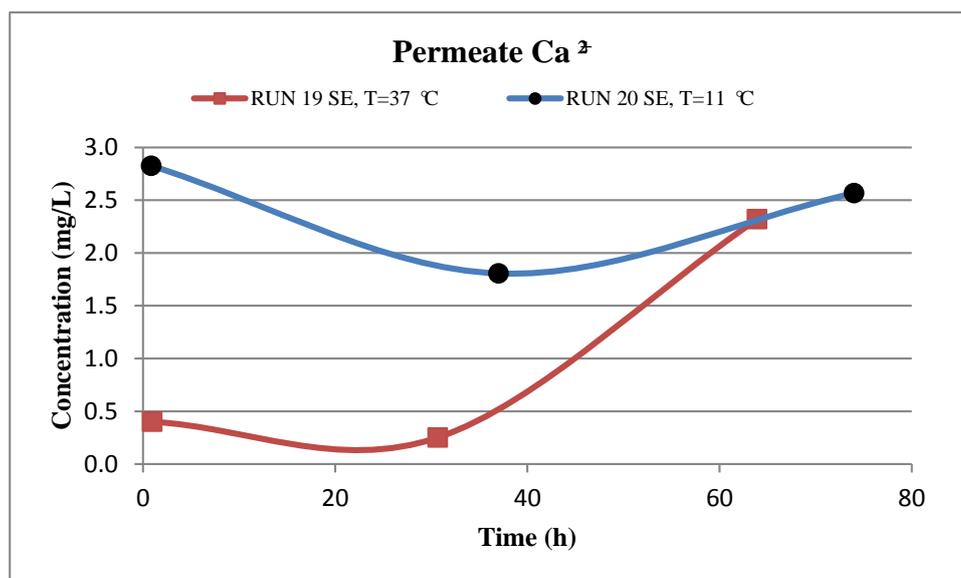
Figure 10. Evolution of the permeate calcium concentration of run 19 at 37 °C and run 20 at 11 °C. Runs 19 and 20 were conducted at a feed flow rate of 2.27 Lpm of location 5 and a range of feed pressure of 2620–2757 kPa.

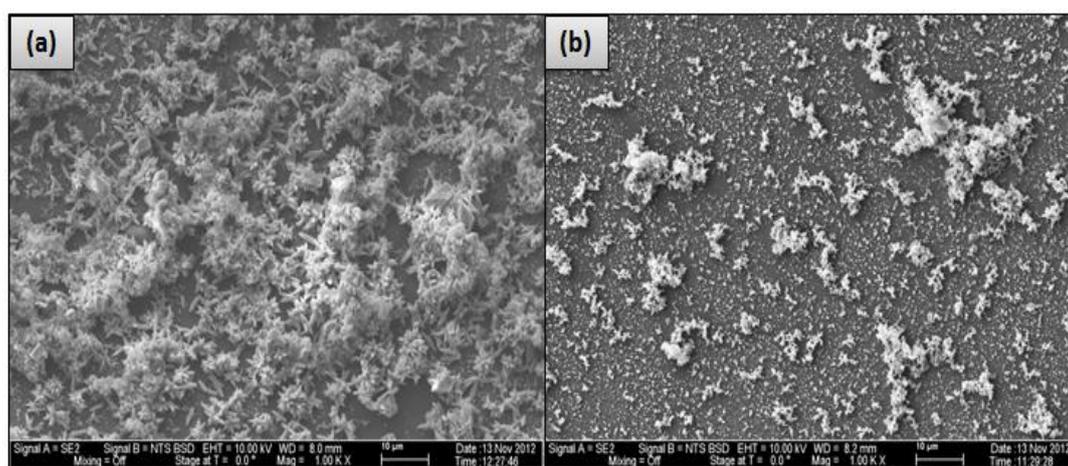
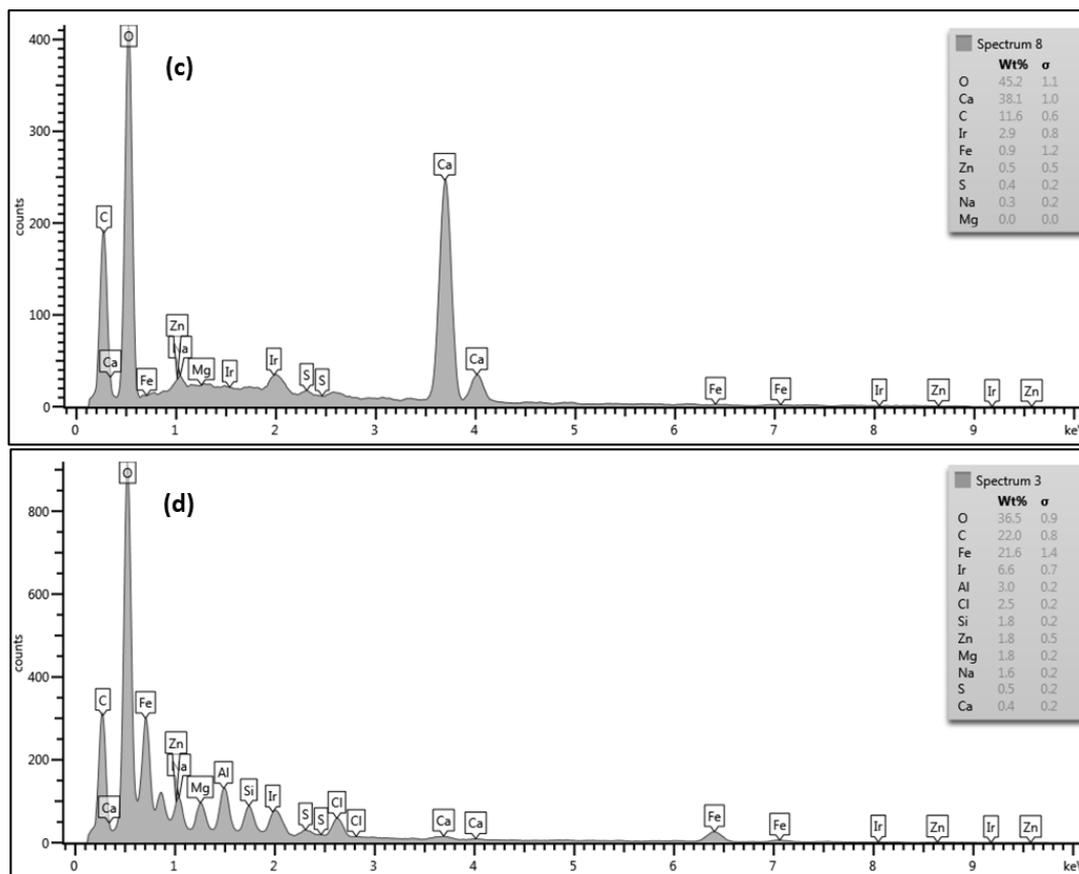
The effect of using a 0.1-micron MF membrane, which is considered the most appropriate method to remove larger particulates as a pretreatment unit for the feed water in advance of the RO membrane [5], on the precipitated material on the membrane surface was also investigated. Figure 11 shows an SEM image comparison of the fouled material of the un-pretreated (run 3) and pretreated (run 9) feed water in location 6 on the CE membrane surface. The SEM images in Figure 11 show that the extent of the fouling across the surface of the CE membrane conducted without the MF membrane covers more than 70% of the membrane surface, compared to about 25% of that of the CE membrane conducted with the MF membrane. Supporting this idea was the fact that the initial permeate flux of the run conducted with the MF membrane was higher than the initial permeate flux of the run conducted without using the MF membrane. For example, the initial permeate flux of run 3, which was conducted without an MF membrane, is 0.481 Lpm/m², compared to 0.716 Lpm/m² for run 9 conducted with the MF membrane. Additionally, the formation of the fouled materials from the pretreated feed water by the MF membrane on the CE membrane surface (run 9) is apparently in clusters, and the EDSX spectrum of run 9, as shown in Figure 11d, displays high peaks of C and O, indicating that most of the fouling is organic matter. Furthermore, the EDSX spectra of run 3 and run 9 show that the precipitated calcium level on the membrane surface decreased from 38.1% to 0.4%. In addition, the permeate calcium concentration of run 9 conducted with the MF membrane is lower than that of run 3 conducted without an MF membrane, as presented in Figure 12a, while the final concentration of the calcium in the concentrate stream of run 9 is higher than that of run 3, as displayed in Figure 12b. The results suggest that more organic matter, which plays an important role in reducing calcium diffusivity in the fouled layer [13,24,25], deposited on the RO membrane surface of run 9, and also more inorganic material was captured by the MF membrane. Therefore, the precipitated calcium on the surface of the fouled CE membrane was considerably reduced, and consequently the concentration of the calcium in the permeate stream of run 9 was reduced as well.

Figure 11. (a) SEM image of the fouled CE membrane by the un-pretreated feed water of location 6 by MF membrane (run 3); (b) SEM image of the fouled CE membrane by the pretreated feed water of location 6 by MF membrane (run 9); (c) EDSX spectrum of run 3 and (d) EDSX spectrum of run 9. Both runs were conducted at a feed flow rate of 2.27 Lpm, a temperature of 37 °C and a range of feed pressure of 2620–2757 kPa.

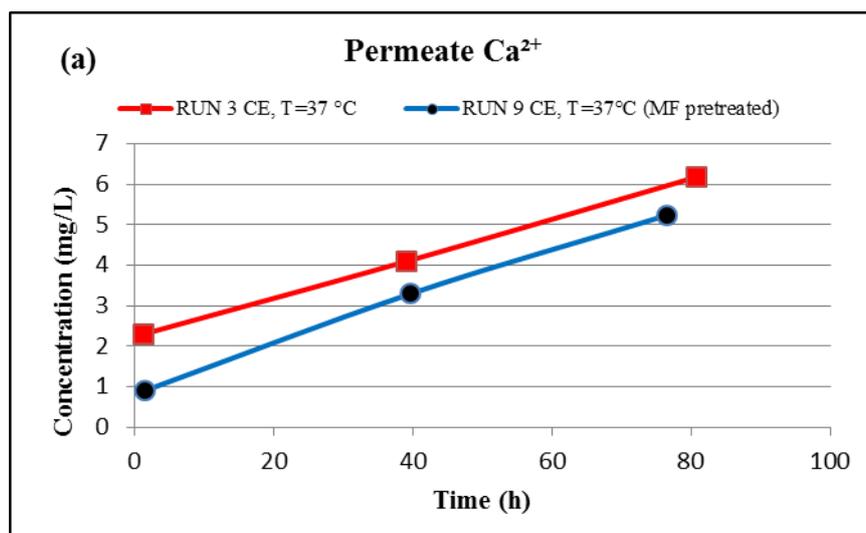
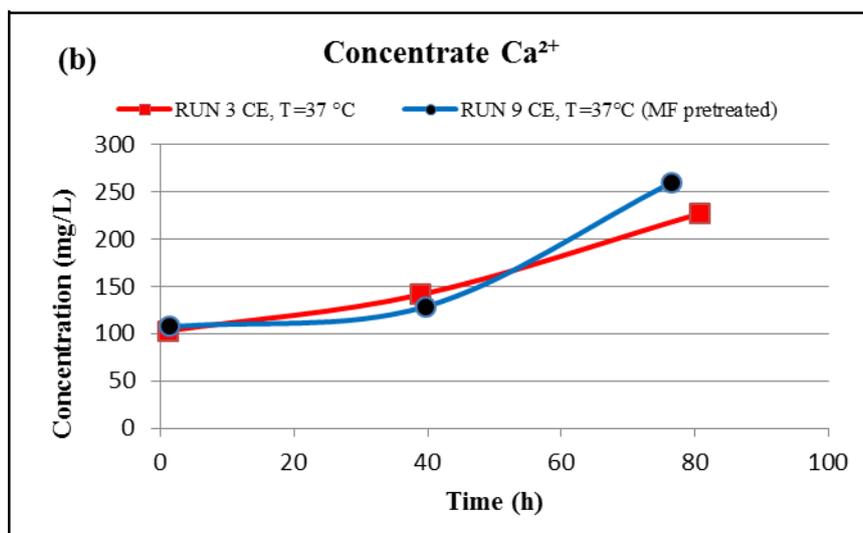
Figure 12. Evolution of the permeate (a) and concentrate (b) calcium concentration of runs 3 (without MF pretreatment) and 9 (with MF pretreatment). Runs 3 and 9 were conducted at a temperature of 37 °C, feed flow rate of 2.27 Lpm of location 6 and a range of feed pressure of 2620–2757 kPa.

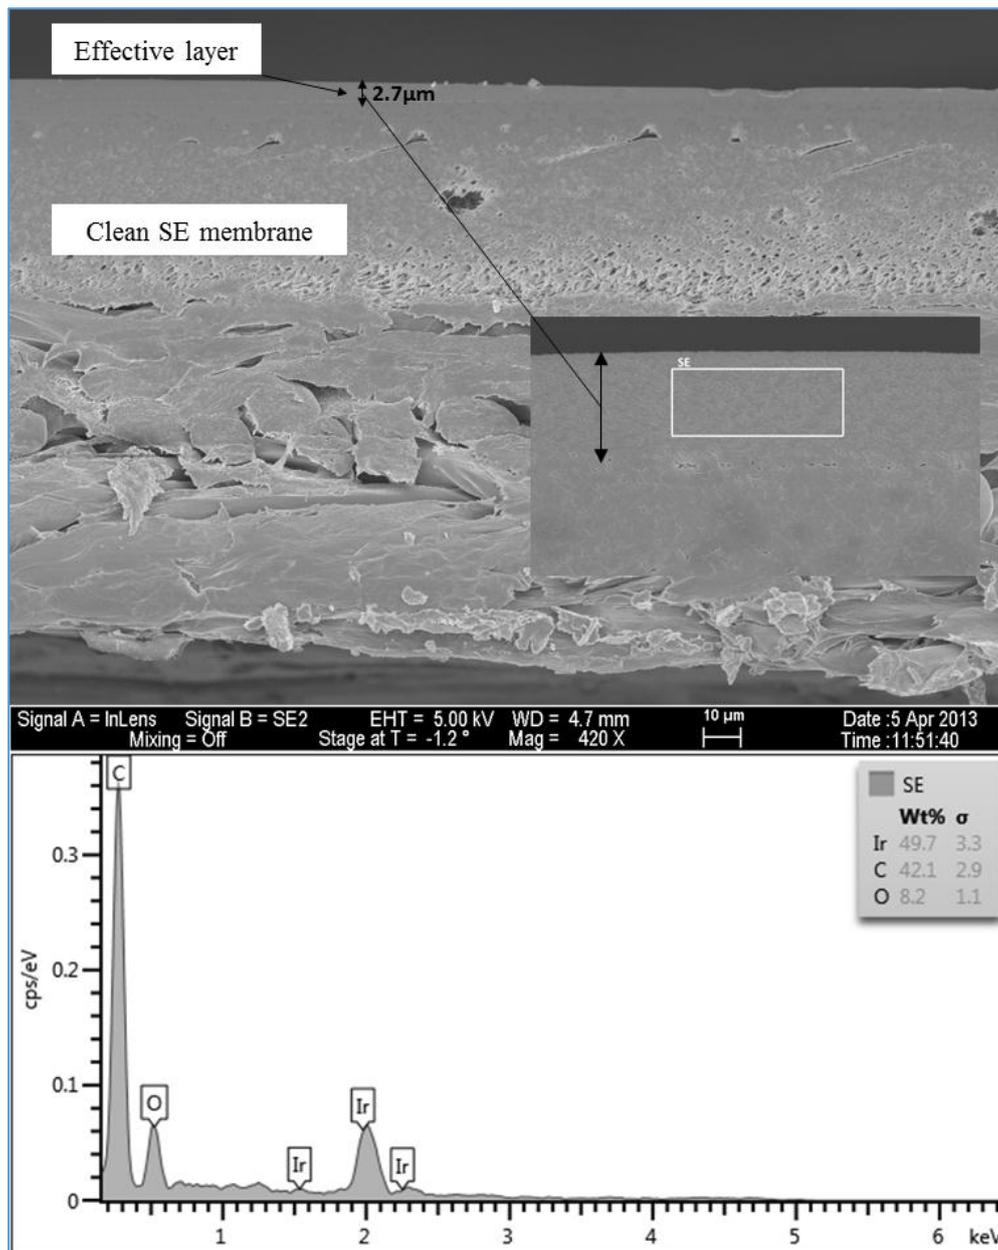
An SEM/EDSX investigation of the cross section of the fouling layer on the SE membranes from the three water qualities was also done in this study. In general, an RO membrane sheet is comprised of either cellulose acetate membrane, which is made from a combination of cellulose diacetate and triacetate, or a thin-film composite polyamide membrane, which is manufactured by combining three structurally different layers. The first layer is typically made of a thin-film of cross-linked aromatic polyamide materials with a thickness of approximately 0.2 μm . The function of this layer is to reject dissolved and suspended solids in the feed water on one side and allow water to permeate. The second and the third layers are supporting layers which are polysulfone layer with a thickness of 50 μm and a non-woven polyester fabric layer with a thickness of 150 μm [2,21]. The SEM image in Figure 13 shows that the clean SE membrane has also three distinct layers. However, the top layer which is the effective layer has a thickness of about 2.7 μm . The spectrum of the clean membrane showed some peaks of Ir, which was used to coat the membrane samples to prevent the charge-up of the material surface. Figure 14 illustrates the thickness and morphology of the scale formation of the fouling on the SE membrane from the feed water of location 6 (high TOC and high TDS). The EDSX spectrum of run 1, shown in Figure 14, showed that, as previously observed in the plan view SEM image (Figure 4), the scale formation was due to a combination of organic matter and inorganic material. However, a higher level of Ca^{2+} was noticed in the cross section SEM image than in the plan view SEM image. Also, a high level of Ni and Fe was noted in the fouling layer. Figure 15 displays the SEM images of the cross section of the fouling on the SE membrane from location 1 (moderate TOC and moderate TDS). Like the observation seen in run 1, the spectrum of run 13, shown in Figure 15, indicated that the fouling layer contained both organic and inorganic materials. However, the level of Ca^{2+} of the cross section SEM image was lower than that of the plan view SEM image (Figure 9). In addition, Figure 16 illustrates the thickness and the formation of the fouled materials from location 5 (low TOC and low TDS) on the SE membrane. Moreover, like the observation seen in the plan view SEM image (Figure 9), the spectrum of the cross section SEM image of the fouling of run 19, illustrated in Figure 16, exhibited high organic matter and lower inorganic material. Generally, the SEM images of the cross section of the scale formation showed that the composition of the fouled material was about the same through the entire thickness. In addition, the results revealed that there were no distinct layers present through the

Figure 13. SEM images and EDSX spectrum of the cross section of the clean SE membrane.

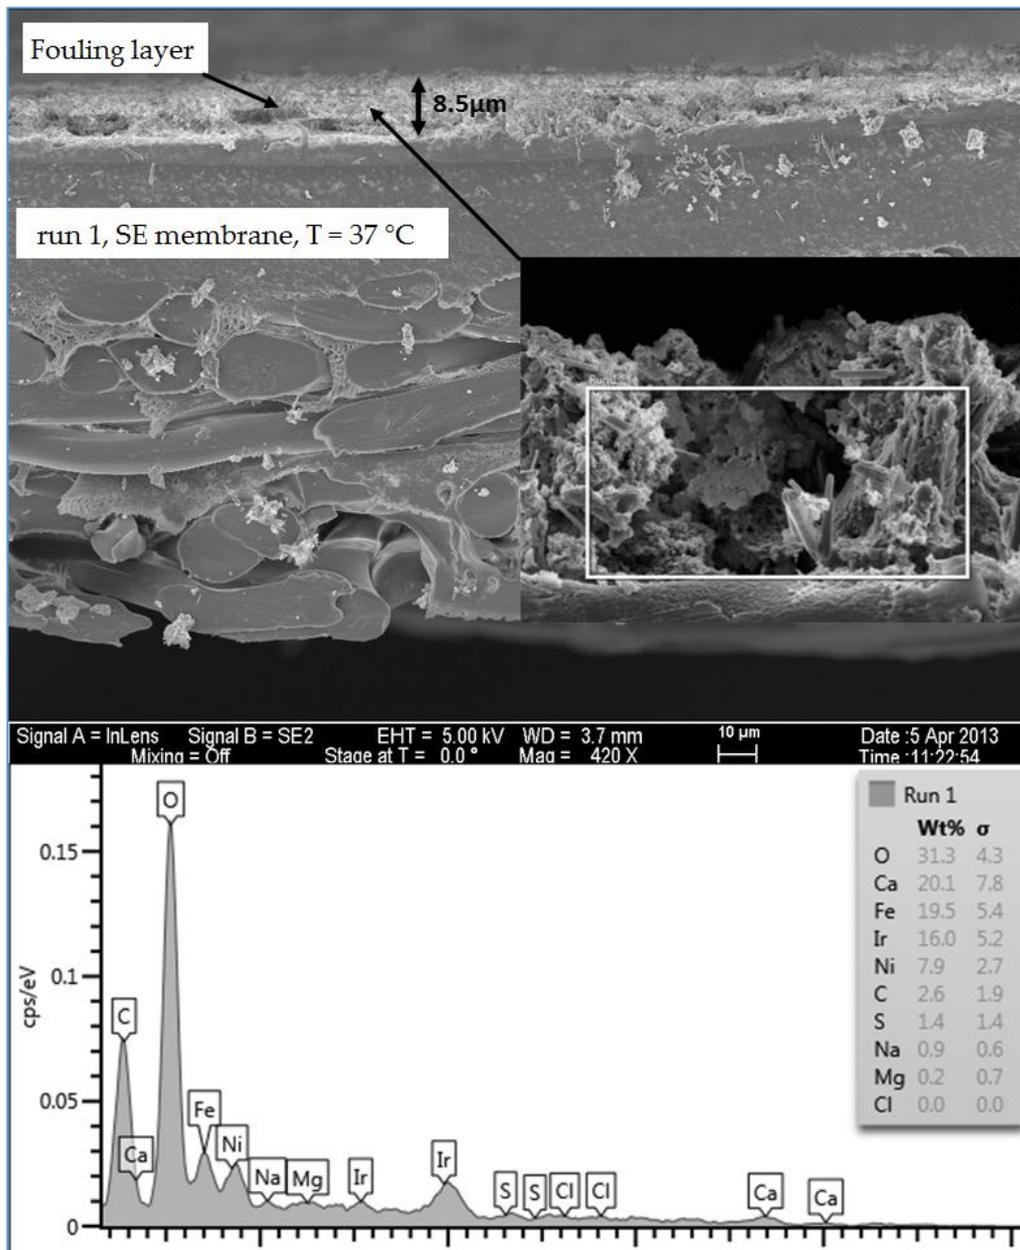
Figure 14. SEM images and EDSX spectrum of the cross section of the fouled SE membrane for location 6 (run 1).

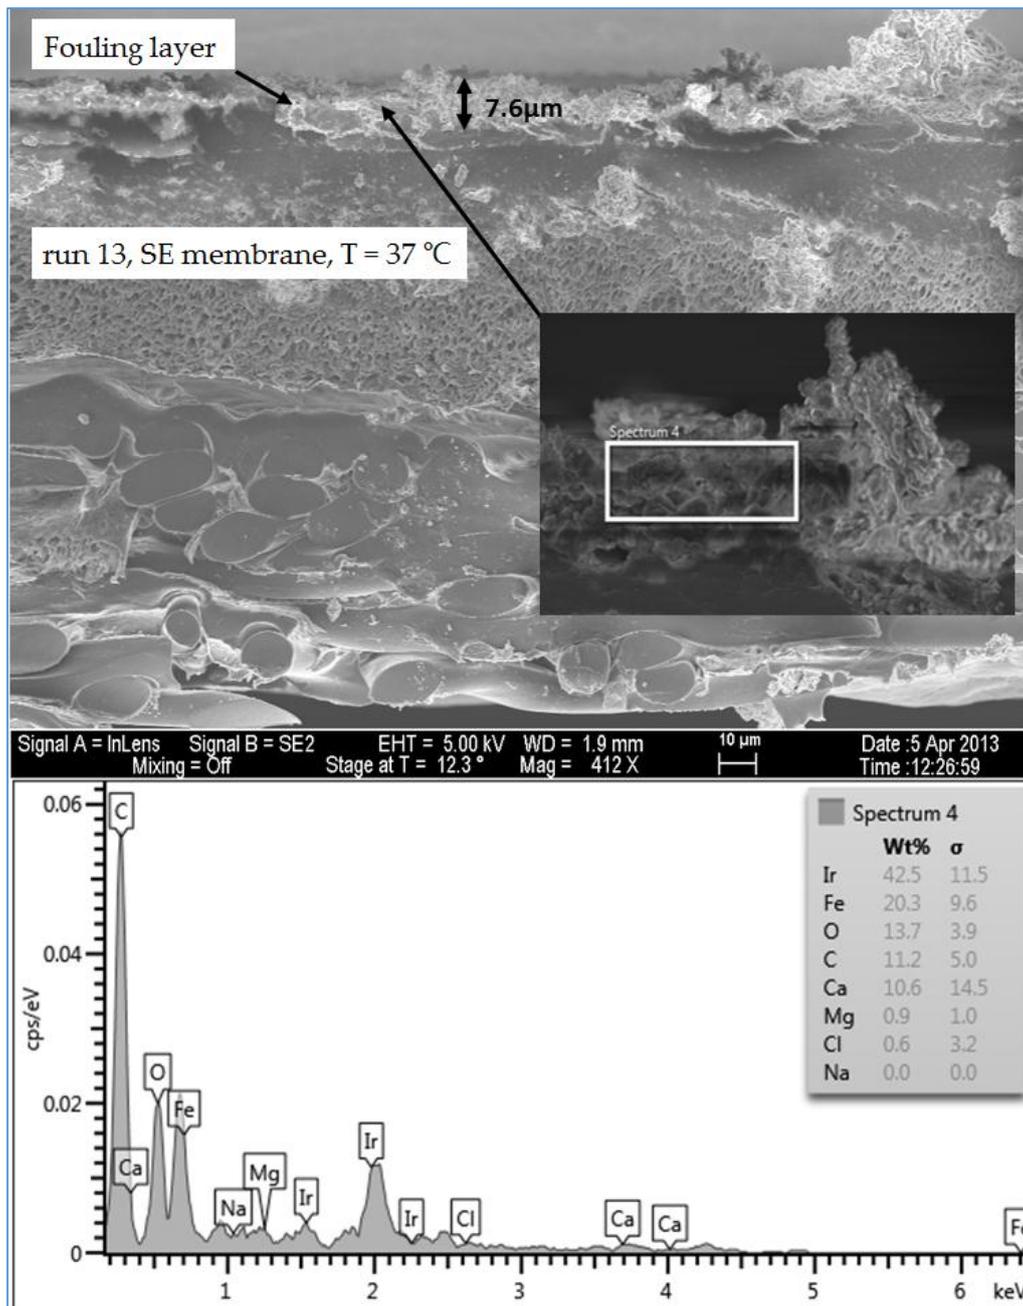
Figure 15. SEM images and EDSX spectrum of the cross section of the fouled SE membrane for location 1 (run 13).

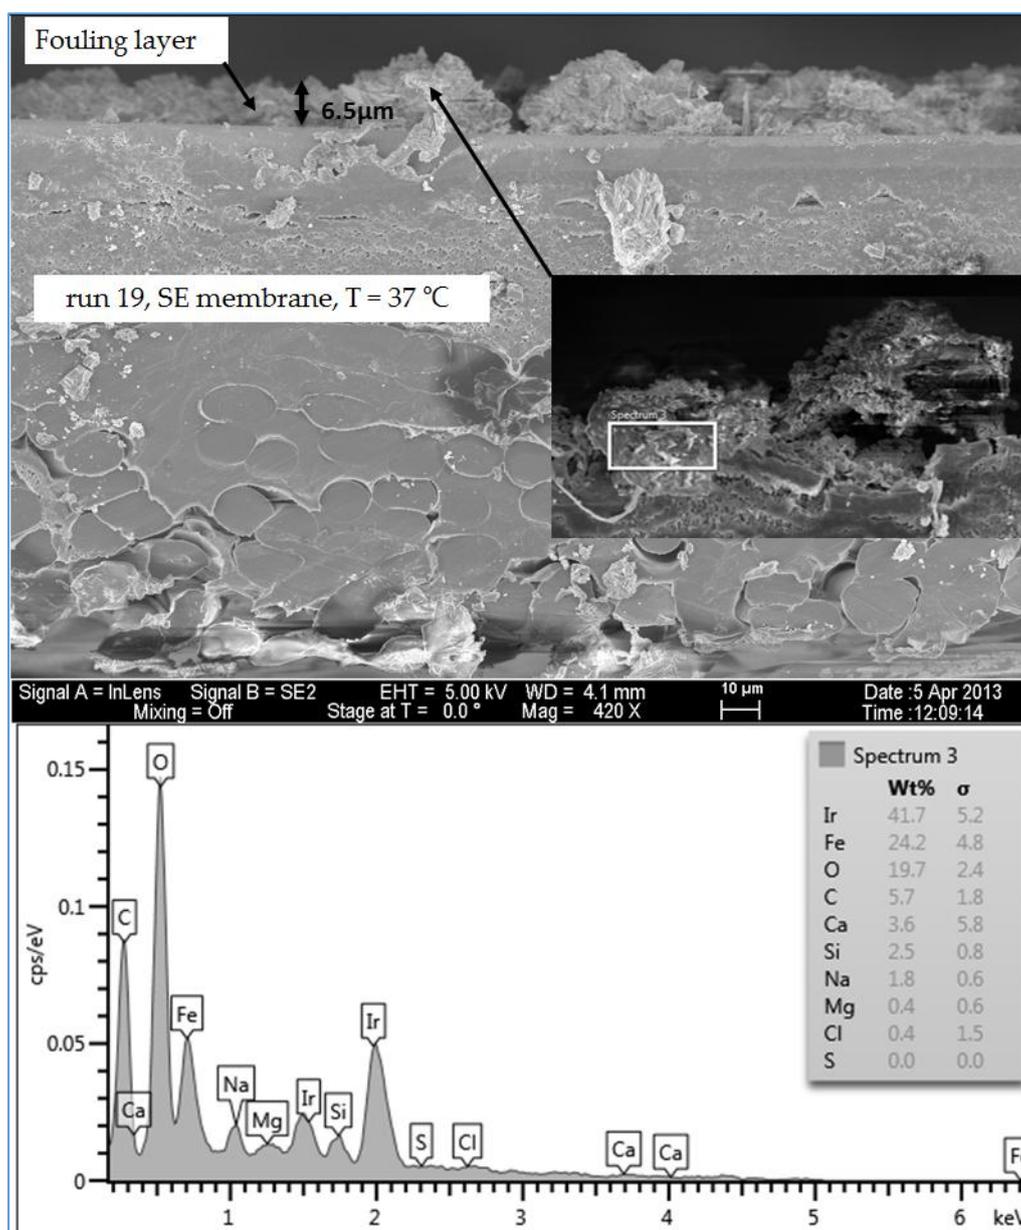
Figure 16. SEM images and EDSX spectrum of the cross section of the fouled SE membrane for location 5 (run 19).
