Foulant Analysis of Three RO Membranes Used in Treating Simulated Brackish Water of the Iraqi Marshes

Abstract: In this work, three different types of Reverse Osmosis (RO) (Thin-Film Composite (SE), Cellulose Acetate (CE), and Polyamide (AD)) were used to perform foulant analysis (autopsy) study on the deposited materials from three different simulated brackish surface feed waters. The brackish surface water qualities represented the water quality in Iraqi marshes. The main foulants from the simulated feed waters were characterized by using Scanning Electron Microscope (SEM) images and Energy-Dispersive X-ray Spectroscopy (EDXS) spectra. The effect of feed water temperatures (37 °C and 11 °C) on the formation of the fouled material deposited on the membrane surface was examined in this study. Also, pretreatment by a 0.1 micron microfiltration (MF) membrane of the simulated feed water in advance of the RO membrane on the precipitated material on the membrane surface was investigated. Finally, Fourier Transform Infrared Spectroscopy (FTIR) analysis was used to identify the functional groups of the organic matter deposited on the RO membrane surfaces. The SEM images and EDSX spectra

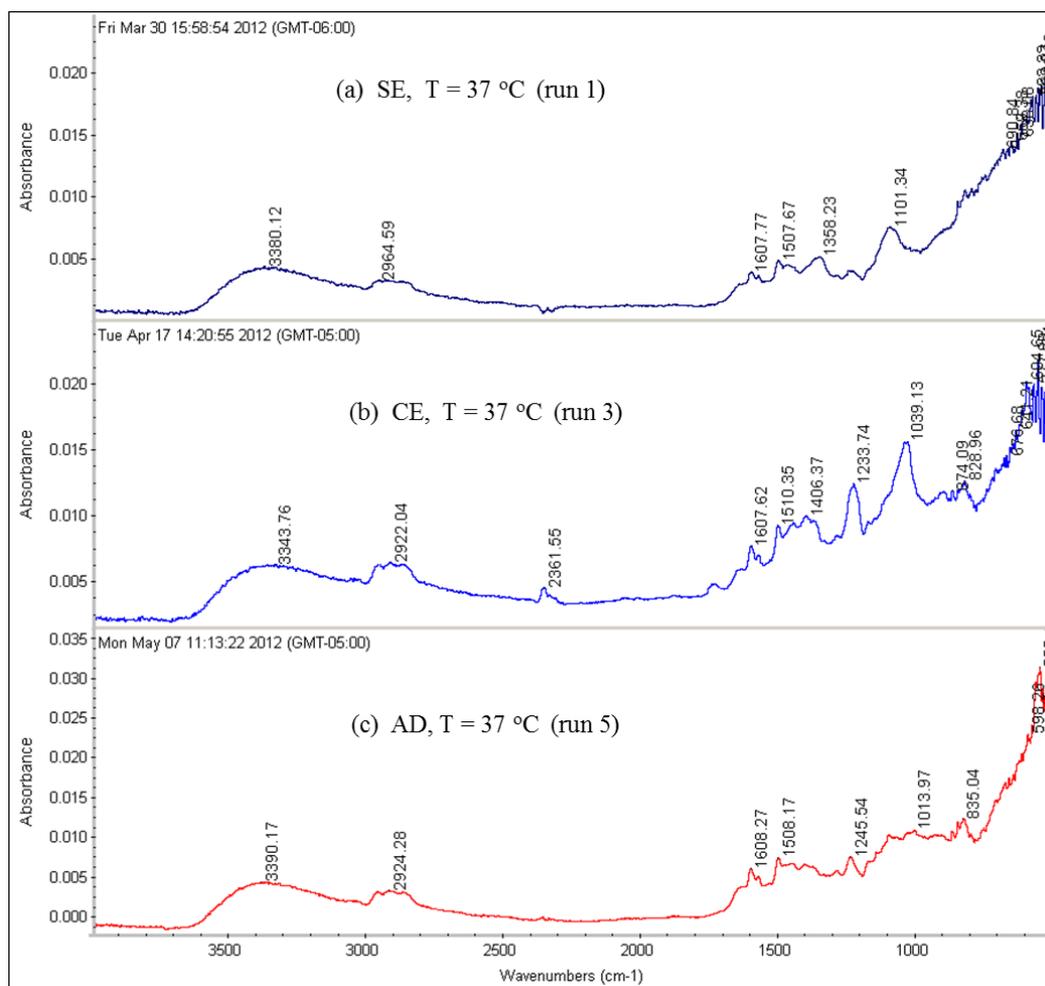
Several FTIR spectra from used RO membranes were done in this study. FTIR spectral interpretation of the absorption bands was provided by the software with the FTIR spectrometer, itself. Because the FTIR spectral interpretation for the absorption peaks present in the spectra of all runs is similar, only Figures 17 and 18 for runs 1 through 6 are shown here. The FTIR spectral interpretation shows that the predominant functional groups are aromatic hydrocarbons (between 3100 and 3000 cm^{-1} , and between 840 and 800 cm^{-1}), aliphatic alcohols (between 3600 and 3200 cm^{-1} , and between 1150 and 1100 cm^{-1}), aromatic ethers (between 1300 and 1200 cm^{-1}), aliphatic hydrocarbons (between 2990 and 2850 cm^{-1} , and between 1460 and 1350 cm^{-1}), and inorganic carbonate (between 1550 and 1300 cm^{-1} , and between 880 and 700 cm^{-1}) and lower amounts of olefins (between 3100 and 3000 cm^{-1}).

Figure 17. FTIR spectra for the RO membranes fouled by the feed water of location 6 at 37 °C: (a) SE membrane (run 1); (b) CE membrane (run 3) and (c) AD membrane (run 5).

The results of the FTIR spectra suggest that the organic foulants contain humic substances (aliphatic and aromatic compounds) and polysaccharides due to C–O deformation [2,11].

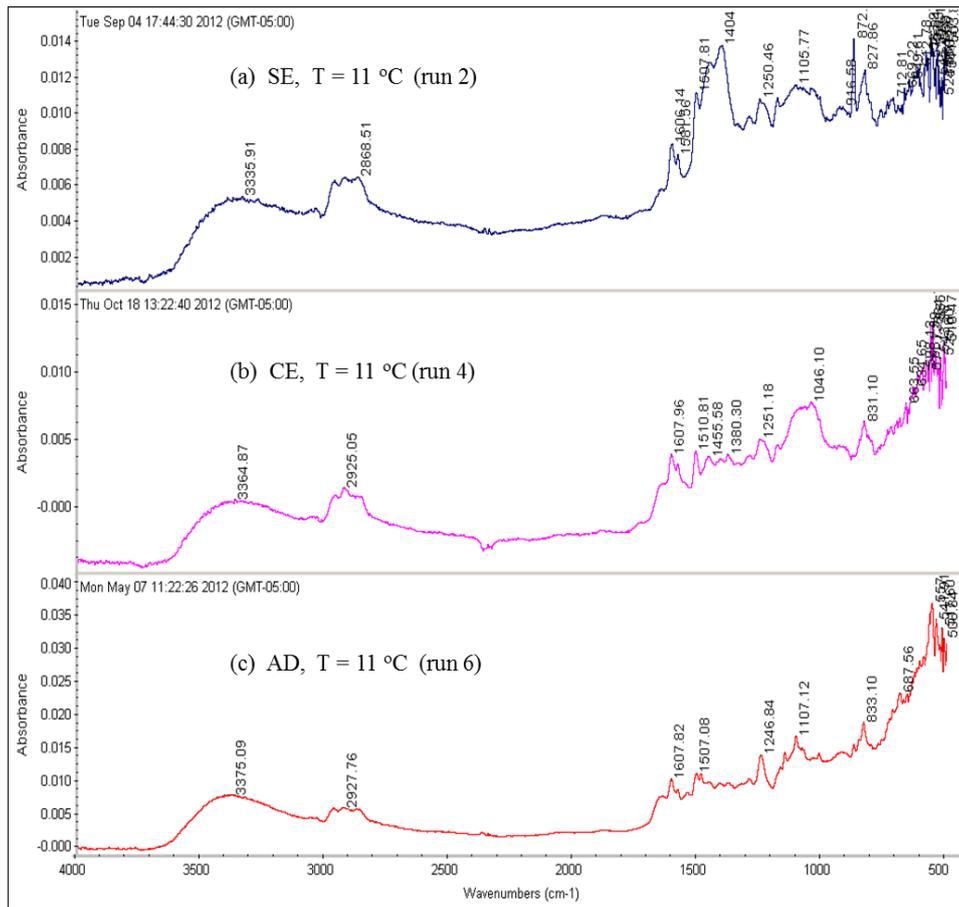
Figure 18. FTIR spectra for the RO membranes fouled by the feed water of location 6 at 11 °C: (a) SE membrane (run 2); (b) CE membrane (run 4); (c) AD membrane (run 6).

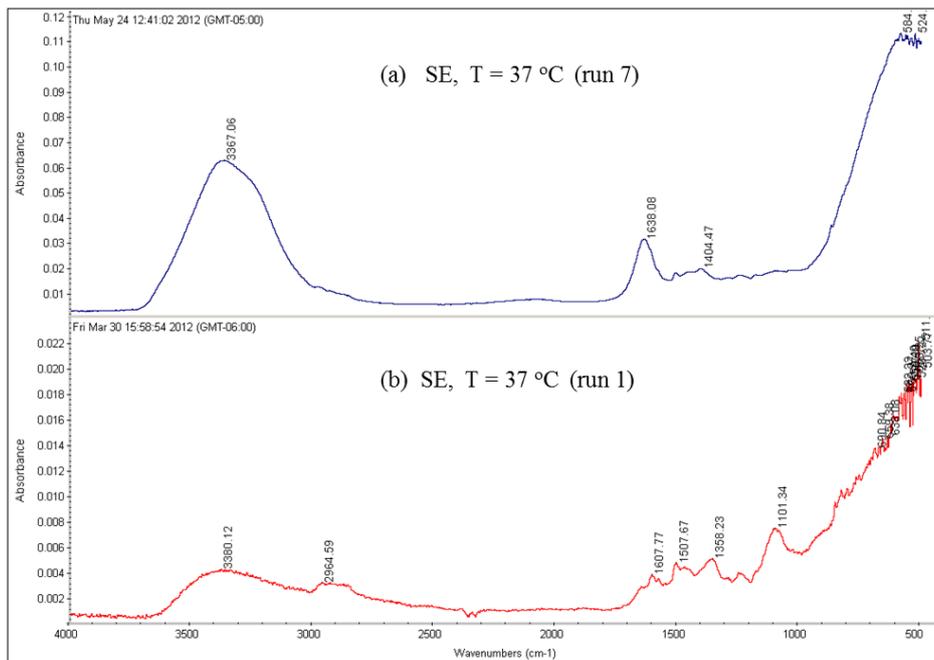
Moreover, the FTIR spectra of the fouled SE membrane with and without using an MF membrane as a pretreatment unit for the feed water of run 7 and run 1, respectively, are shown in Figure 19. The results revealed that, in run 1, the main absorption functional group is the aromatic hydrocarbons, which are near 3050 cm^{-1} , 1500 cm^{-1} and 820 cm^{-1} . However, the FTIR spectrum of run 7 shows a main absorption near 3367 cm^{-1} , which is due to the O–H stretches of the aliphatic alcohols and amides and a lower absorption near 1638 cm^{-1} due to aliphatic C=O deformation. The main absorption functional groups seen in the FTIR spectra of run 7 are also the main absorption functional groups seen in the FTIR spectra of the clean SE membrane, indicating less (than run 1) fouling material deposited on the membrane surface of run 7.

Figure 19. FTIR spectra for the SE membranes fouled by the feed water of location 6 at 37 °C (run 7 with MF pretreatment and run 1 without MF pretreatment).
