Review

Impact Testing on the Pristine and Repaired Composite Materials for Aerostructures

Keywords: carbon fibre reinforced polymer composites; impact testing; finite element analysis

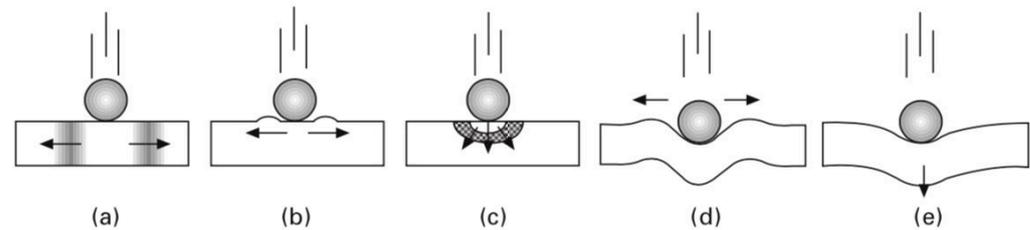
Figure 1. Wave shapes discussed by Olsson [11]: (a) fast tensile or compressive waves in the plane of the laminate, (b) fast surface waves along the laminate surface, (c) somewhat slower tensile or compressive waves through the thickness of the laminate, (d) relatively slow transient shear and flexural waves within the laminate, and (e) slow oscillation involving global quasi-static deflection.

Research in this area has been carried out by Olsson [11] who considered low- and medium-velocity impacts as a cause of failure in polymer matrix composites. These velocities are defined as considerably less than 75 m/s, which is said to be the minimum velocity for penetration to occur and therefore is considered a high-velocity impact. Olsson [11] discussed different wave shapes that can occur from an impact: (a) fast tensile or compressive waves in the plane of the laminate; (b) fast surface waves along the laminate surface; (c) somewhat slower tensile or compressive waves through the thickness of the laminate; (d) relatively slow transient shear and flexural waves within the laminate; and (e) a slow oscillation involving a global quasi-static deflection mode. These wave shapes are shown in Figure 1 below.

It is noted that the third of these wave shapes, the through thickness wave, easily causes damage. This is said to be because it has a large amplitude and acts in a direction with low strength, but the influence of these waves is fairly local. Furthermore, it is stated that impact damage may reduce the strength and stability of composite structures significantly. Olsson [11] found the effect to be large in compression, with reductions of up to 70% from the undamaged strength being observed. From experimentation, it was concluded that the reduction in failure strain is smaller for tougher resins. However, the

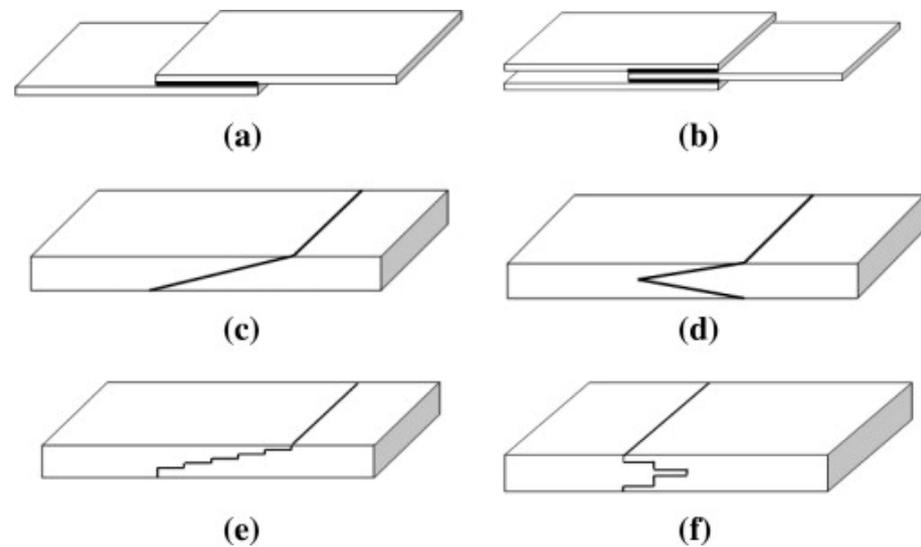
Figure 2. Types of adhesive joints shown by Kiniaiefar et al. [14]: (a) single lap joint, (b) double lap joint, (c) scarfed lap joint, (d) double sided scarfed joint, (e) stepped lap joint, and (f) double sided stepped lap joint.

There are various ways to repair a composite sample, with a scarf joint being one option. A selection of some of the joint options by Kimiaefar et al. [14] is shown in Figure 2.

Reasoning for choosing scarfed joints over lap joints was discussed by Pinto et al. [15], who stated that scarf repairs reduce peel stresses due to not causing substantial bending. It was also commented that the tapering of the edges means that the shear stress distributions are more uniform along the bond for scarf joints.

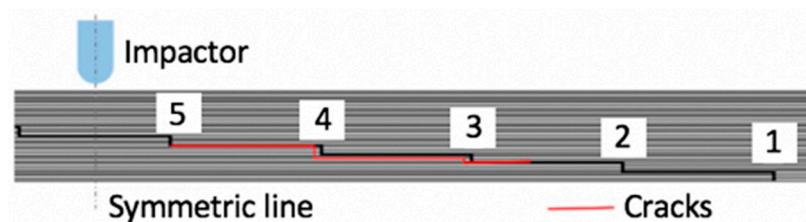
Figure 3. Location of cracks from 10 J impact performed by Liu et al. [24].

Low-velocity impacts were performed on scarf-repaired CFRP composites by Liu et al. [24] using a drop weight machine. The samples tested were $250 \times 25 \times 6 \text{ mm}^3$, with the stepped repair spanning 90 mm over the 100 mm cut-out window of the impact set up. Later, after testing, the panels were cut along the central line and assessed using optical microscopy. Impact energies of 3, 4, 5, 6, 8, and 10 J were used, with an energy above 4 J causing damage along the adhesive line. The adhesive damage occurred within steps one to five, which were subjected to tensile forces in addition to the shear forces throughout the material. Contrastingly, steps six to ten had little to no adhesive damage due to experiencing compressive forces that did not aid in the progression of the adhesive failure. Figure 3 below demonstrates where the adhesive damage occurred after undergoing a 10 J impact. Two main observations from the experimentation were commented on. Firstly, the adhesive failure from the impacts reduces the residual strength of the material, since the ability to withstand tensile forces is greatly reduced. Secondly, delamination of the composite itself initiates before the adhesive cracking and progresses at a slow rate through the material.

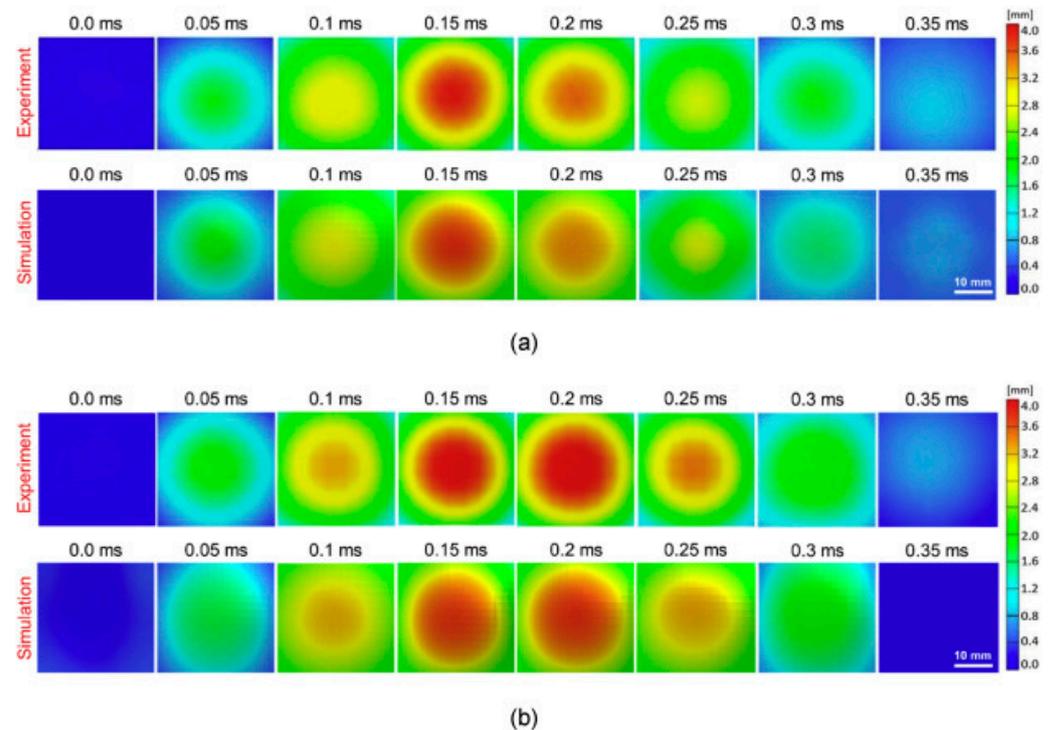
Figure 4. The out-of-plane displacement traces of high-velocity impacts on woven carbon-fibre/PEEK samples from experimental and numerical work for (a) a gelatine projectile, and (b) a HDPE projectile by Liu et al. [48].

Lastly, Liu et al. [48] used the same model to consider both hard and soft high-velocity impacts to consider the effect of the projectile hardness on the impact response of the composite. Since the two types of projectiles behave differently upon impact, it was required to create two simulations. As in the papers above, the SPH modelling technique was used for the soft projectile. Contrastingly, the hard projectile was much simpler to model, with elastic material elements being employed. The good agreement achieved from both simulations can be seen in Figure 4.

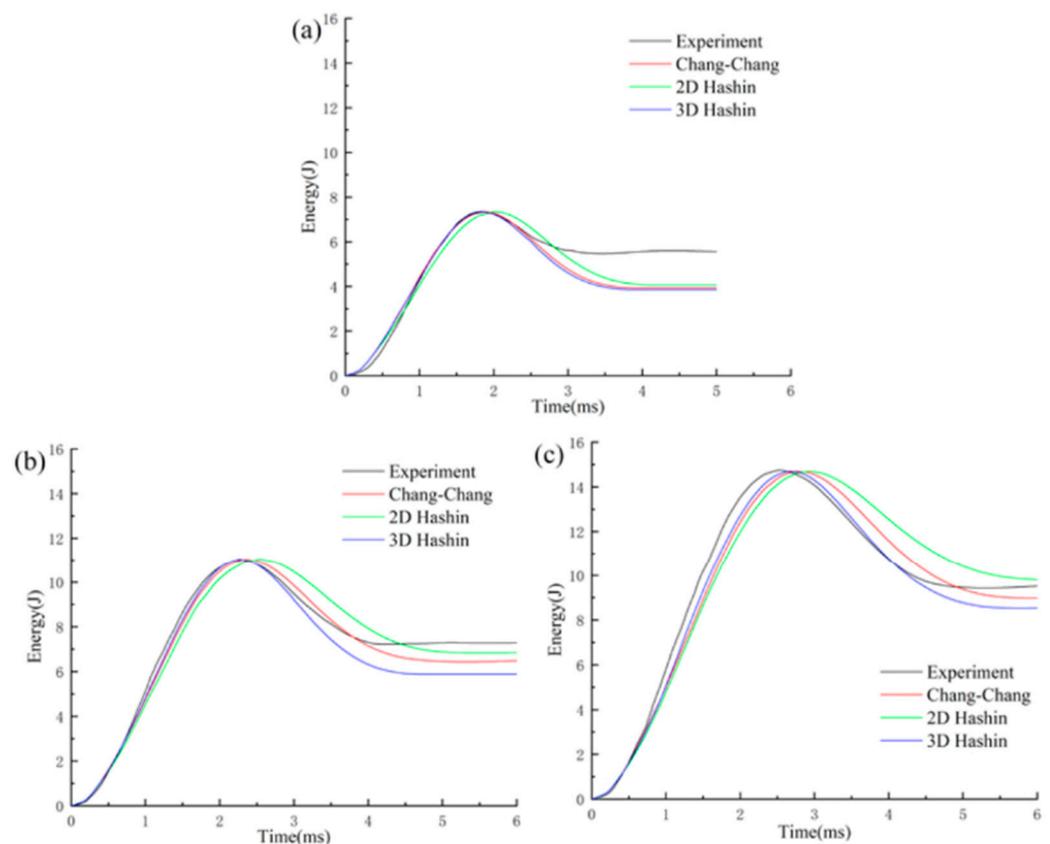
Figure 5. Comparison of time energy traces for 2D Hashin, 3D Hashin, and Chang-Chang failure criteria to experimental results at impact energies of (a) 7.35 J, (b) 11.03 J, and (c) 14.70 J [56].

Shao et al. [56] compared the three modelling techniques used for predicting intralaminar damage. It was found that, including the effect on the damage within the matrix from the normal stress that acts through the thickness of the composite, two of the models gave better results and aligned more closely with those obtained experimentally. Both the 3D Hashin criteria and Chang-Chang criteria include this, but the 2D Hashin does not, highlighting the biggest drawback of the latter. Between the other two techniques, the 3D Hashin criteria gave slightly more accurate results. However, as can be seen in Figure 5 below, there is minimal difference, and all three techniques perform worse at a higher impact energy.
