# Article False Ceiling Deterioration Detection and Mapping Using a Deep Learning Framework and the Teleoperated Reconfigurable 'Falcon' Robot

Keywords: defect detection; Faster R-CNN; deep learning; object detection; IoRT; inspection robot

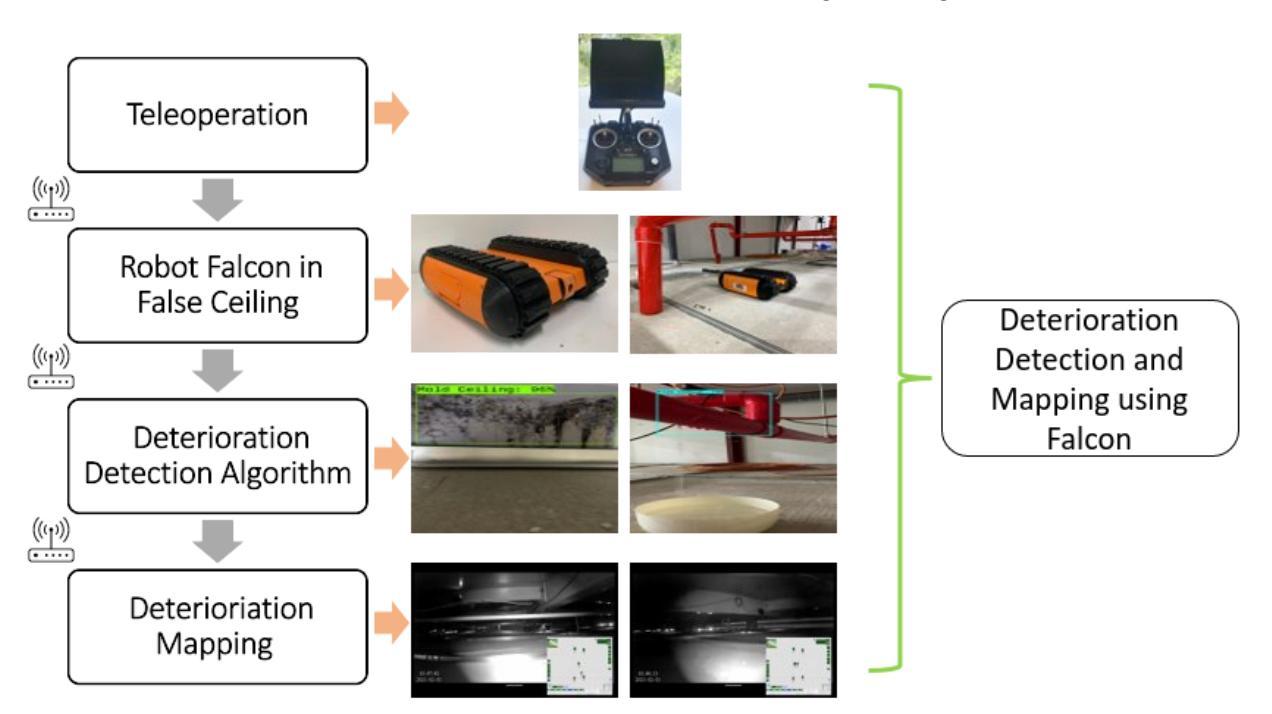
Figure 1. Overview of the proposed system.

Figure 1 shows an overview of the false ceiling inspection and deterioration mapping framework. Our in-house-developed crawl class Falcon robot was used for false ceiling inspection, and a deep-learning-based object detection algorithm was trained for deterioration detection from robot captured images. Further, a UWB localization module was used to localize the deterioration location and generate a deterioration map of a false ceiling. The detail of each module and functional integration is given as follows.

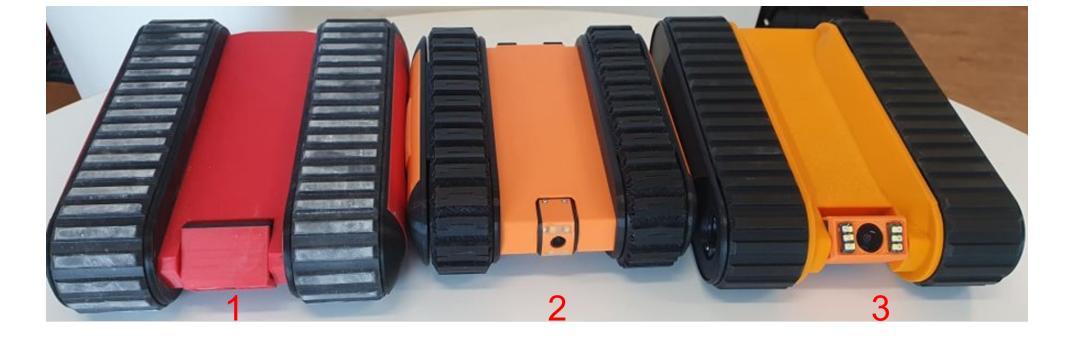
Figure 2. Different Version of Falcon Robot (Version 1, 2 and 3).

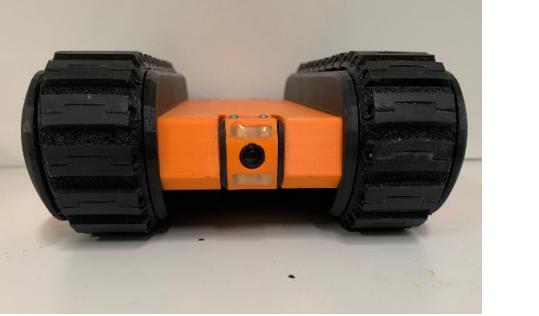
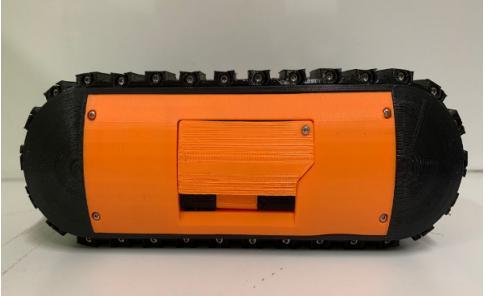
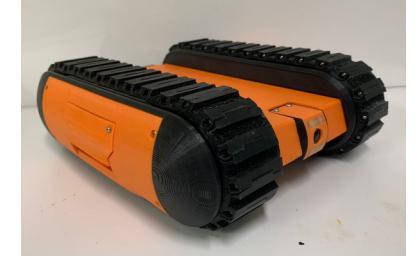
(a) Front View

(b) Side View

(c) Isometric View

Figure 3. Different view of the Falcon Robot (Version 3).

**Locomotion Module:** An important design consideration for a false ceiling robot is the form factor to overcome obstacles with a height of 55 mm and to traverse through low hanging spaces under 80 mm. In order to overcome these narrow spaces and tall obstacles, a locomotion module in the form of tracks that has maximized the contact area was used. The tracks extended along the dimension of the vehicle and were configured to be 236 (L)  $\times$  156 (W)  $\times$  72 (H) [mm  $\times$  mm  $\times$  mm]. The Falcon can operate regardless of the direction it flips over, as both sides of the locomotion modules are consolidated with hemispherical attachments to avoid stabilizing laterally. However, the operational terrain of the false ceiling may impose uncertainty on the Falcon robot. Therefore, the motors with higher specifications were chosen; e.g., a safety factor of 2 on a maximum inclined slope of 12 degrees.

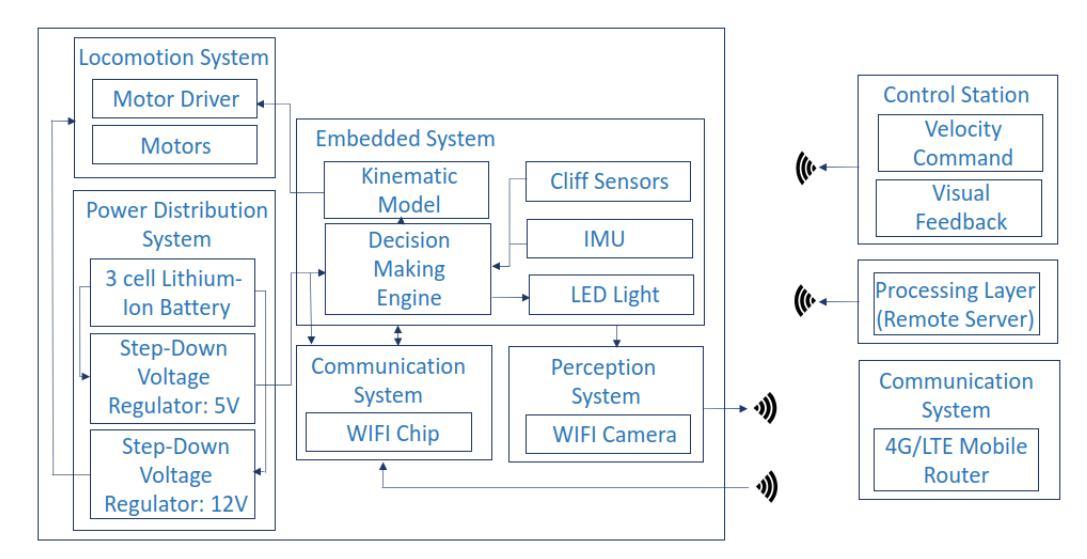
Figure 4. System architecture of the Falcon.

Figure 4 illustrates the system architecture of the Falcon robot. It consists of the following units: (1) a locomotion module, (2) a control unit, (3) a power distribution module, (4) a wireless communication module, and (5) a perception sensor.

**Perception Module** The WiFi camera module operates with a 5 V power rating and a  $640 \times 480$  pixel density at 30 fps. The encoded video feed is a recorder and is additionally used to process the data through computer vision and machine learning algorithms to identify defects. Since the perception system relies heavily on lighting conditions, a NeoPixel stick with an 8~50 RGB LED strip is used as the robot's light source. Furthermore, a dedicated router is used to avoid data loss and for improved data security. Finally, a titling camera (up to 90 degrees) was incorporated considering broader field of view requirements using a servo motor controlled by A Teensy-embedded computing system.

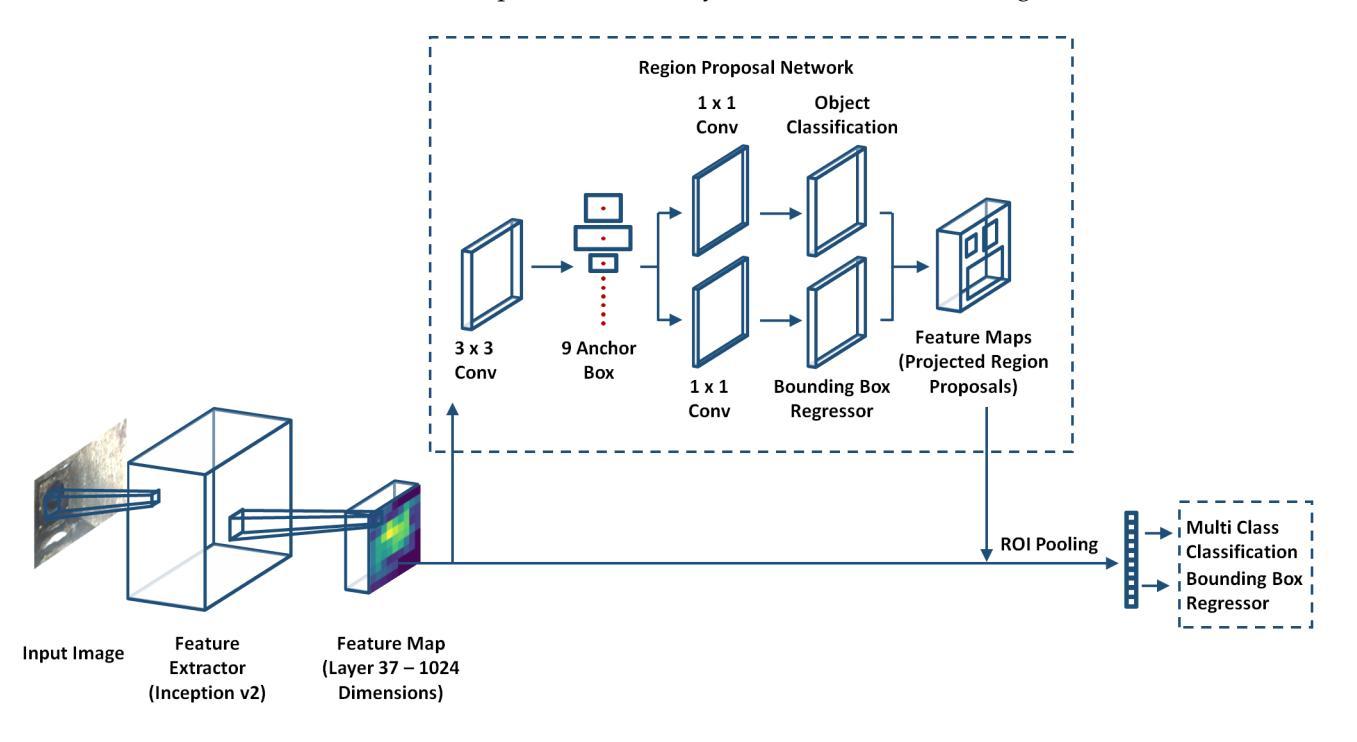
Figure 5. Functional block diagram of the deterioration detection algorithm.

Generally, deterioration factors in false ceiling environments are tiny and cover only a small number of the pixels of an image. Therefore, there is a requirement of a detection algorithm able to detect small objects to mitigate overlap or pixelated issues. Furthermore, the information extracted from images is lost due to multiple layers of the convolution neural network. The inspection algorithm needs an extensive, accurate, and apt framework with a small object detection capability. A Faster R-CNN model is an optimal framework when compared with similar CNN architectures and was used to detect small deterioration factors of the false ceiling environment in our case study [9,10]. Figure 5 shows an overview of the Faster R-CNN framework. Its architecture comprises three main components: the feature extractor network, the Region Proposal Network (RPN), and the detection network. All three components are briefly described in the following section.

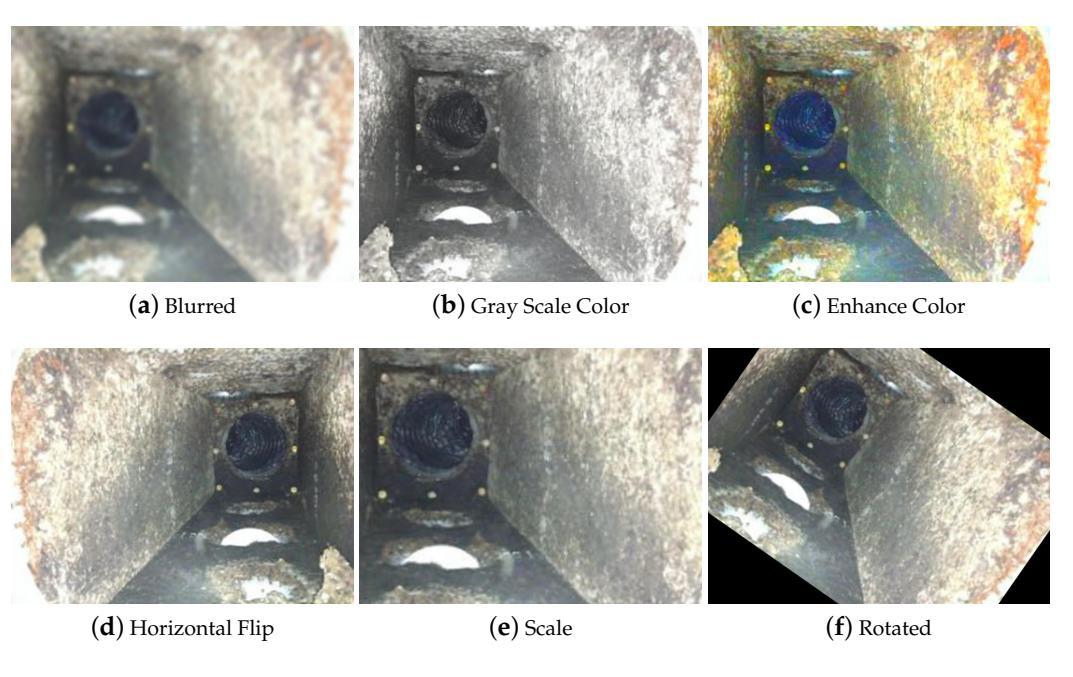
Figure 6. Sample of data augmentation of one image.

Further, the data augmentation process was applied on labeled images to help control the over-fitting and class imbalance issues in the model training stage. Data augmentation processes such as horizontal flips, scaling, cropping, rotations of the image, blurring, grayscale colors, and color enhancing were applied to the collected images. Figure 6 shows a sample of the data augmentation of one image. Further, Table 4 elaborates the settings of the various types of augmentations applied.

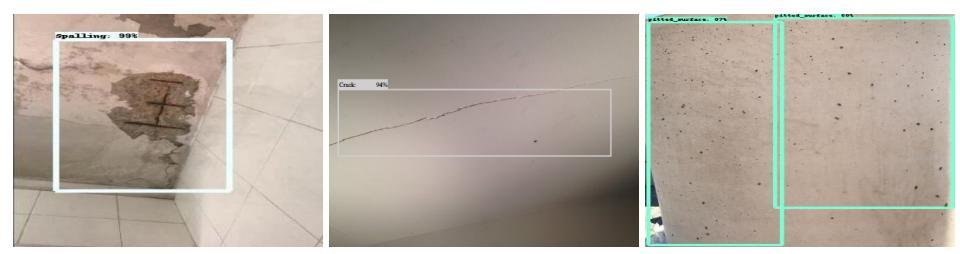
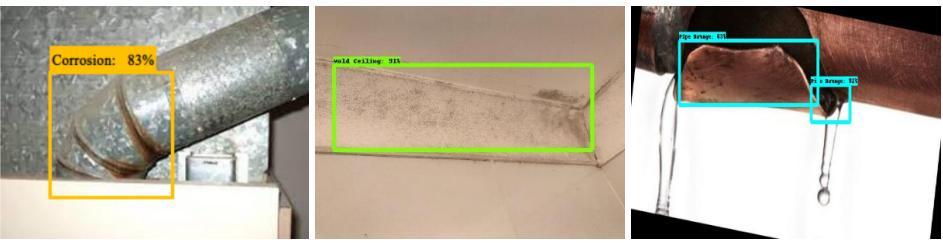
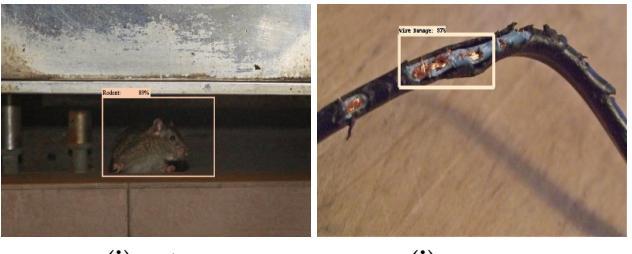
Figure 7. Structural Defects (a-d), degradation in HVAC system (e-g), infestation (h,i), electrical damage (j) during Offline Testing.

The trained model's deterioration detection and classification accuracy were evaluated using the test dataset. In this evaluation process, 100 images were tested from each class. These test datasets were not used in the training and cross-validation of the model. Figure 7 shows the detection results of the given test dataset.

The experimental results show that the deterioration detection algorithm accurately detected and classified the deterioration in the given test images with a high confidence level average of 88%. Further, the model classification accuracy was evaluated using standard statistical metrics such as accuracy (Equation (1)), precision (Equation (2)), recall (Equation (3)), and  $F_measure$  (Equation (4)).

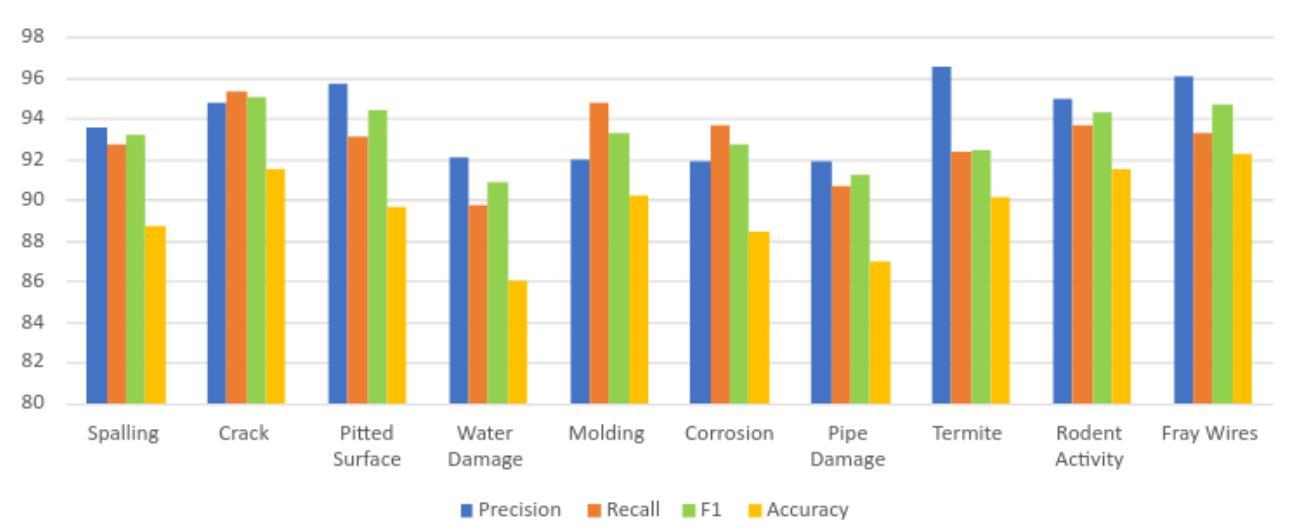
Figure 8. Graphical representation of the statistical measures of the proposed framework.

Here, *tp*, *fp*, *tn*, *fn* represent the true positives, false positives, true negatives, and false negatives, respectively, as per the standard confusion matrix. Table 5 provides the statistical measure results of the offline test. Figure 8 demonstrates the graphical representation of Table 5 for improved visualization.

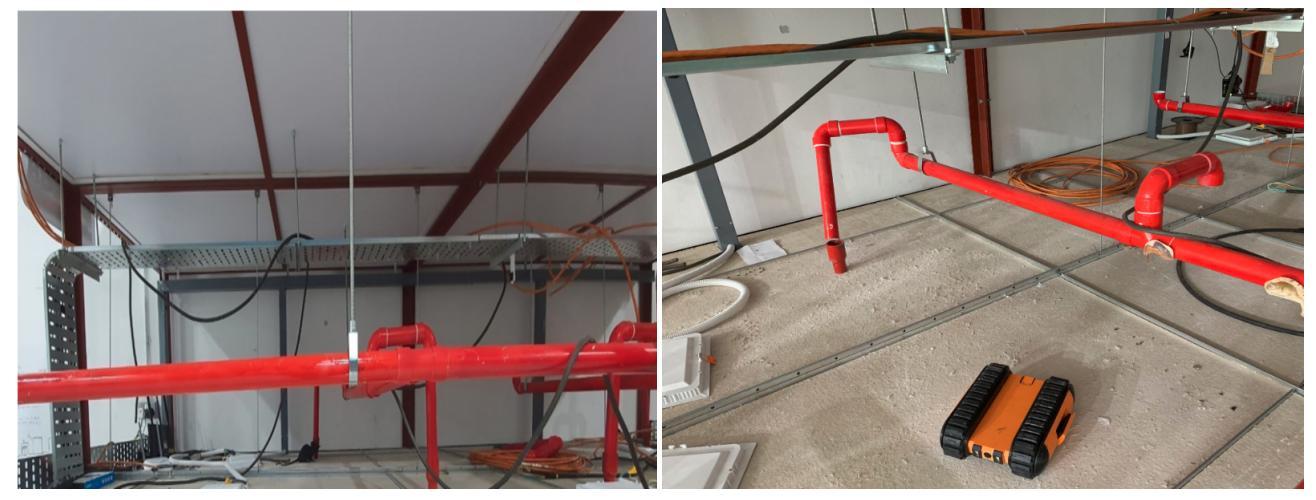
Figure 9. Falcon and the false ceiling testbed prototype.

Figures 9 and 10 show the Falcon robot in the prototype of the false ceiling (Oceania Robotics test bed), while Figure 11 shows the robot in a real false ceiling environment (SUTD ROAR Laboratory). During the inspection, the robot was controlled by a mobile GUI interface, and the robot's position and the defect region were localized through UWB modules fixed in the false ceiling environment. The robot was paused at each stage for a few seconds to capture better quality images in these real-time field experiments.

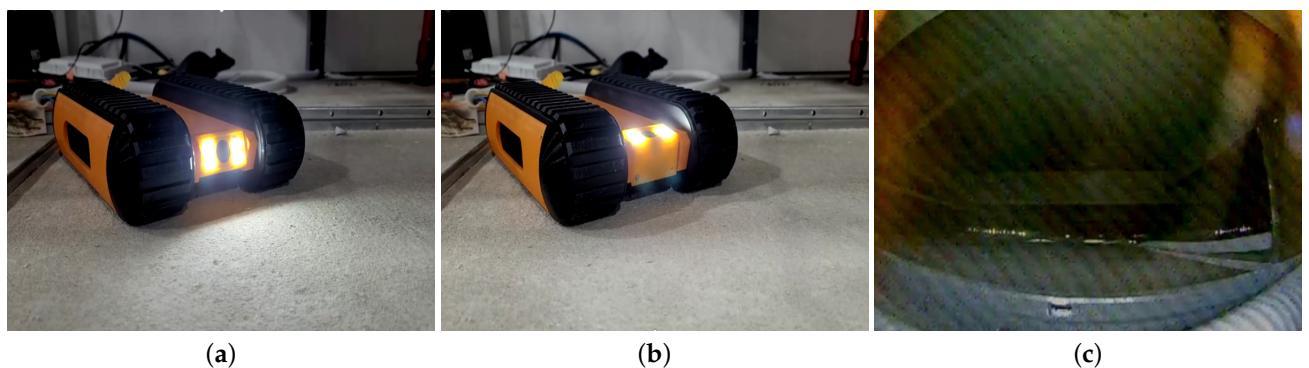
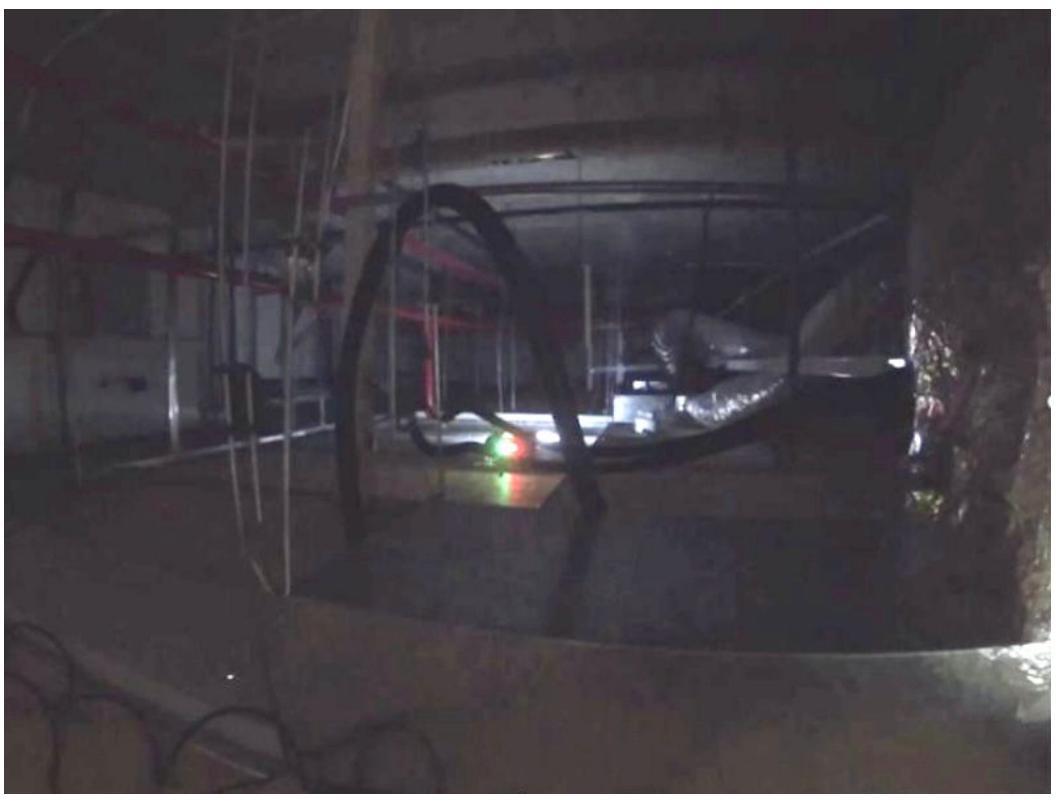
Figure 10. Falcon's performance on the false ceiling prototype at Oceanica Robotics. (a) Falcon in Prototype of False Ceiling (Camera at 0 degree); (b) Falcon in Prototype of False Ceiling (Camera at 90 degree); (c) Image collected by Falcon; (d) Falcon in Prototype of False Ceiling (Zoomed out).

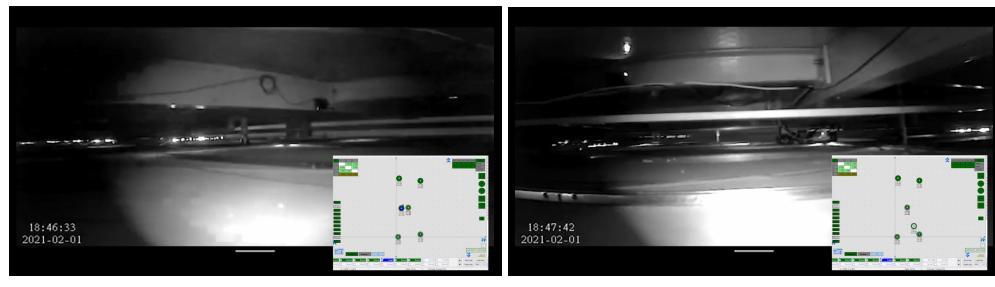
(a) Falcon at Location 1

(b) Falcon at Location 2

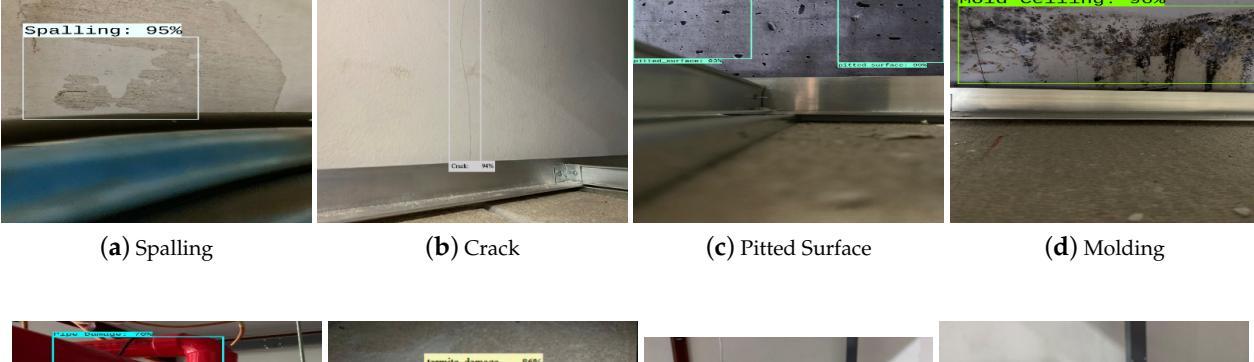
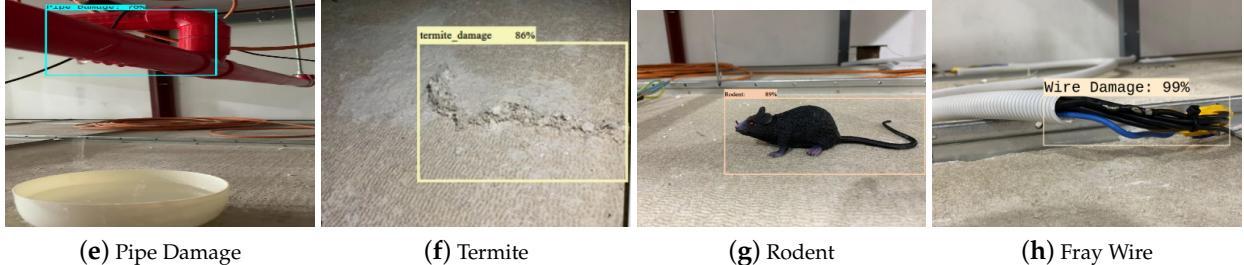
**Figure 12.** Structural defects (**a**–**c**), degradation in the HVAC system (**d**,**e**), infestation (**f**,**g**), and electrical damage (**h**) during online testing.

The captured images were transferred to a high-powered GPU-enabled local server for false inspection tasks via WiFi communication. Figure 12 depicts the real-time filed trial deterioration detection results of the false ceiling testbed, and its localization results are shown in Figure 13. These deterioration-detected image frame locations were identified by fusing the beacon coordinates, wheel decoder data, and IMU sensor data on the Marvel Mind Dashboard tracking software. Figure 13 also shows the deterioration location mapping results for the real-time field trials, where the color codes indicate the class of deterioration.

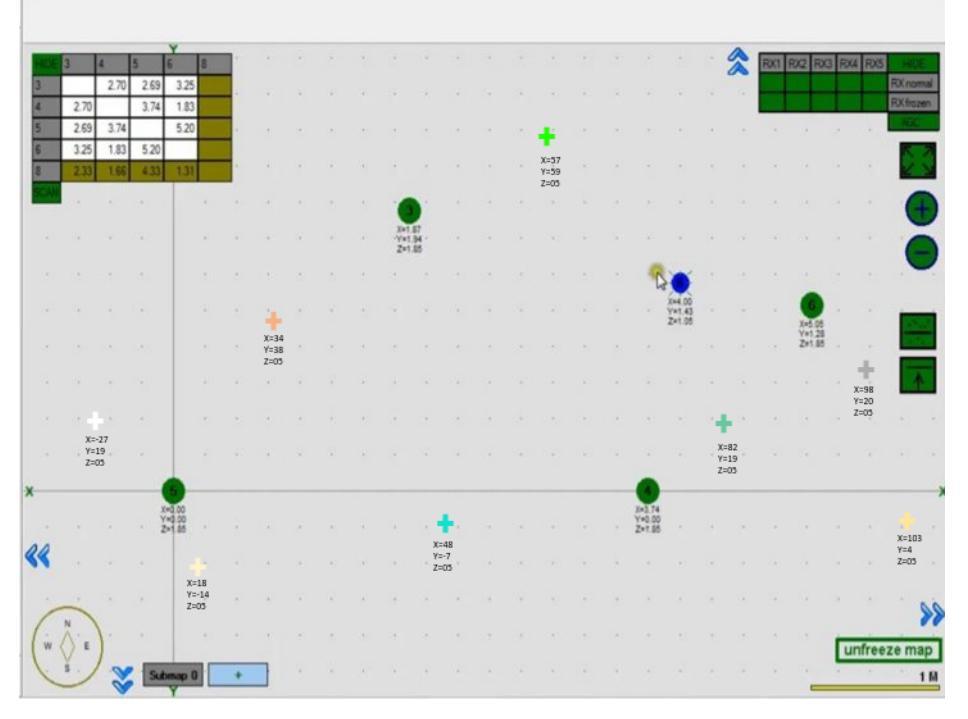
Figure 13. Beacon maps with static beacons and a mobile beacon.

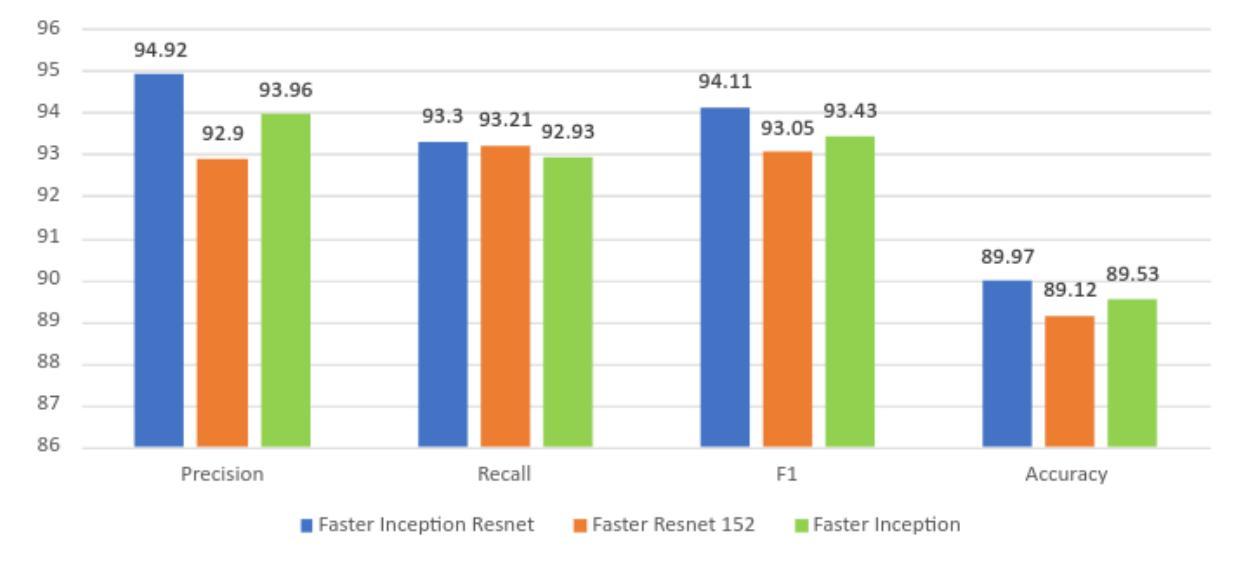
Figure 14. Graphical representation of the comparison with other detection frameworks.

The proposed system's performance is discussed in this section by a comparison with two models (Faster Inception ResNet and Faster Resnet 152) and other existing studies. The comparison analysis findings are shown in Tables 6–8. The three detection frameworks were trained on the same image dataset and with the same number of epochs. Here, overall detection accuracies of 86.8% for the Faster Resnet 152 and 86.53% for the Faster Inception Resnet were observed. The detection accuracy of these two models was relatively low due to a high false-positive rate and misclassification issues due to similar deterioration factors and the impact of object illumination. These issues can be further resolved by retraining the algorithm with misclassified classes and applying nonlinear detrending techniques [32]. Further, Figure 14 shows a graphical representation of Table 8 for improved visualisation.
