# Non-Destructive Testing of Technical Conditions of RC Industrial Tall Chimneys Subjected to High Temperature

# Marek Maj <sup>1,\*</sup>, Andrzej Ubysz <sup>1</sup>, Hala Hammadeh <sup>2</sup> and Farzat Askifi <sup>3</sup>

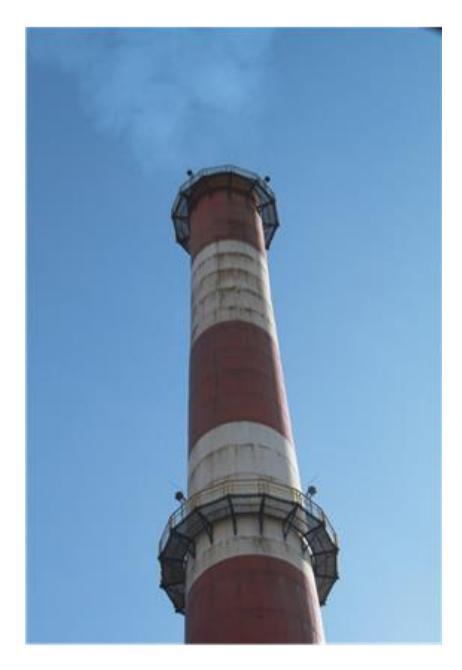
As the condensate penetrates through cracks in the lining, it makes the mineral wool damp, whereby the latter loses its insulating properties. Moreover, the damp mineral wool sinks, and as a result, areas devoid of thermal insulation are created. As the coefficient of thermal conductivity decreases, the temperature of the chimney's inner wall falls further, and so does the temperature of the flue gas. As a result, more and more flue gas condenses on the chimney's inner wall, whereby the degradation processes in the chimney's RC shell intensify (Figures 1–3).

Figure 1. Deposition of condensation on outer surface chimney wall along construction joints.

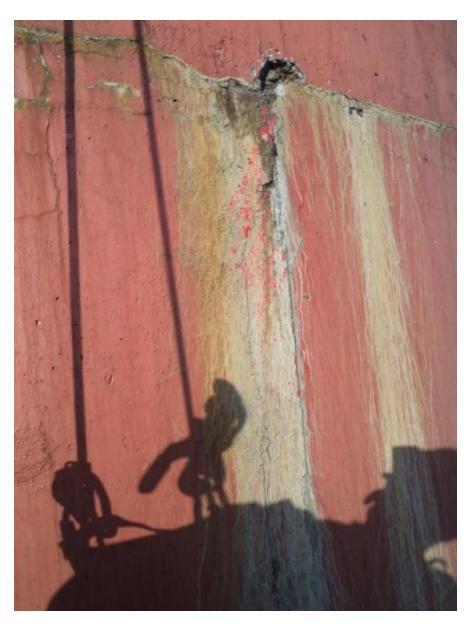
Figure 2. Condensation degrading of chimney wall.

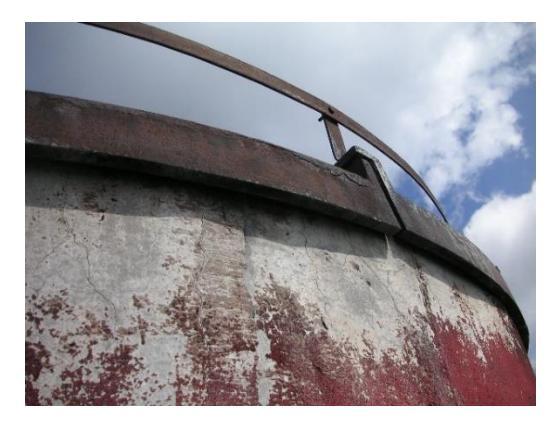
Figure 3. Condensation dripping down from a chimney upper ring.

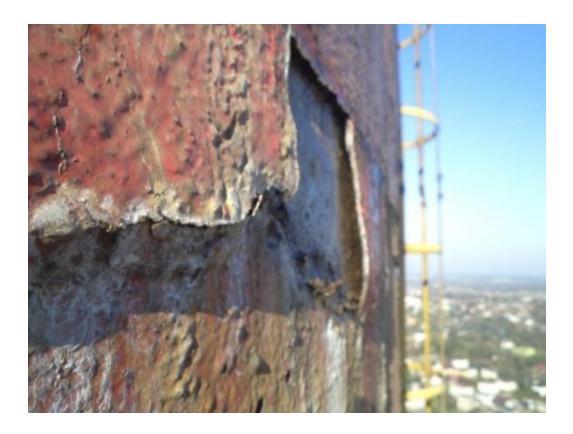
As condensation drips down the inner wall, it penetrates via cracks to the mineral wool and outside to the reinforcement of the concrete wall, causing intense corrosion of the concrete and the reinforcing steel (Figure 4).

Figure 4. Condensation penetrating chimney crown wall.

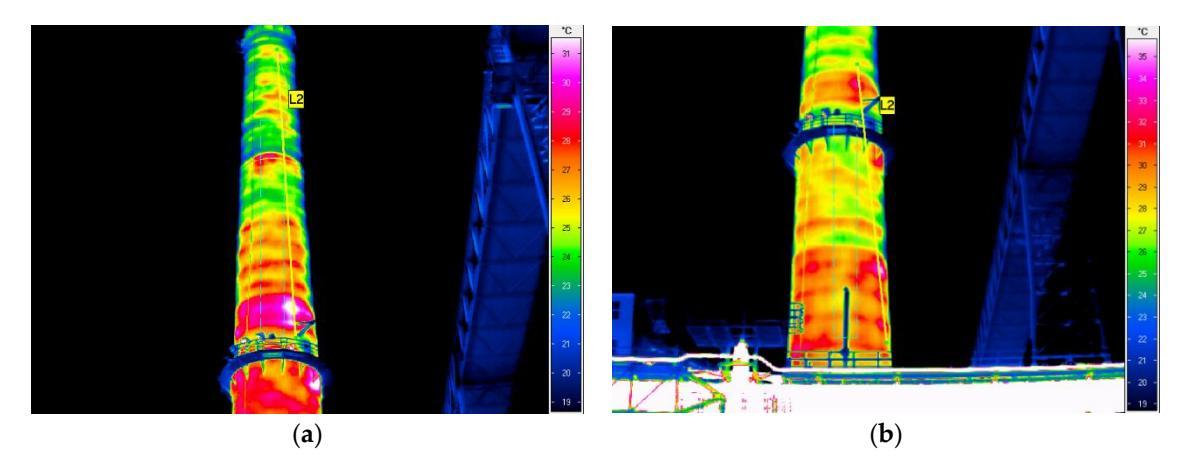
- As much as 21.8 °C in the chimney's upper part;
- 15.9 °C in the chimney's middle part;

• 10.5–11.9 °C (being more uniform) in the chimney's lower part (Figure 5).

**Figure 5.** Chimney thermograms revealing insulation imperfections: (**a**) No thermal insulation more than two metres above and under platform; (**b**) Varied temperature distribution in chimney shaft.

The lower part of the chimney does not show such a high degree of degradation as its middle and upper parts. The thickness of the outer reinforced concrete shell, which is considerably greater in the lower part of the chimney, is one of the determining factors.

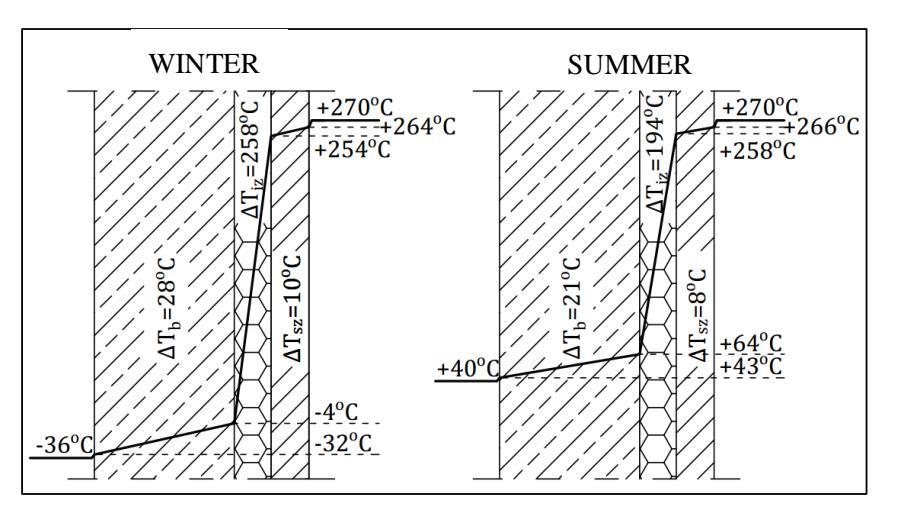
Figures 6 and 7 show temperature drops in the particular layers in the winter season and in the summer season. The largest temperature drop occurs in the full insulation layer, and it is about 10 times larger than in the reinforced concrete shaft. Because of the small thickness of the fire brick layer, the temperature drop in this layer is the smallest.

Figure 6. Temperature drops in particular layers for the winter and summer season.

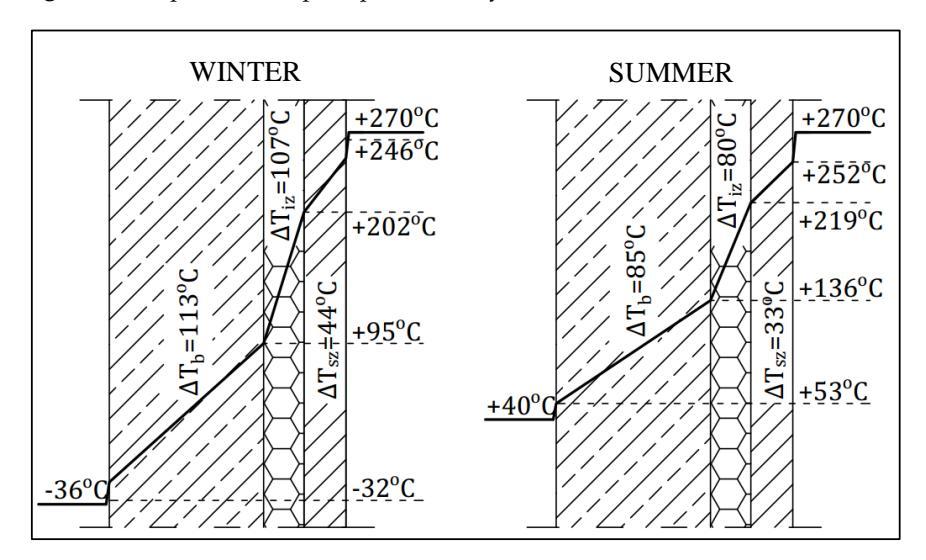
**Figure 7.** Temperature drops in particular layers of design chimney insulation in the first segment with damaged insulation.

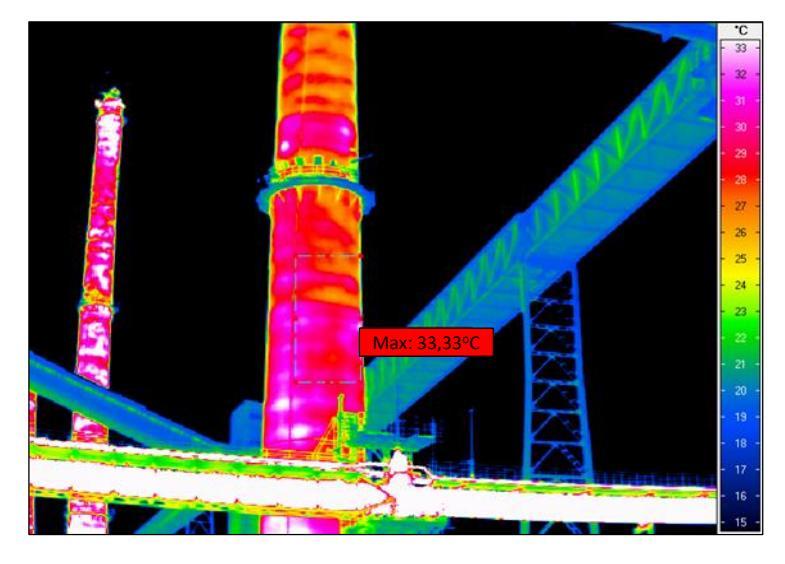
The thermographic surveys revealed temperature differences on the chimney's surface, which indicates that the insulation was not uniform, there were gaps in it, and in places the insulation had slid down and was damp. The temperature differences can also be due to the degradation of the reinforced concrete chimney shaft. Since the measurements were carried out outside the chimney, the places with deteriorated thermal insulation are visible as dark red (the hottest places). The suspected places

where the insulation is missing are visible in the thermograms as bands running at regular intervals around the circumference of the chimney. One can discern a certain pattern in insulation discontinuity: the bands are spaced at every 1 to 3 m. The insulation loss is most visible in the lower part of the chimney, and it is uniform there. In the thermographic picture, the surface temperature in this part reaches about 34 °C. In the segments situated higher one can see more distinct temperature differences on the outside surface, ranging from 22 to 34 °C.

Figure 8. Thermographic picture of the lower part of chimney shaft.

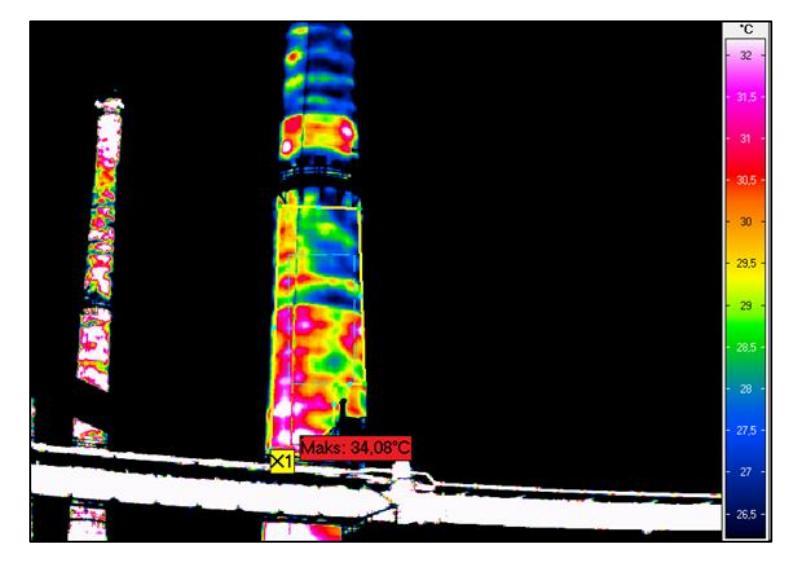
Figure 9. Thermographic picture of the middle part of chimney shaft.

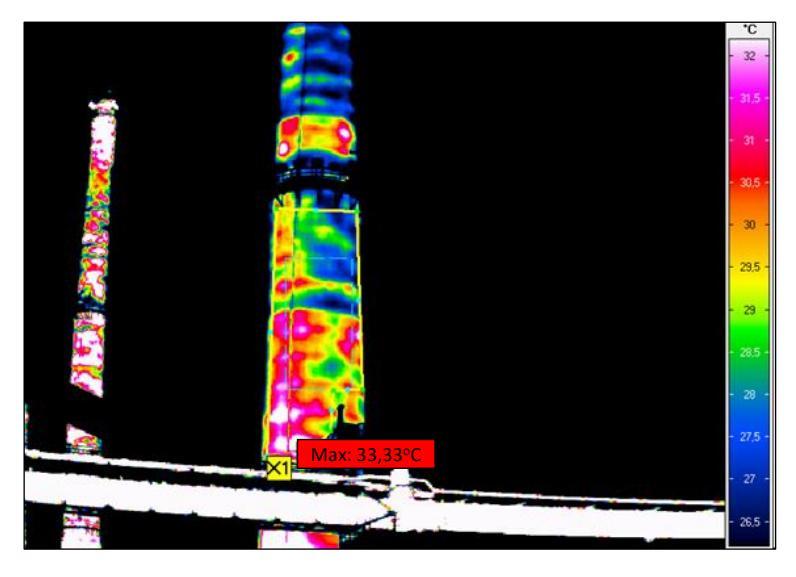
Figure 10. Thermographic picture of the upper part of chimney shaft.

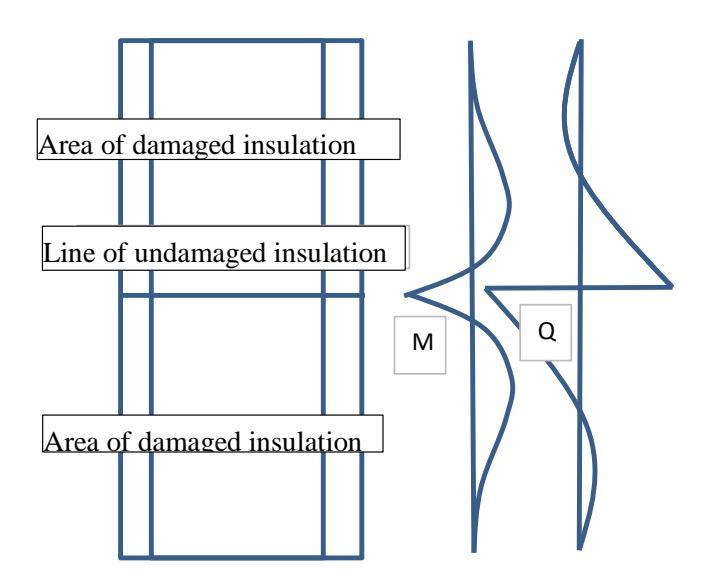
Using such a static load model one gets additional bending moment *M* and additional shear force Q (model is presented on Figure A2. The calculation of these additional factors is presented in Appendix B.

Figure A2. Model of influence damaged on the undamaged area of insulation.
