Article Determination of Loss of Reinforcement Due to Corrosion through X-ray Computer Micro-Tomography

Fernando França de Mendonça Filho *🝺, Oguzhan Copuroglu 🕩, Erik Schlangen 🕩 and Branko Šavija 🕩

Abstract: X-ray computer scanning tomography (CT scan) is an increasingly more available technique, which has been applied to material sciences for years. Although most of its use is qualitative for gaining insights on material behavior, quantitative analysis for estimations of deterioration rates is possible. This paper describes an unbiased, straightforward method to determine the amount of reinforcement lost to corrosion through the use of X-ray tomography without the need to remove the concrete cover. Other methods of assessment such as gravimetric analysis, half-cell potential, resistivity of mortar cover, corrosion current, and scanning electron microscopy (SEM) are used in the same samples for comparison. While the electrical and electrochemical tests are valuable to describe the state of the samples, those demonstrated poor capacity of determining the stage of corrosion of the reinforcement in terms of amount of material lost. Electron microscopy could determine how much of t

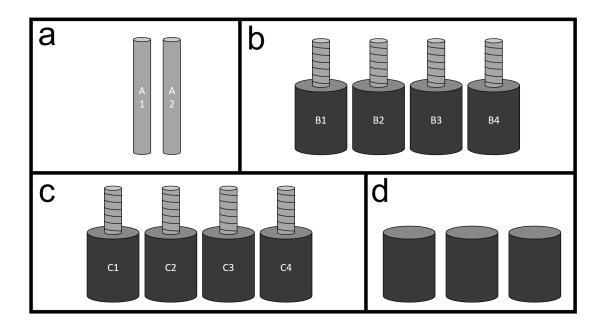
Four sample sets were used for the experiments, as sketched in Figure 1. The first set (assigned with the letter "a" in the figure) consists of plain steel bars and is described in the second paragraph of this section. The second and third sets (assigned with the letters "b" and "c" in the figure) consist of mortar samples reinforced with ribbed steel bars, these are described in the third paragraph of this section. The fourth set (assigned with the letter "d" in the figure) consists of plain mortar samples discussed in the fourth paragraph of this section.

Figure 1. Sketch of different sample sets used for experiments: (a) Plain steel bars, (b) plain mortar cylinders, (c) mortar cylinders reinforced with ribbed steel bars, and (d) mortar cylinders reinforced with ribbed steel bars that were put in compression.

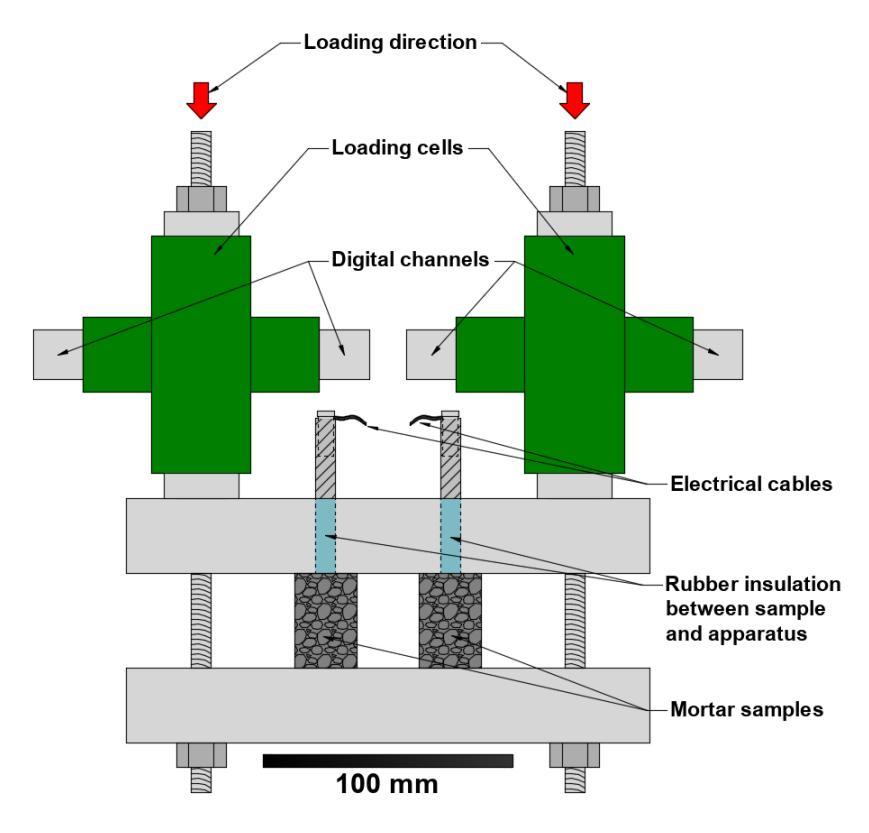
The partial compression of samples C1 to C4 was achieved through the use of a couple of loading cells and a stainless steel set-up stiff enough to be considered rigid (Figure 2). All samples were then immersed in a 3.5 wt.% sodium chloride (NaCl) solution for 60 days in laboratory conditions ($22 \,^{\circ}$ C, 65% RH), and the level of the solution was slightly lower than the top of the mortar in order to avoid direct contact of salt with the reinforcement. During the period of exposure the solution was constantly renewed in order to keep NaCl concentration constant.

Figure 2. Experimental set-up for samples subjected to compressive loads.

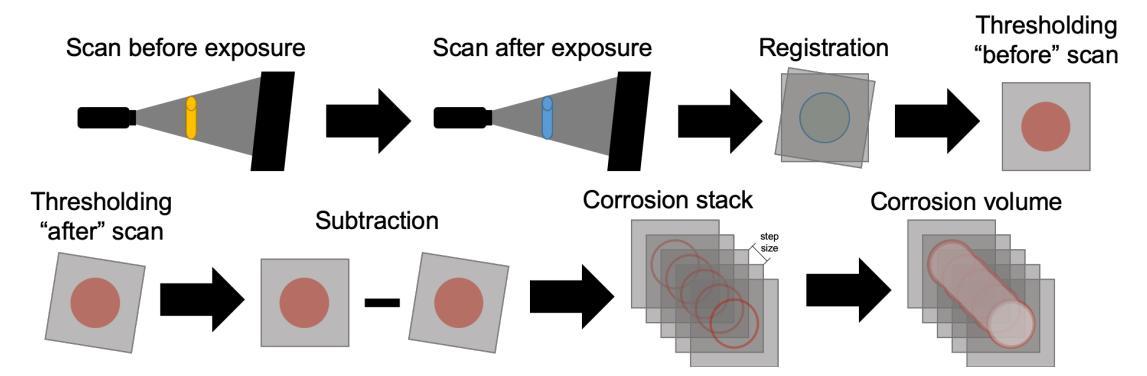
For samples A1 and A2, the postprocessing of the images used the freeware Fiji [22]. To account for slight misalignment between the scans performed before and after exposure, rigid registration was carried out. Max entropy threshold [23] was used for segmentation, followed by the subtraction of the second scan out of the first (scheme in Figure 3). The result was a binary stack containing only lost material. The interest area of each image was computed and multiplied by the step size to give the results in volume.

Figure 3. Schematic representation of the method used for determination of material loss through CT scans.

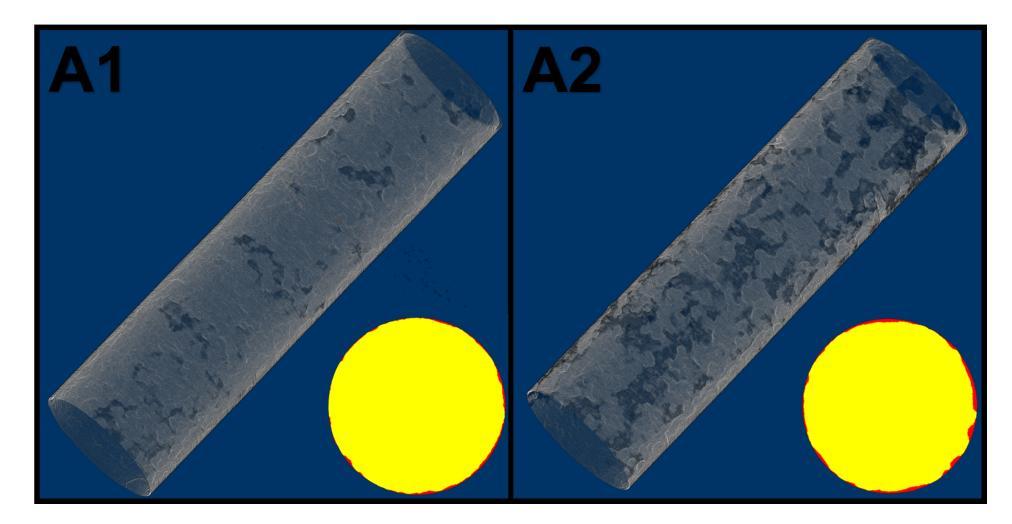
The results of the registration process on the tomography of the plain bars can be seen in Figure 4. The loss of volume of the samples is presented in Table 2. The mass values of the gravimetric analysis were converted to volume in function of the measured density of each samples. The agreement between techniques was very good, especially considering the small scale of the study. Both samples went through general corrosion, the view in Figure 4 might be misleading as A1 seems to have more distributed loss of material, however, upon cross section analysis it is noticeable that A2, although more spaced, has deeper patches of damage. The slight misfit between the techniques is attributed to the necessity of averaging the space between slices of the tomography stacks.

Figure 4. Volume of steel lost to corrosion (in gray) from samples (A1) and (A2), in the bottom there are cross sections with steel in yellow and corrosion products in red.

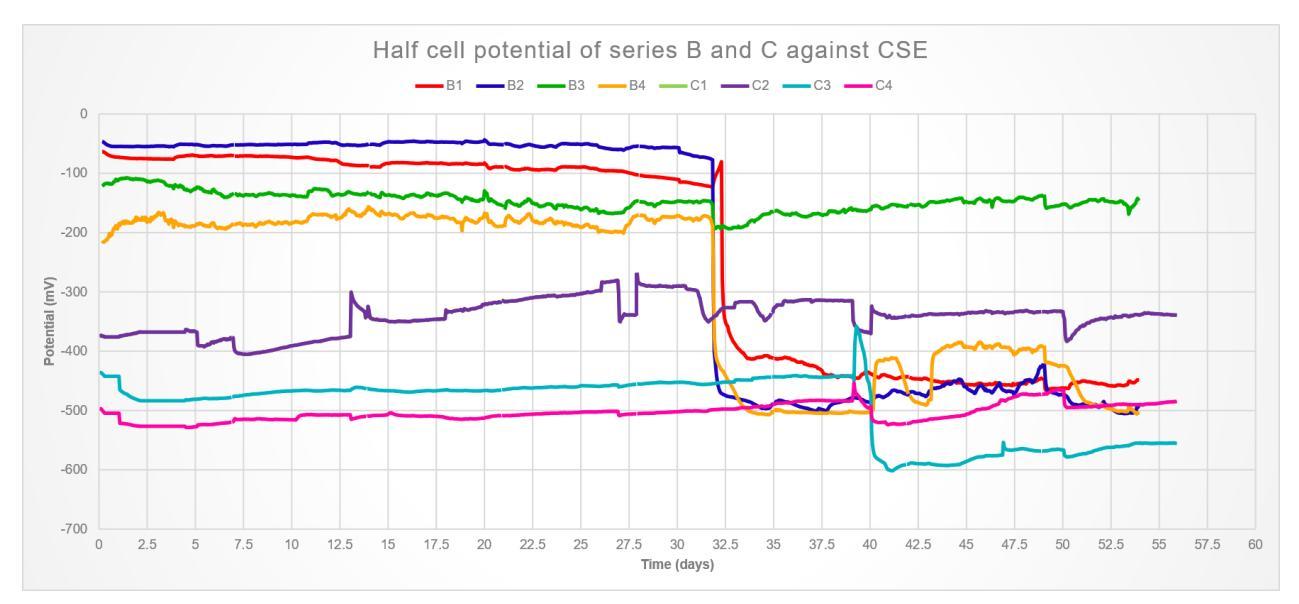
The results for the electrical potential over time are show in Figure 5. Although a calomel electrode was used, the results were converted to their copper–copper sulfate respective so Table 1 could be used. An evident distinction is observed between series B and C, the unloaded samples started with values above the threshold and corrosion seems to take place after 32 days of immersion, with the exception of sample B3 that has not entered the corrosion zone.

Figure 5. Electrical potential of samples B1 to B4.

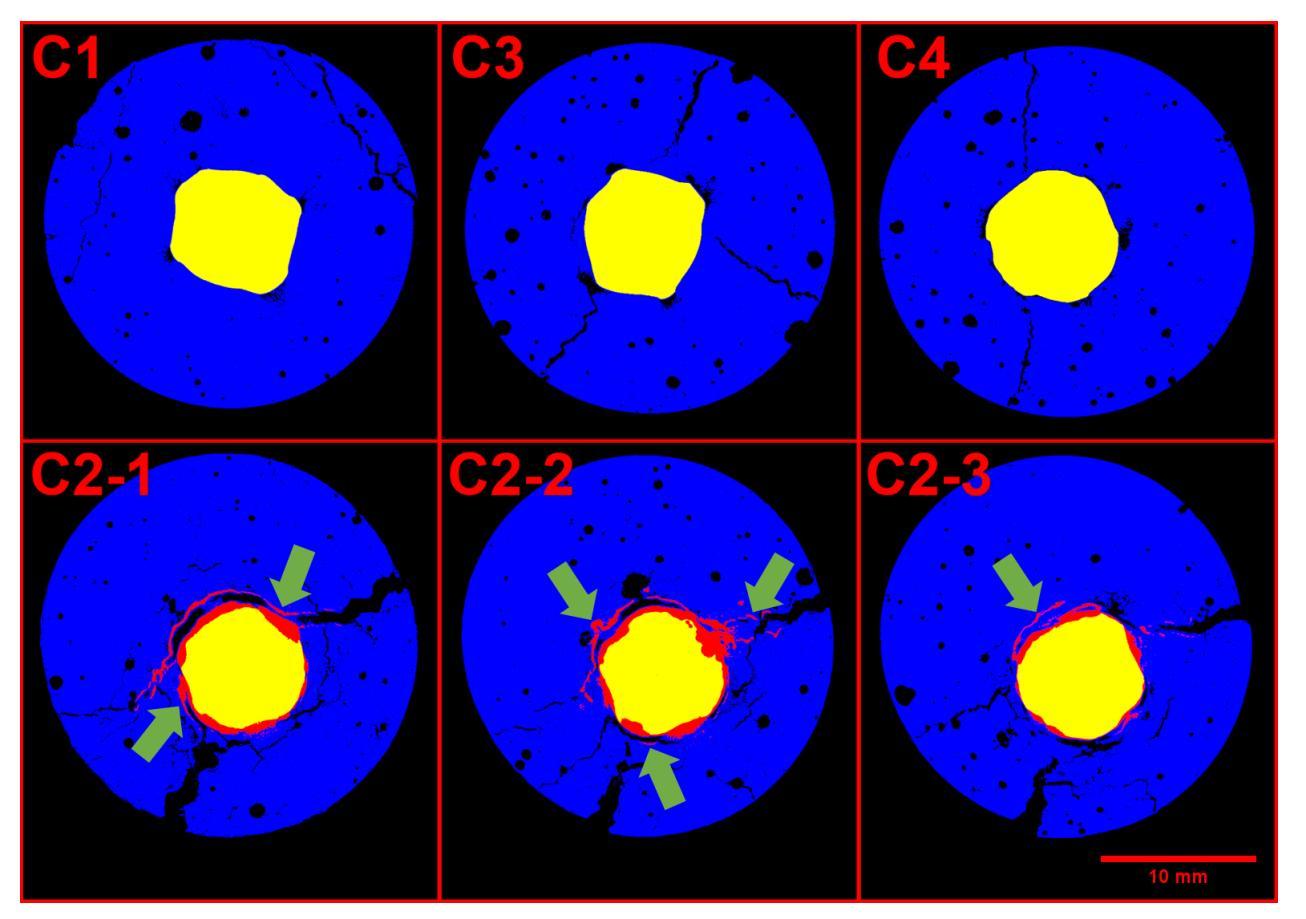
The mortar portion of the samples was undamaged in all unloaded samples, but presented cracking in the loaded ones, Figure 6 shows the cracking on each sample. Three slices at increasing depth are shown of C2 given its higher variability depending o height.

Specimen C2, on the other hand, might have a combination of the loading plus the stress from rust formation as responsible for the cracks. There were two main fractures in the sample with an average opening larger than 0.8 mm that correlate well with the corrosion products (as pointed in Figure 6).

Figure 6. Cross section of loaded samples, the mortar phase is displayed in blue, pores and cracks in black, the steel is in yellow, and the corrosion products are shown in red. The green arrows show cracked zones filled with corrosion products.

The reference scans did not contain significant cracks; therefore, such cracks happened during the exposure period. Sample C1 had minor cracking on the surface, but nothing close to reinforcement. Samples C3 and C4 had cracks going from the surface until reinforcement with an average size of 0.2 mm and 0.1 mm, respectively. These observations agree with the previous assumptions that C1 was acting as cathode and C2 as anode, given the obvious ease of chloride access to C2. Further, the confirmation of microcracking in C3 and C4 explains the electrical results. Still, C3 and C4 did not display considerable rust formation, thus, the cracking is most likely caused by the mechanical loading.

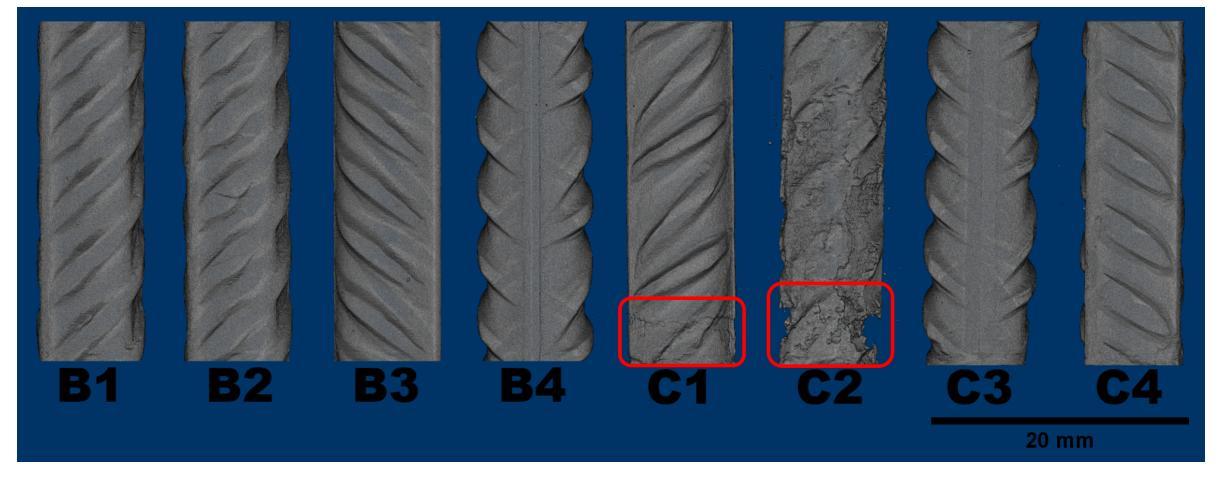
Regarding the steel phase, detailed volumetric reconstructions are displayed in Figure 7. Uniform corrosion is often hard to notice in the initial state because of the small change in cross section. The notable exceptions are samples C1 and C2 that rather suffered localized corrosion at the bottom (marked in red on Figure 7). It should be noted that the deterioration of both samples is present at the bottom, where the connection was presumed.

Figure 7. Reconstruction of the remaining sound steel in each sample after 60 days of exposure.

Localized corrosion is particularly dangerous because of the speed in which diminishes the load capacity. Sample C2 poses as a prime example, after only eight weeks, it has little more than half its original cross section at critical height. Even if another sample had lost the same amount of reinforcement through uniform corrosion, the loss in cross section would be much smaller, which highlights the importance of knowing the corrosion location. Table 5 shows the changes in volume for each steel bar computed through tomography and the results of corrosion current.

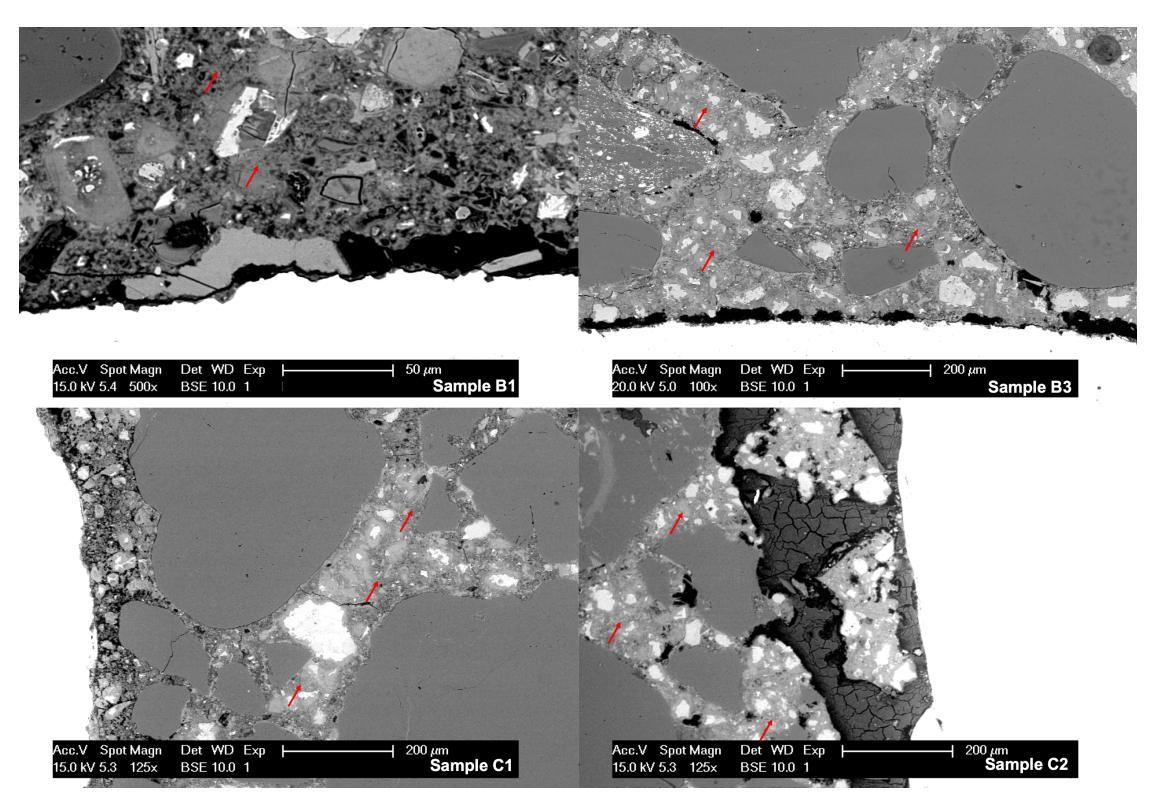
An average of 50 EDS spectra were collected per sample. These were pointed at C-S-H preferentially, so the chloride content could be quantified and atomic ratios were estimated. Typical locations for the analysis can be seen in Figure 8 marked by red arrows. In the same image it is also possible to observe high porosity zones in samples B1, B3, and C1, usually between 50 μ m and 200 μ m from the steel. Sample C2 presented corrosion products between mortar and the reinforcement.

Figure 8. Micrographs of samples B1, B3, C1, and C2. Red arrows indicate typical spots where EDS analysis was carried. The porous zone between the mortar and the steel in samples B1 and C1 can be seen, the morphology of corrosion products in sample C2 can be appreciated in dark gray.

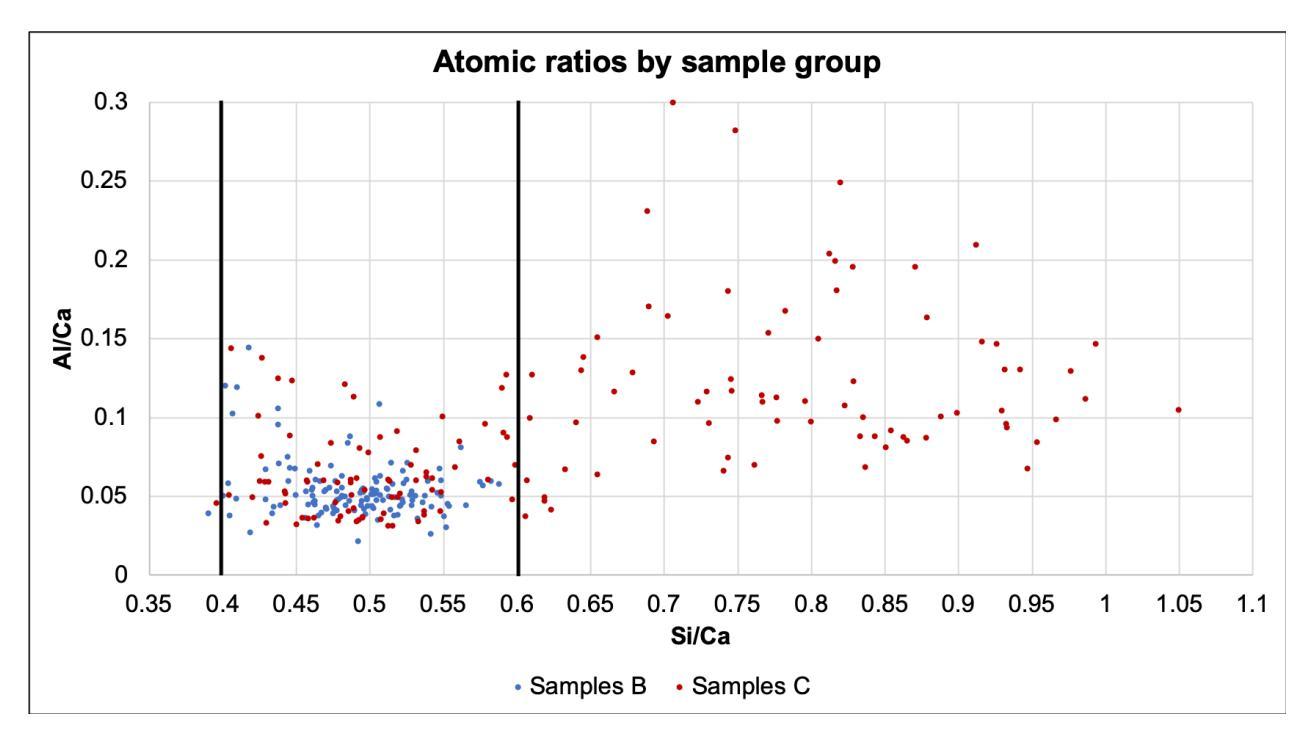
The atomic ratios are presented in Figure 9. While all samples of series B present a Si/Ca ratio between 0.4 and 0.6, more than half of the other samples display a much higher ratio, close to 1.0. Because the chloride solution was changed weekly, the chemical shock might have caused leaching on the samples. As specimens C1 to C4 had microcracking from the loading, the solution could arrive farther in less time, facilitating the leaching. Additionally, Rougelot et al. [31] found that leaching can further cause micro-cracking, starting a positive feedback loop. Whether the same phenomena can be expected in full scale structures or has been emphasized due the small size of the samples is not clear and requires future investigations.

Figure 9. Atomic ratios of samples separated by series.

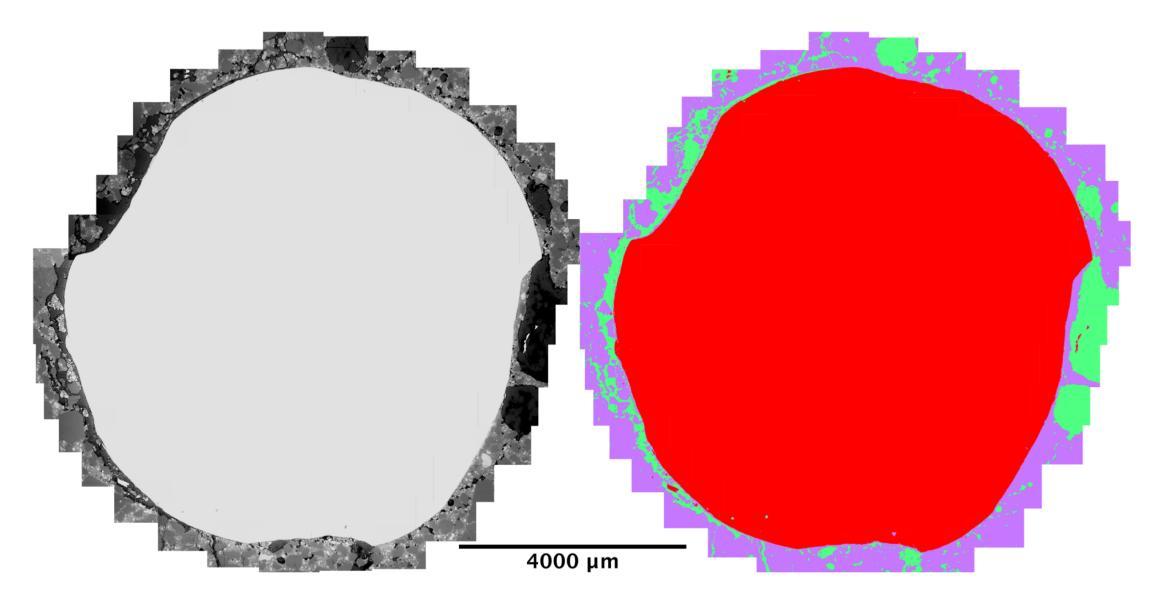
steel–concrete interface [32]. Afterwards, segmentation was performed to classify the components into steel, mortar or corrosion products (shown in Figure 10).

Figure 10. (Left) Stitching of 34 electron micrographs to obtain the region around the steel bar on sample C2. (**Right**) Segmented version of picture on the left, steel is in red, mortar in purple, and rust in green.

In the case of microscopy, the type of analysis is valuable for additional information on both, thermodynamics and kinetics of corrosion, as it can provide the distribution and composition of corrosion products (see Figure 10). However, because this technique still requires many hours of specialized labor, it is often performed for a single cross section, which is hardly representative. In the case of the present study, it was later determined that for an accurate distribution of the corrosion products, a bigger area of the sample would be necessary, requiring many hundreds of micrographs. In addition, the stitching of big amounts of high quality pictures generates image files of several tens of gigabytes, which can demand considerable computation power during image analysis.
