Abstract: Overhead wiring structures (OWS) provide physical support to overhead electrical wires that power trains. They are typically spaced at 50 to 70 m. In a rail network, tens of thousands of these structures are required. Although they are simple structures, due to their numbers; design, construction and maintenance often involve large capital investments. Their reliability is also crucial to a safe operating rail network. This paper presents a review of OWS in Australia. Electrification of train services began in the 1910s, making some of the OWS over 100 years old. Descriptions in this article include their structural forms, design, construction, assessment and maintenance. It follows with a structural assessment carried out on a century-old riveted OWS built in the 1910s. This OWS was decommissioned in a recent railway renewal project which allowed the assessments to carry out. The assessment provides insights into hundreds of similar aged OWS still being used today. Assessments carried out consisted of tensile tests, corrosion depth measurements, radiographic imaging, scanning electron microscopy (SEM) and energy dispersive spectroscopy (EDX). Crevice corrosion is common

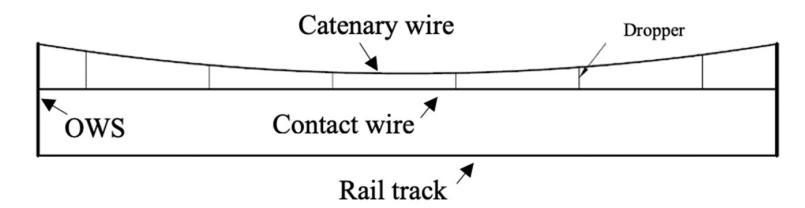
Figure 1. Schematic diagram of rail overhead wiring.

Overhead wiring structures (OWS) play a vital role in the operation of electrified rail networks. They support overhead electrical wires that provide the necessary power to the operation of trains. Typical spacing between OWS in a straight track is between 50 to 70 m. In sharper turns, their spacing may reduce to 30 m [1]. Trains draw electric power through their pantographs, which require leveled power wires. To achieve this, the wire which supplies electricity, called the contact wire, are suspended from sagged catenary wires using droppers. Their relationship is illustrated in Figure 1. The wires are tensioned to a specific value, e.g., at 20 kN. Weight stacks and pulleys are commonly used to provide a constant tension regardless of temperature, as shown in Figure 2. In some instances, modern overhead line tensioners with self-regulated compensation mechanisms are used.

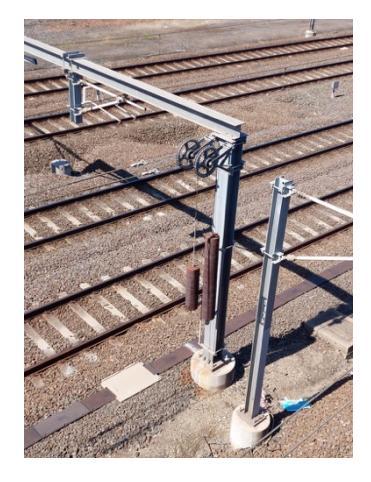
Figure 2. Weight stack and pulley system.

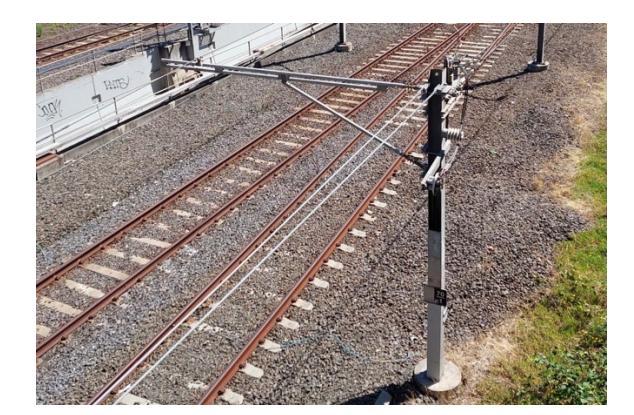
Single mast OWS are usually constructed from steel H-sections (called universal columns in Australia) with a fixed base. An example is shown in Figure 3. The base fixity is provided either by a base plate and holding down bolts embedded in a reinforced concrete footing, or a long length of steel section potted in an augured hole with reinforced concrete surround. The catenary wire is supported by a cantilever jib via a suspension insulator. The jib is commonly clamped onto the H-section instead of permanent welding or bolting to facilitate adjustment of its elevation. Single mast OWS are typically used for a single-track arrangement. Common durability issues of single masts include corrosion, loss of grout/crack at base plate, and deviation from plumb.

### Figure 3. Single mast OWS.

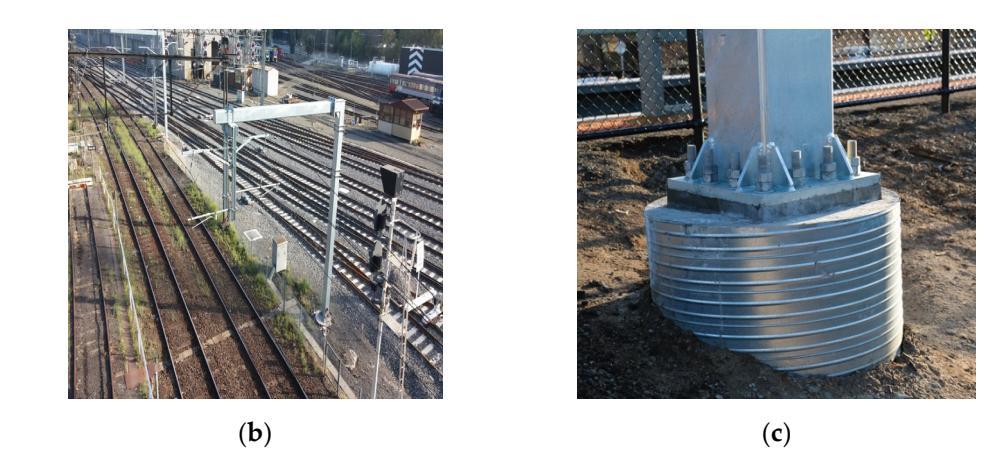
Historical cantilever OWS are riveted laced truss with a braced knee to enhance their bending strengths, as shown in Figure 4a. In these riveted structures open sections such as angles, channels and flat plates are often used. The crevices between joined members accumulate moisture and are frequently susceptible to corrosion. Modern cantilever OWS (Figure 4b,c) are typically made up of rectangular hollow sections. They are comprised of a vertical cantilever column and a horizontal beam with a vertical drop at its end. An end-plate connection between beam and column is commonly adopted to facilitate in-situ installation. The vertical drop is clamped onto the beam to allow in-situ adjustment of its position. Two dressing arms (one for the contact wire and one for the catenary wire) extend across one or two tracks in order to provide support to the overhead wirings over two tracks. Durability issues in addition to those in single masts include crevice corrosion between connecting plates (especially in riveted OWS), deflections on cantilever arms, etc.

Figure 4. (a) historical riveted cantilever OWS, (b) a newly built cantilever OWS and (c) its foundation.

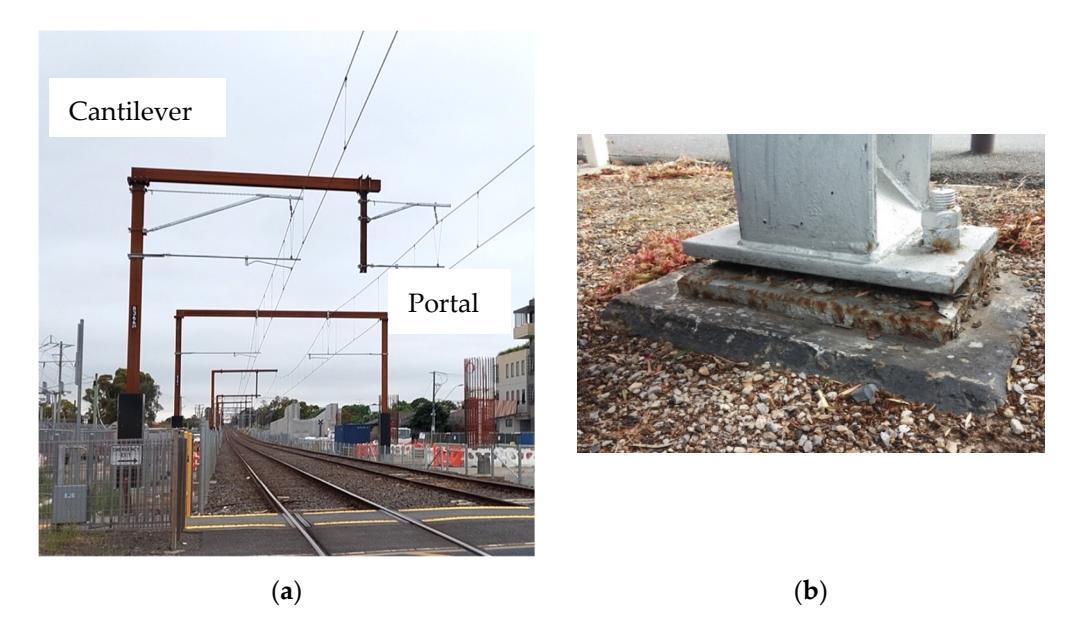
Portal OWS are simple portal frames which are often used to support overhead wirings in twin-track arrangements. Structural I-sections are typically selected as frame members. Wirings are supported by clamped vertical drops. Therefore, portal OWS provide better geometrical flexibility such as in curved tracks, track junctions, and at train stations. Sometimes "knees" at beam-to-column connections are provided to enhance structural strength. Out-of-plane stability is provided by fixity at their bases, similar to those in cantilever OWS. Figure 5a shows a portal OWS is used in conjunction with cantilever OWS in a newly built rail line. Corrosion in locations where moisture accumulates, such as bottom flanges of I-sections and at base connection (Figure 5b).

Figure 5. (a) Newly built cantilever and portal OWS; (b) Base plate of an old portal OWS.

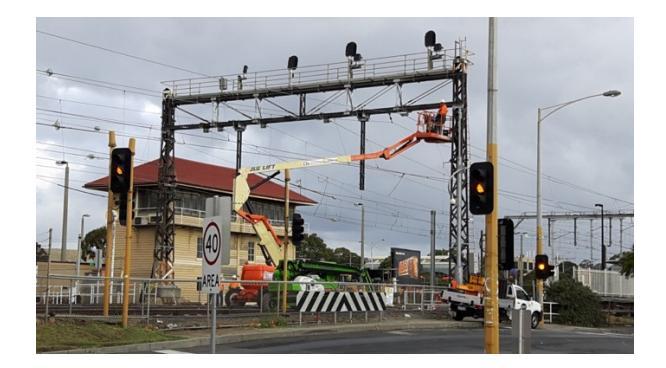
Walkway OWS are larger structures that provide easy access to signal hardware and/or feeder wirings, as maintenance may be frequent. Walkway OWS could be portal structures, cantilever structures but more commonly a truss type portal as shown in Figure 6. Handrails and access ladder are installed to provide a safe work environment.

Figure 6. A signal gantry.

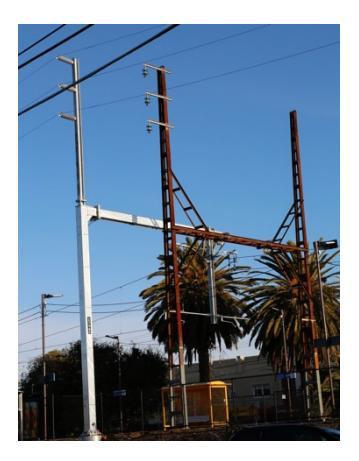
Construction of OWS is carried out by specialist contractors who are experienced in steel work fabrications and installations. Segments of OWS are fabricated off-site in shop environment and delivered to site for installation. Construction is facilitated by specialized trucks which have modified wheels to travel on tracks and are equipped with elevated platforms and cranes. Structural joints are fabricated to facilitate rapid bolting. In-situ bolting is preferred over welding for better construction efficiency and workmanship control. Structural members are galvanized in order to provide good durability under exposed condition. In case of replacement of old OWS, temporary suspension of train services is required. It is common to install new OWS in close proximity to a decommissioned one to facilitate relocation of existing wiring, as shown in Figure 7.

Figure 7. Construction of a new OWS next to a decommissioned one.

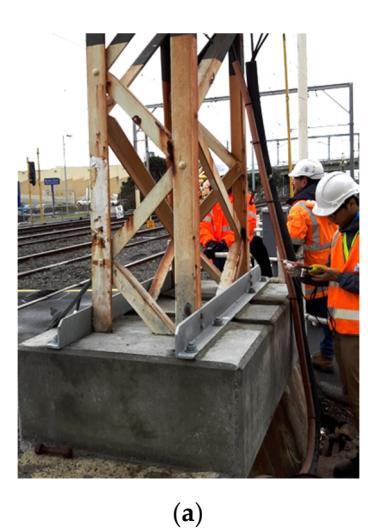
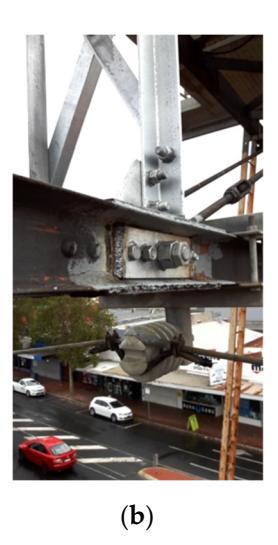
Figure 8a shows an example of retrofitting of an OWS by replacement of foundation. Extensive spalling of concrete was observed in the original foundation and new reinforced concrete is cast around an existing laced column of a signal gantry. Figure 8b shows partial replacement of corroded steel members in a signal gantry with new galvanized sections. The heavily corroded portion is patched up with a steel plate.

**Figure 8.** Retrofits of an existing OWS. (**a**) New concrete foundation, (**b**) Partial replacement of steel truss members.

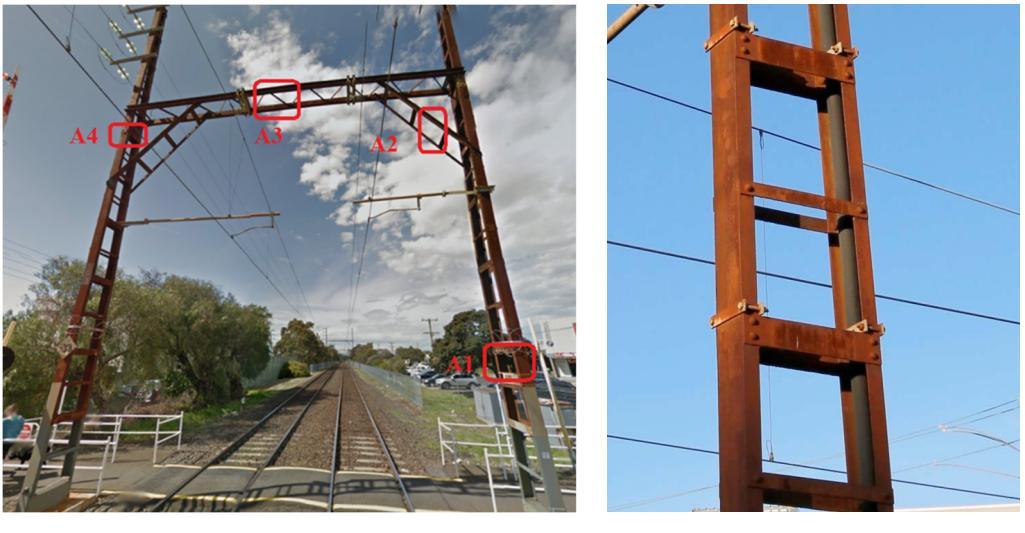
The OWS described in this section is a twin-track riveted portal structure that belonged to a railway line approximately 250 m away from the seashore. Figure 9a shows the OWS prior to its demolition. A 9.14 m (30') long laced steel beam was elevated at 8.7 m (28'8") above ground by two battened columns and carried centenary wires for two tracks. It also carried electricity transmission lines for power distribution. The OWS appeared to be unpainted except the bottom 2 m near the foundation. The age of the structure precedes the invention of weathering steel in the 1930s, however. The annotation represents the sampling locations, and Figure 9b shows the construction of battened column. Vertical members of the battened columns were equal flange channels connected by horizontal steel

Figure 9. (a) Assessed OWS prior to demolition, (b) battened column.

Test coupons were taken from a battened column, and bridge and knee brace of the examined structure, as indicated in Figure 9a. Dimensions according to AS1391 [58] were followed. The true stress versus strain diagram is shown in Figure 12 and Table 4 summarized the results. Yield stresses of specimens were very close to modern-day Grade 250, with ultimate stress in excess of 540 MPa (current standard requirement is 410 MPa) [59]. All samples exhibited good ductility.

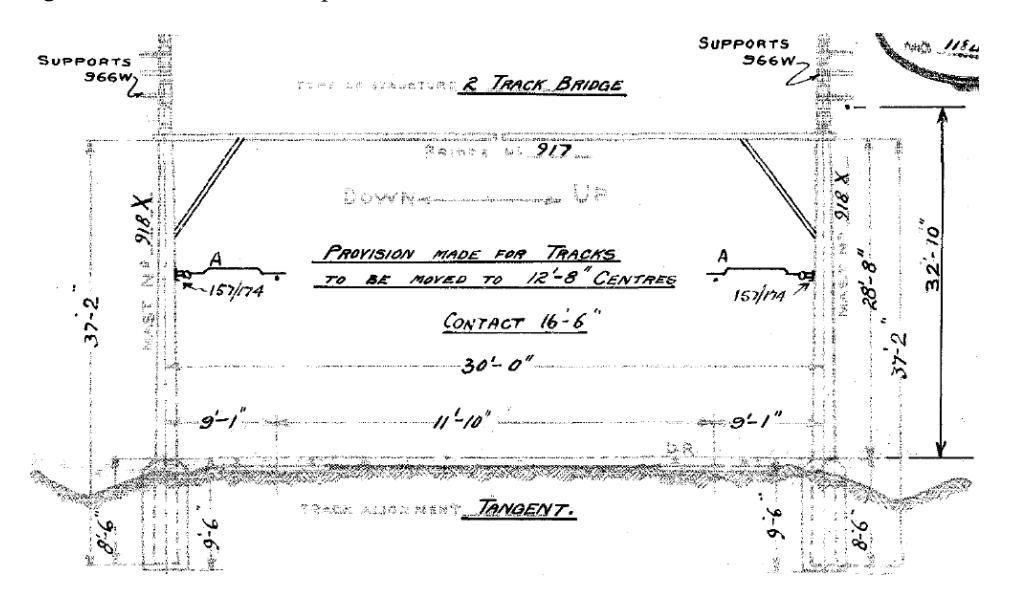
plates. The structure was connected with rivets. The original structure was built in the 1910s during the electrification of the railway, making it approximately a century old at the time of this writing. The manufacturer was uncertain but given its age the steel members were probably imported from Britain. The material specifications and maintenance records could not be identified. The structure was decommissioned in an upgrade project in which most of the OWS in the same train line were replaced. The bottom 2 m segments of the battened columns were covered by paint. Figure 10 shows the original drawing dated in the 1910s.

Figure 10. Original drawing in the 1910s.

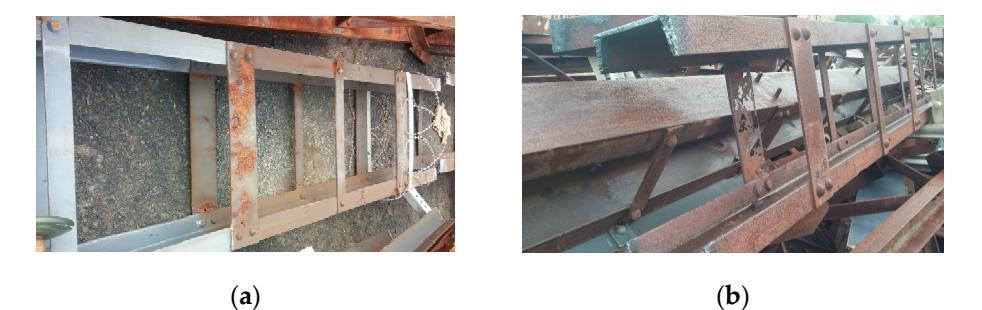
The decommissioned OWS were cut into segments and stockpiled in a scrap metal yard, which allowed the authors to carry out a close examination. An identification number on the structure allowed the authors to identify this structure to its original drawing. The bottom 2 m of the battened column were painted, and this portion was in good condition as indicated in Figure 11a. Immediately above the paint, however, significant deterioration on batten plates is observed. The severity varied significantly: one particular batten plate was corroded through, while the next plate at the same elevation appeared intact, as shown

in Figure 11b. The rivets observed were intact and tight. Crevice corrosion frequently occurred at junctions between riveted parts where moisture accumulated. Samples of the structures were taken to further laboratory testing.

Figure 11. Demolished battened column. (a) bottom section, (b) Mid-section.

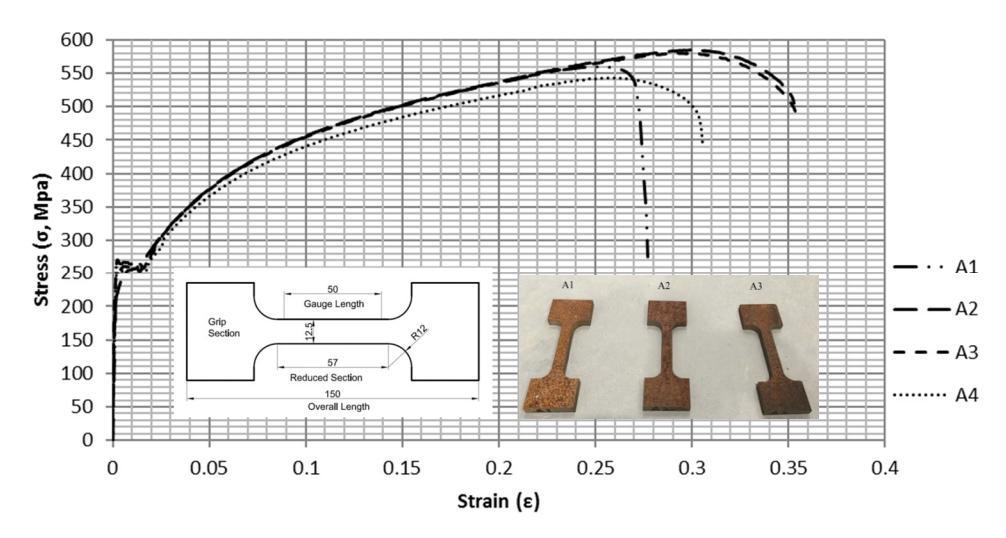
Figure 12. True stress-strain behavior from tensile tests.

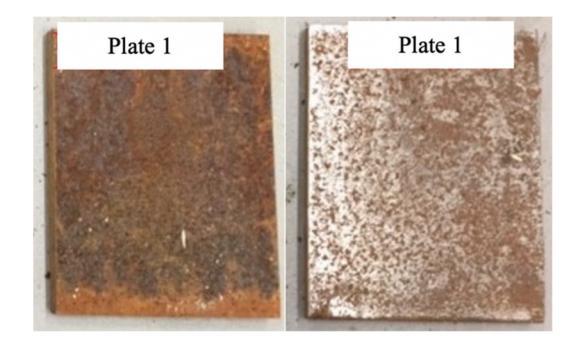
Corrosion depths were estimated by comparing original thickness and measured thickness of samples collected when rust was removed (there was no paint on the samples). An ultrasonic thickness gauge was used for this purpose. To obtain meaningful measurements, surface rust must be removed [60] and it was carried out manually and the specimens were cleaned and degreased. Care was taken to ensure only the rust was removed. Figure 13 shows the sample before and after rust removal. Twelve measurements were made on each sample and corrosion depths were estimated by comparing to historical nominal values. Results are summarized in Table 5. Percentage loss showed a great variation. The largest material loss was found in steel angles sourced from the knee brace, apparently attributed to moisture accumulation. It was impossible to calibrate any corrosion model with measurement at a single point in time, and a general rate of corrosion is inconclusive given the variability in observed results. However, corrosion depths were less than those predicted by AS4312, for which it predicted 2.5–8.0 mm at category C3/C4 medium to high corrosivity [61].

Figure 13. Sample before and after rust removal.

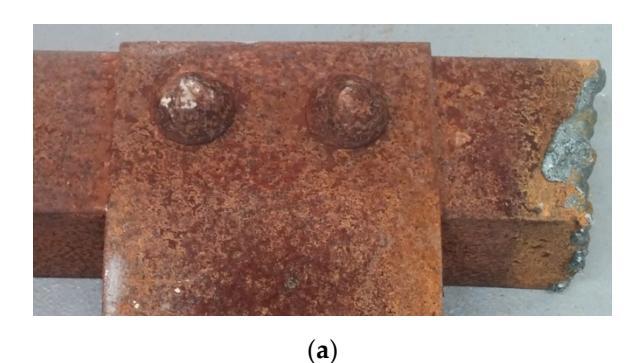
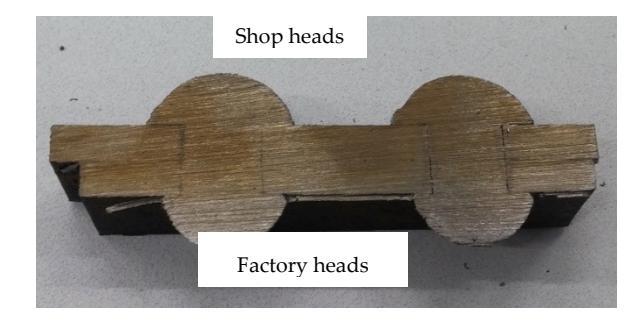
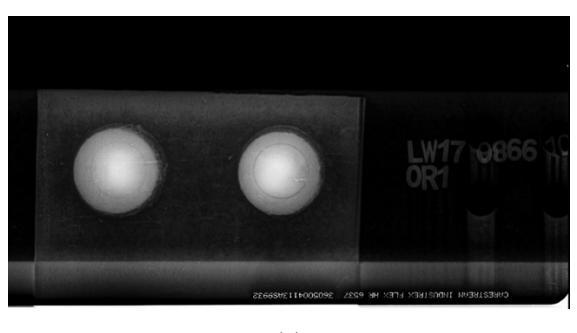
A rivet joint from a knee brace was cut through for examination, as shown in Figure 14a. The surface of the rivets was heavily rusted, but the connection was tight. The connection was cut through, exposing its cross-section as shown in Figure 14b. The 1/8" (3.175 mm) hole clearance had been completely closed by forging. The rivets clamped two connecting plates tightly and corrosion was not evident. The shop heads could be readily identified by its imperfect shape, and they were larger than the factory heads. Radiographic images were taken, and a sample image is shown in Figure 14c. No internal crack was identified in any sample collected. It indicates that the rivets performed satisfactorily and eliminated air and moisture even after 100 years of usage.

Figure 14. Riveted joint (a) sample as collected, (b) cut-through section and (c) radiographic image.

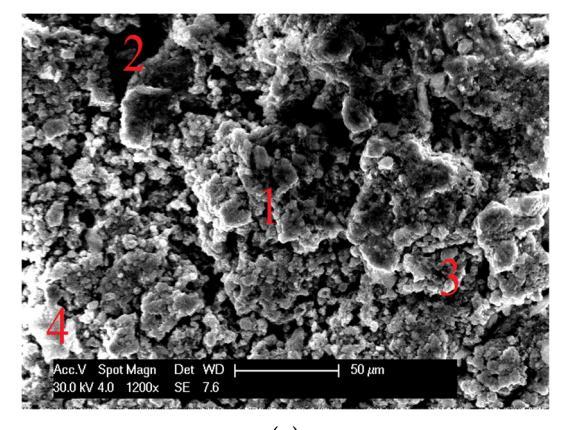
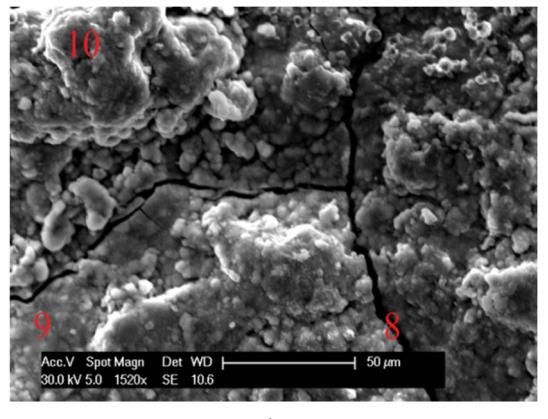
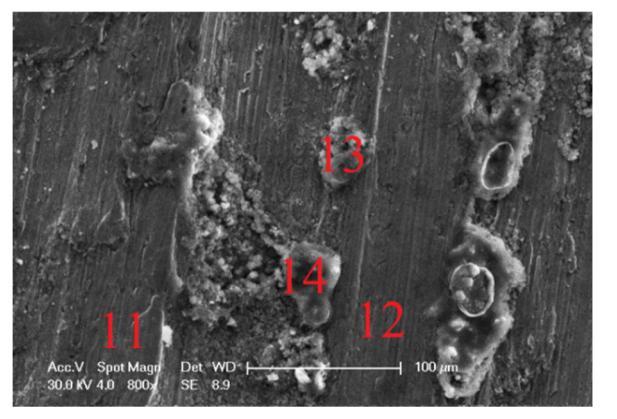
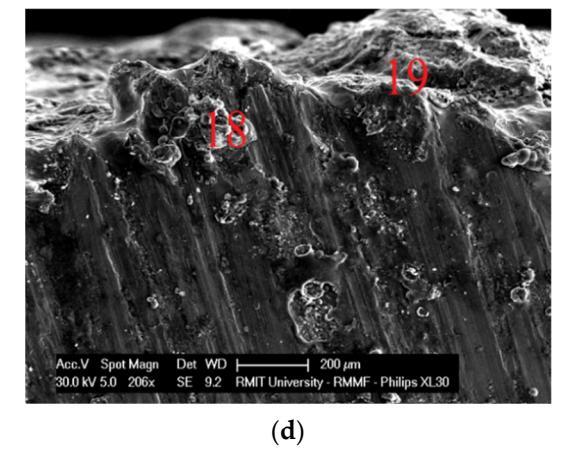
Scanning Electronic Microscopy (SEM) was carried out on steel specimens taken from the battened column using a Philips XL30 SEM. The microscope had a specimen stage of  $50 \text{ mm} \times 50 \text{ mm}$ , which was limited by the size of its vacuum chamber. The microscope is also equipped with an energy dispersive X-ray (EDX) detector. The samples were cut into approximately 20 mm  $\times$  20 mm. Figure 15a,b show typical images taken on the rust surface. The numbers indicate on the image were the sites where EDX was carried out. Rust products of rough and loose structure were visible. Results of EDX taken on rust surface revealed that, in addition to iron and oxygen, traces of lead and arsenic were found. It indicated that certain kinds of lead-based and arsenic-based corrosion inhibitors were applied. Figure 15c,d show images taken on a cut surface. In Figure 15c, deposits of corrosion products have grown, and straight grain boundaries are visible. Figure 15d shows an image taken on the edge of the cross-section. EDX results measured on the cross-section surface revealed impurities including silicon (max. 0.3%), manganese (max 0.5%) and silicon (max. 0.3%) were detected. However, their concentrations were low and within requirements of Grade 250 at modern-day standard (AS3678 [59]). However, the concentration of sulphur (max. 0.5%) exceeded the limits in two measurement locations.

Figure 15. SEM images. (a) and (b) surface and (c) and (d) cross section.
