Article Durable Testing and Analysis of a Cleaning Sieve Based on Vibration and Strain Signals

Keywords: combine harvester; cleaning sieve; durability test; signal acquisition; signal analysis

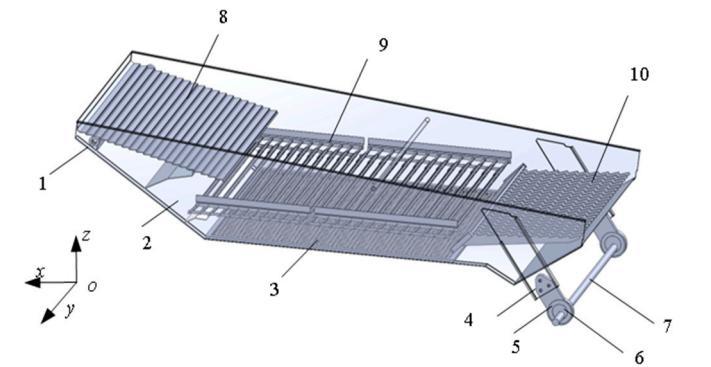
Figure 1. Structure diagram of the cleaning sieve: 1—front bearing, 2—cleaning sieve frame, 3—mesh sieve, 4—bearing seat, 5—bearing, 6—eccentric, 7—drive shaft, 8—shaking plate, 9—top sieve, 10—rear sieve.

This paper focuses on the cleaning sieve of a prominent crawler combine harvester in China, which serves as the research subject. The structure of the cleaning sieve is depicted in Figure 1, and encompasses the drive shaft, cleaning sieve frame, shaking plate, top sieve, mesh sieve, and rear sieve [18,19]. The eccentric wheel is set in motion by the rotational force of the drive shaft, causing the reciprocal movement of the front-end bearing within the chute. This motion is governed by the revolute pair and the notch, while the bearing seat, bearing, eccentric wheel, and drive shaft are interconnected through the revolute pair [20,21]. The vibration source of the cleaning sieve is driven by the motor to generate the amplitude of the crank slider mechanism (eccentric), and the vibration frequency typically ranges from 4–5 Hz during practical field operations. In contrast to the studies on impurity rate and loss rate, which primarily concentrate on configuring parameters like the sieve's inclination angle, the pivotal parameter in the durability testing of the sieve is its vibration frequency [22]. Therefore, in accordance with the normal operating parameters of the cleaning sieve, the vibration frequency is designated as 5 Hz, equating to a driving shaft speed of 31.4 rad/s.

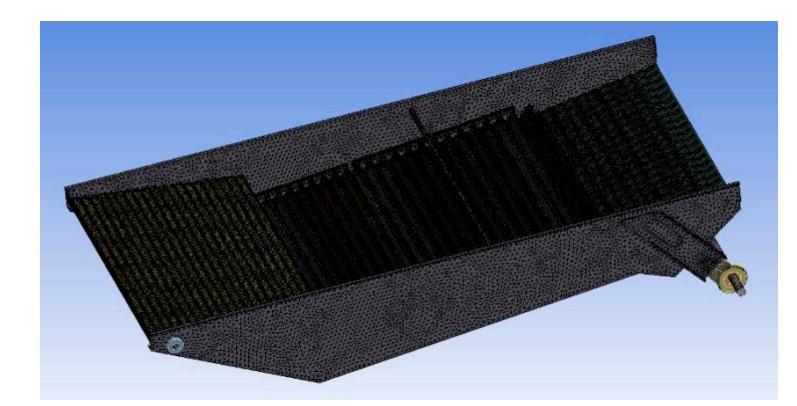
Figure 2. Meshing of the cleaning sieve.

SolidWorks2020 software was utilized to establish an accurate and comprehensive 1:1 three-dimensional model of the cleaning sieve based on the physical object. Subsequently, the established model was imported into ANSYS2021 Workbench for further analysis. Considering the occurrence of nonlinear deformation or local stress concentration, and the requirement for contact on both sides of most components in the screen box model, solid elements are used for mesh division. In order to improve computational accuracy and accelerate convergence, hexahedral elements are primarily used for mesh division, supplemented by tetrahedral elements. Due to the thin frame of the sieve, tetrahedral units are predominantly utilized in this part. By referencing Table 1, the mesh size of the cleaning sieve model was precisely set to 8 mm. To enhance the analytical capabilities and optimize the mesh quality, corner encryption processing (with a mesh size of 1–2 mm) was applied to both the top sieve and the rear sieve, thus effectively eliminating undesired small features and yielding a superior mesh structure. The resulting mesh consisted of a total of 704,846 units and 1,577,310 nodes, with a unit mass of 0.62. The overall mesh quality was excellent, and the outcomes are showcased in Figure 2.

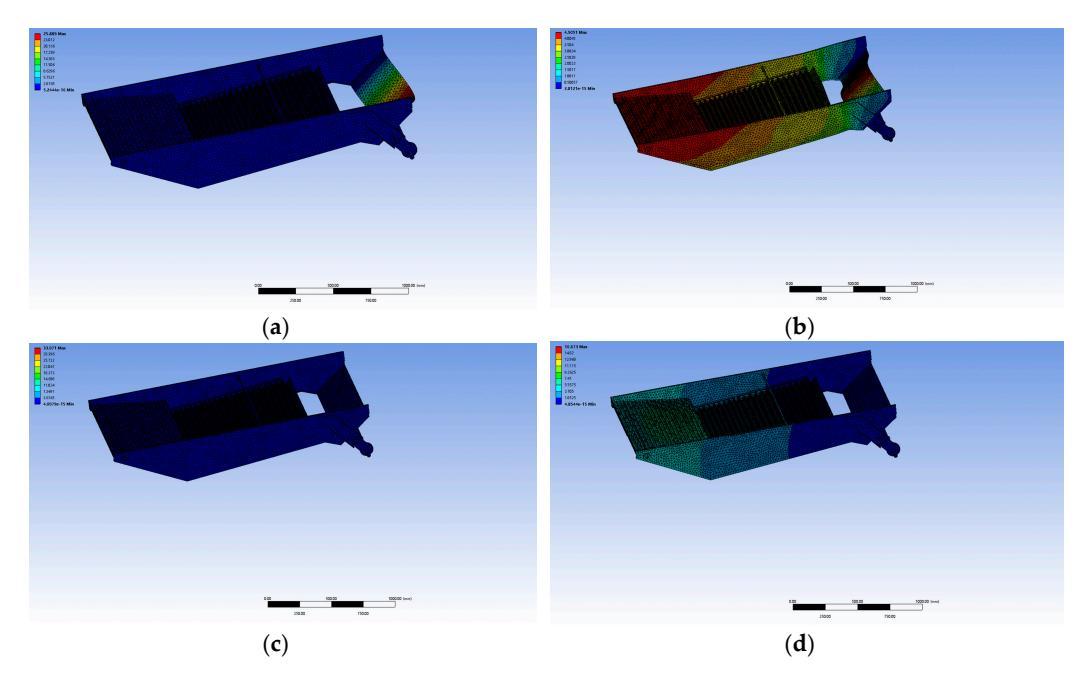
Figure 3. Modes of each order: (**a**) 1-order vibration mode; (**b**) 2-order vibration mode; (**c**) 3-order vibration mode; (**d**) 4-order vibration mode.

Figure 3 presents the first four modes of the cleaning sieve. It can be seen from these vibration patterns that the front part of the sieve frame, the shaking plate, and the baffle part of the rear sieve experience large deformation during vibration. In particular, in the second-order mode, the deformation caused by the vibration of the sieve frame on the side of the cleaning sieve exhibits an attenuation trend from the front of the sieve to the rear, and the change amplitude is more obvious. Based on this characteristic, in the follow-up durability test, strain gauge sensors were evenly arranged on the side frame of the cleaning sieve to better monitor and analyze the vibration of the sieve.

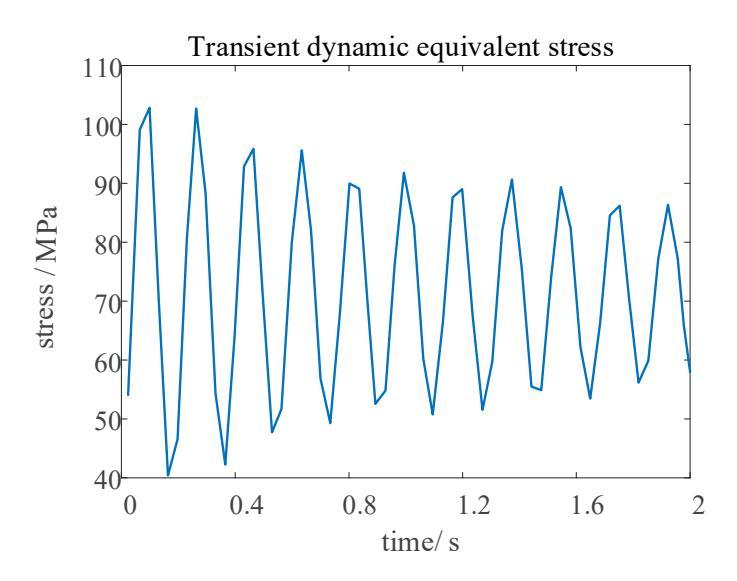
From Figure 4, it can be seen that the equivalent stress value of the cleaning sieve changed periodically in the first 2 s of the simulation. It reached the maximum peak of 102.82 MPa at about 0.07 s, and the peak then gradually decreased with time. After 0.8 s, the peak tended to be less than 91.8 MPa. The simulation results show that the maximum stress value of the main bearing parts of the cleaning sieve was lower than the tensile strength of the material used in the cleaning sieve, namely 370 MPa, and was within the safe range.

Transient dynamic analysis (also known as time-history analysis) can be used to determine the time-varying displacement, strain, stress, and force of a structure under any combination of steady, transient, and harmonic loads. To simplify the simulation process, transient dynamic analysis was only carried out on the main bearing components such as the frame and the shaking plate of the cleaning sieve [25], and the more complicated parts such as the top sieve and the rear sieve were ignored. The simulation analysis results are shown in Figure 4.

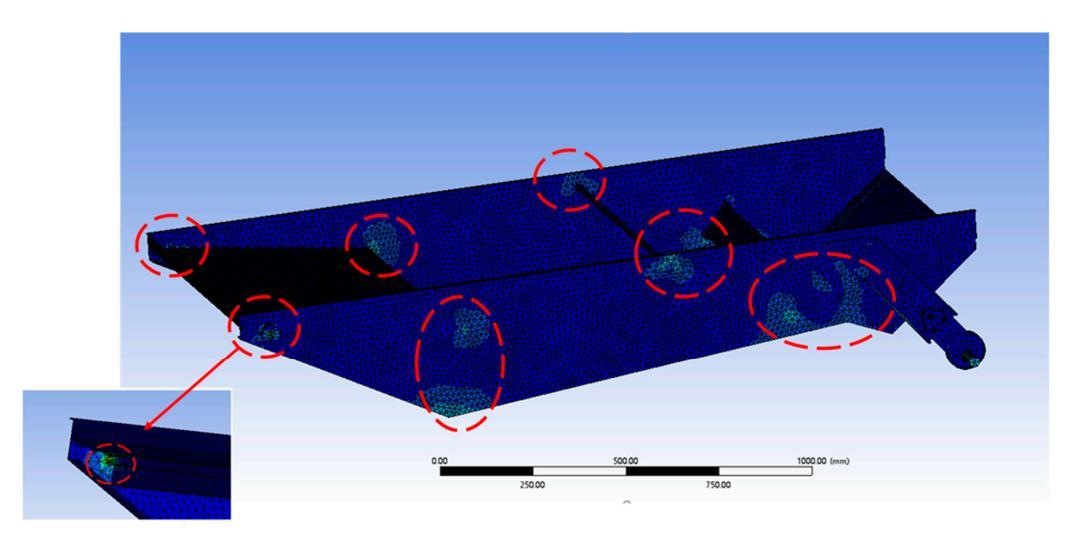
Figure 5. Transient dynamics analysis.

To further analyze the stress distribution of the cleaning sieve, the stress cloud corresponding to the maximum equivalent stress value of the cleaning sieve at 0.07 s was simulated. Figure 5 demonstrates that the maximum stress position occurred on the inside of the front bearing of the cleaning sieve. In addition, the connection between the side wall of the cleaning sieve and the shaking plate, the reinforcing rib, and the rare sieve support plate also experienced large stress in the range of 20–40 MPa. According to the actual operation process of the cleaning sieve, it can be seen that the front bearing and driving shaft are the main bearing parts of the whole sieve, and the analysis results agree with the actual situation.

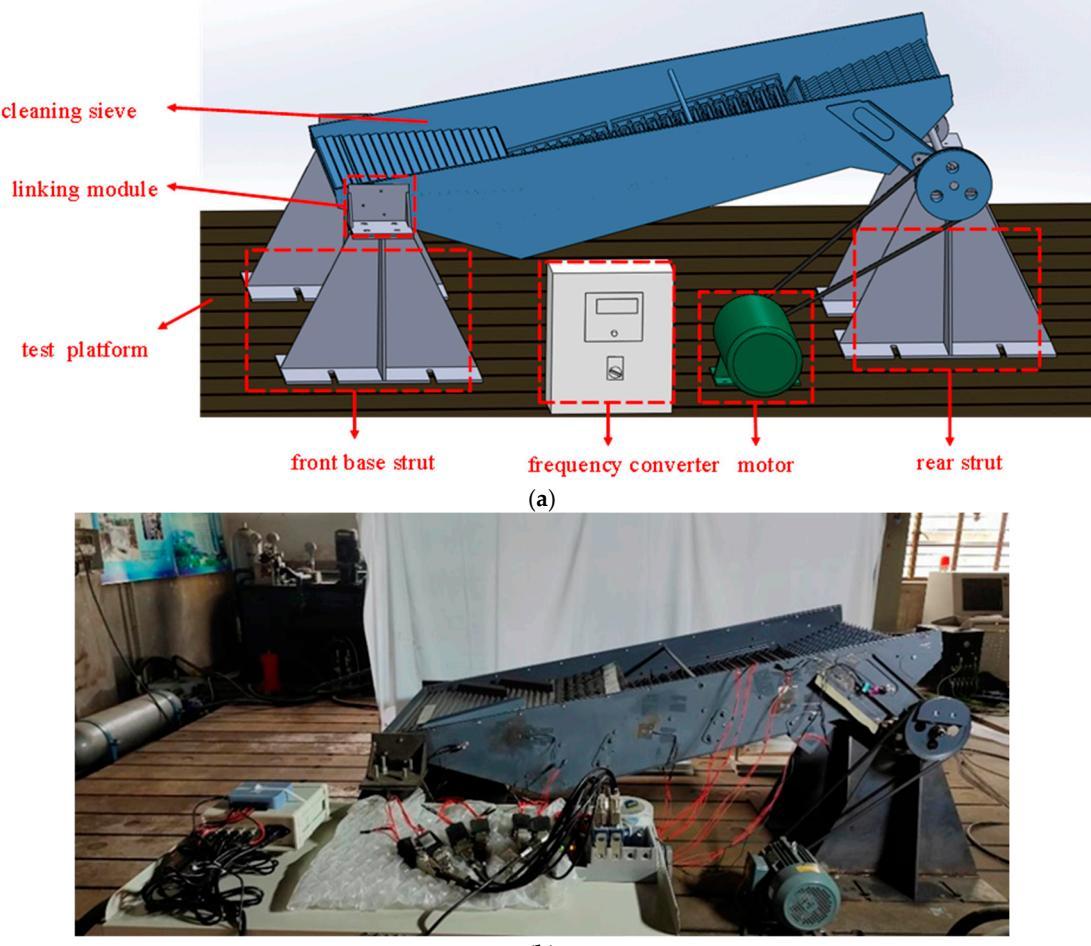
Figure 6. Test bench of the cleaning sieve: (**a**) Simulation diagram of experimental bench; (**b**) Physical image of experimental bench.

A special test bench was designed and constructed to study the durability of the cleaning sieve during the working process. After studying the installation mode of the cleaning sieve on the harvester, and with reference to the fatigue test equipment for car bodies and frames in the automobile field, a durability test bench was designed specifically for the sieve. The test bench is composed of a cleaning sieve, frequency converter, motor, front (back) base pillar, test platform, connection module, and signal acquisition system, as shown in Figure 6. Four pillars were selected to support the front bearing and the drive shaft of the cleaning sieve, respectively. Moreover, the contact area between the bottom of the pillar and the test platform was increased to improve the stability of the platform. During operation, the rotating motion of the three-phase motor is transmitted to the drive shaft through the belt drive, which drives the overall motion of the cleaning sieve [26]. The speed of the motor is regulated by the frequency converter.

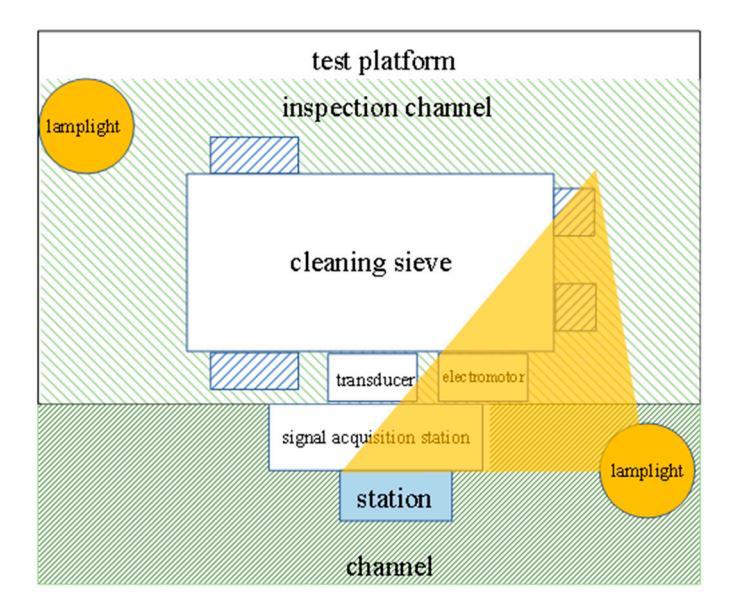
Figure 7. Floor plan of the test area.

The installation position of the cleaning sieve and the layout area of the sensor acquisition system were planned based on the test platform. The specific layout of the test area is shown in Figure 7. The test bench has the following advantages.

- 1. The open design can more intuitively detect the operating status of the cleaning sieve and facilitate the installation of the sensor.
- 2. The bench base comprises four independent pillars, which are fixed on the test platform through T-nuts, and the distance between the pillars can be adjusted to adapt to cleaning sieves of different sizes.
- 3. A modular design is adopted for the connecting parts, and the replacement of the connecting module can be carried out to adjust the installation method of the cleaning sieve. This can meet different test needs, such as changing the tilt angle and simulating the installation error.

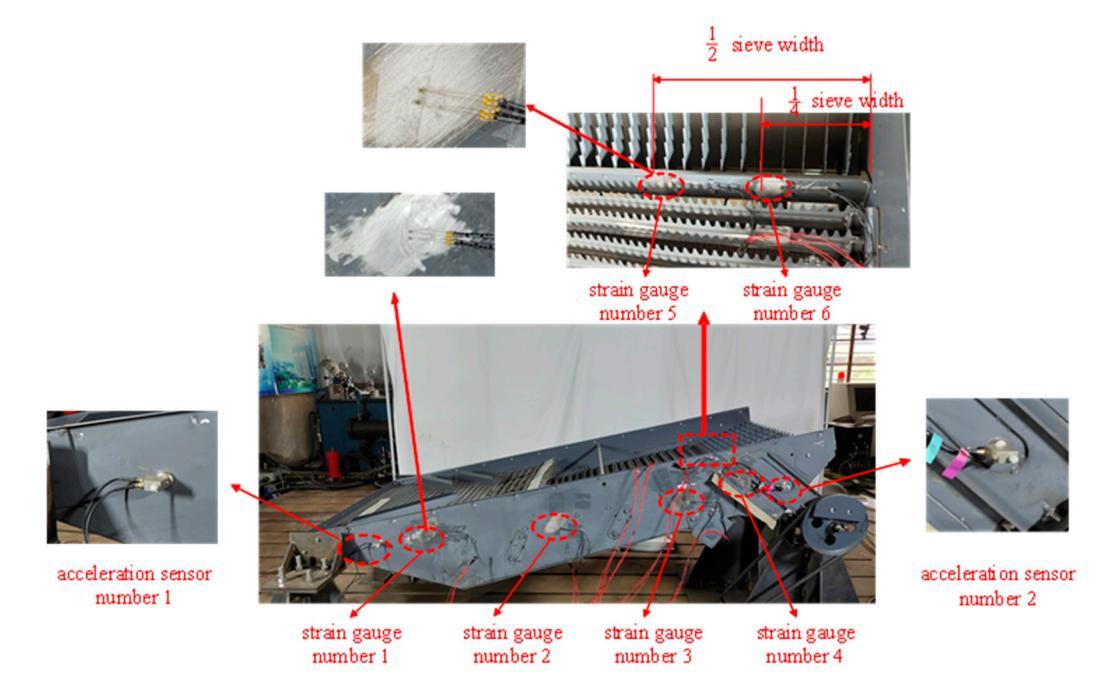
Figure 8. Schematic diagram of strain gauge sensor arrangement.

a strain gauge sensor. To detect the strain distribution of the cleaning sieve in the *y*-axis direction, strain gauge sensors No. 5 and No. 6 are arranged at the 1/2 and 1/4 width of the rear sieve support plate, respectively. The strain gauge sensors in the signal acquisition system are all Chengke 120-1AA sensors, and the specific position of each sensor on the cleaning sieve is shown in Figure 8.

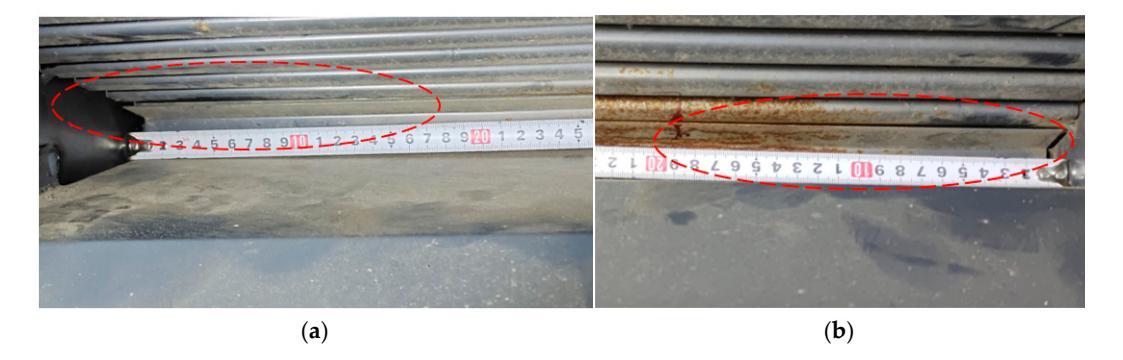
Figure 9. Fault of the cleaning sieve: (a) Left side space; (b) Right side space.

When the durability bench test of the cleaning sieve was carried out to 96 h, the cleaning sieve began to produce a periodic abnormal sound, and with the increase of the vibration frequency of the sieve, this sound became louder. The reason for this was the large gap between the left and right sides of the shaking plate at the front of the cleaning sieve and the lower inclined plate, as shown in Figure 9.

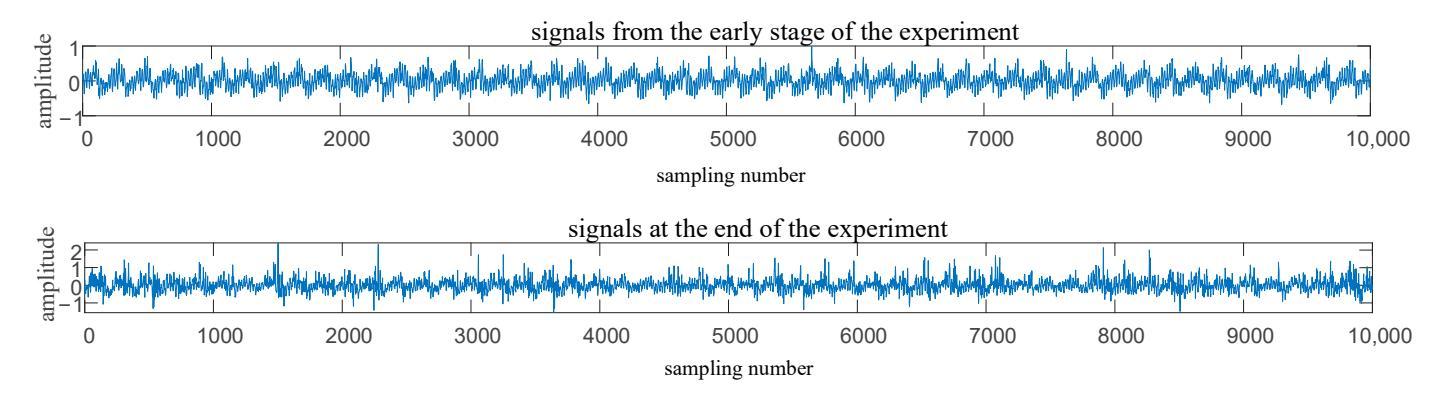
Figure 10. Sensor 1 *x*-axis vibration signal.

After the occurrence of the abnormal sound, the amplitude of the vibration signal was also observed to increase significantly, as shown in Figure 10. The vibration and strain signals are subsequently analyzed in detail.

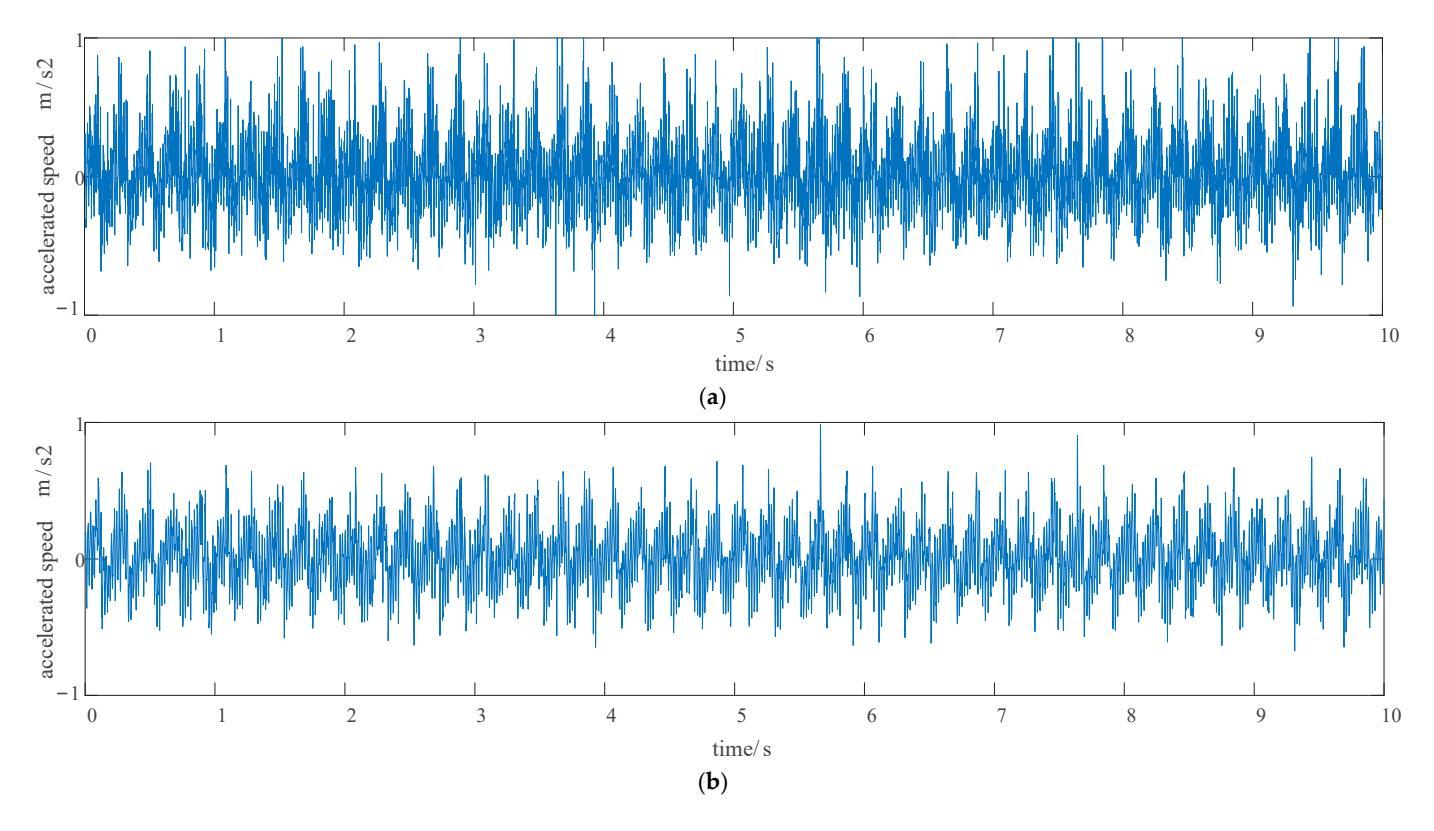
Figure 11. Vibration signal preprocessing: (a) Vibration signal before pretreatment; (b) Vibration signal after preprocessing.

To compare the vibration signals before and after the failure of the sieve, the bench test was carried out to 96 h, for which the abnormal noise fault of the sieve was the dividing point. The smoothness algorithm smooths discrete data by using the least squares method. It has a better effect on data with a burr noise or weak noise and has a faster processing speed. The selected vibration signal was preprocessed by the cubical smoothing algorithm with five-point approximation to clearly reveal the vibration characteristics of the cleaning sieve. The comparison of the signals before and after the pretreatment is presented in Figure 11.

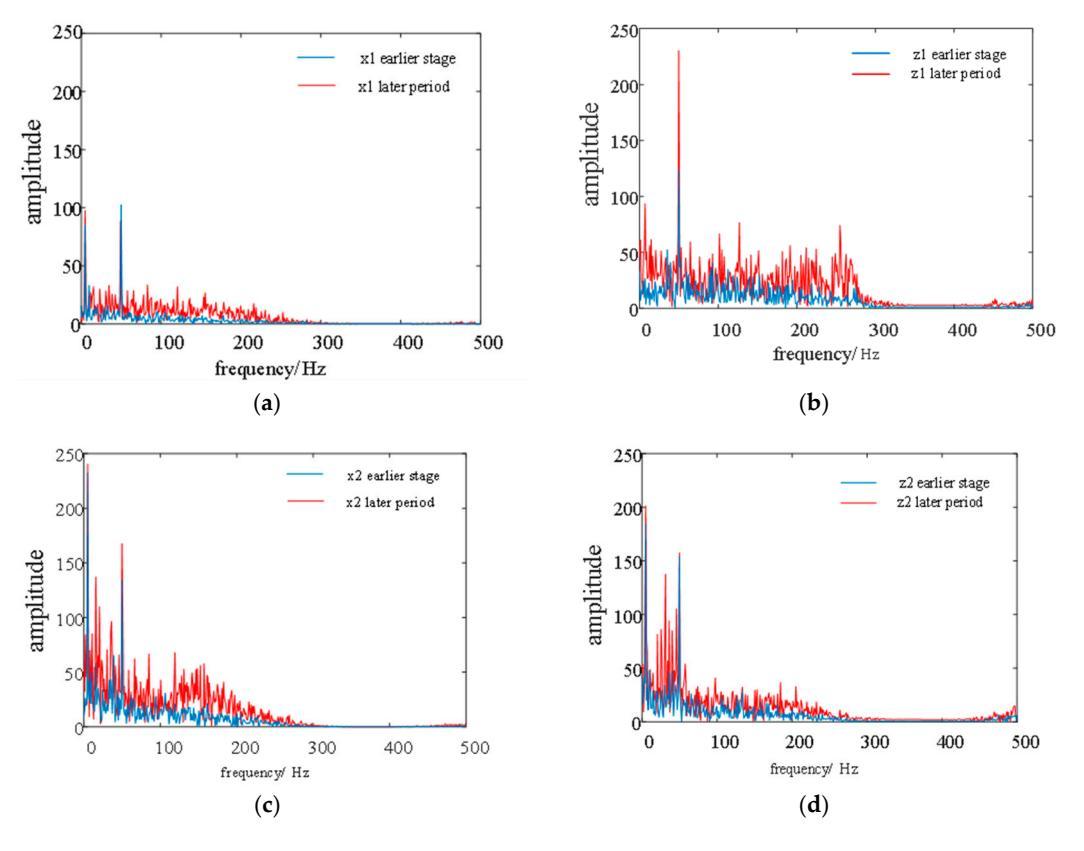
Figure 12. Acceleration sensor vibration signal spectrum diagram: (**a**) *x*-axis spectrogram of sensor 1; (**b**) *z*-axis spectrogram of sensor 1; (**c**) *x*-axis spectrogram of sensor 2; (**d**) *z*-axis spectrogram of sensor 2.

Spectral analysis is the examination of the amplitude and phase spectra obtained after the Fourier transformation of the signal. Figure 12 presents the spectrum diagrams of the two acceleration sensors in the early and late stages of the durability test of the cleaning sieve.

The comparison of the signals of the cleaning sieve under normal and abnormal conditions in the early stage of the test yields the following findings. On the whole, the vibration signals were mainly concentrated in the frequency band of 0–280 Hz, the amplitude exhibited a downward trend, and the basic frequency signal of 5 Hz and the frequency-doubling signal of 50 Hz presented large peaks in each channel. After fault occurrence, the amplitude generally increased to twice that of the previous period. Moreover, the peak amplitude of signal sensor No. 1 in the *z*-axis direction at 50 Hz increased by 86.3%, and sensor No. 2 could judge the fault by the huge change of the amplitude in the frequency band from 0–50 Hz. The analysis reveals that the vibration signals of the two three-way acceleration sensors were more sensitive to the abnormal state and can be used to detect the health state of the cleaning sieve.

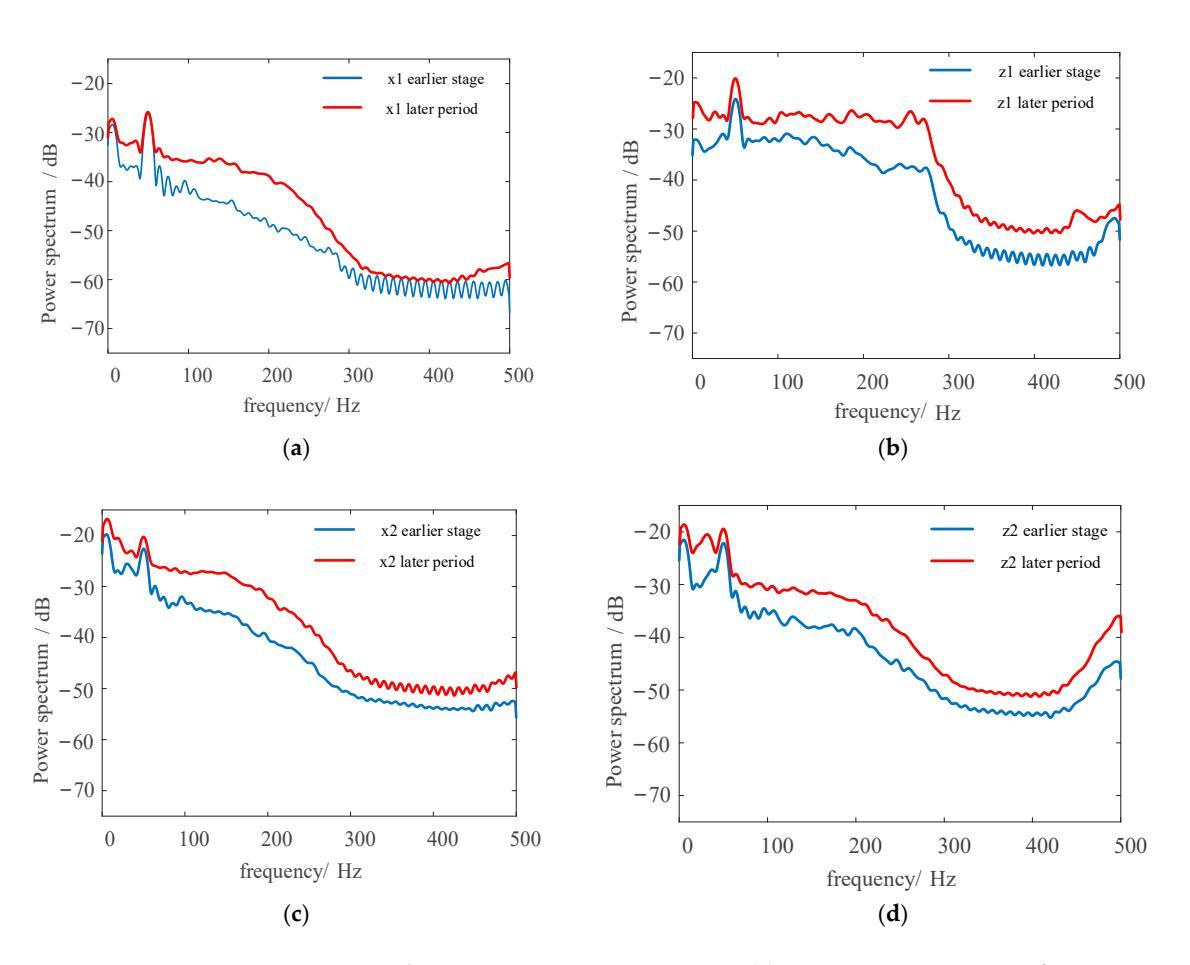
Figure 13. Acceleration sensor power spectrum: (**a**) *x*-axis power spectrum of sensor No. 1; (**b**) *z*-axis power spectrum of sensor No. 2; (**d**) *z*-axis power spectrum of sensor No. 2; (**d**) *z*-axis power spectrum of sensor No. 2.

Because the signals of different spectra may have the same power spectra, the distribution of the signal power in the frequency domain can be understood via power spectrum analysis. The result of the power spectrum is a real number, which is the square of the modulus of the amplitude spectrum [35,36]. The power spectrum loses phase information as compared to the spectrum obtained using the fast Fourier transform. Figure 13 exhibits the power spectra of the two acceleration sensors before and after the durability test of the cleaning sieve.

The comparison of the signals reveals that, on the whole, the power spectrum in the late stage of the test was generally larger than that in the early stage. Except for that of sensor No. 1 in the *z*-axis direction, the power spectrum throughout the whole test exhibited a trend of attenuation in the 0-400 Hz frequency band, and gradually increased in the 400–500 Hz band. In the 100-300 Hz band, the curve of the power spectrum in the late stage was steeper than that in the early stage. The power spectrum presented high peak values at the frequencies of 5 and 50 Hz. The power spectrum in the *z*-axis direction of sensor No. 1 changed little in the 0-275 Hz frequency band, showing a relatively gentle trend, and a large peak value only occurred at 50 Hz. According to the installation position of sensor No. 1 and the abnormal state record analysis of the cleaning sieve, this phenomenon is related to the gap at the shaking plate, which is consistent with the previous FFT spectral analysis results.

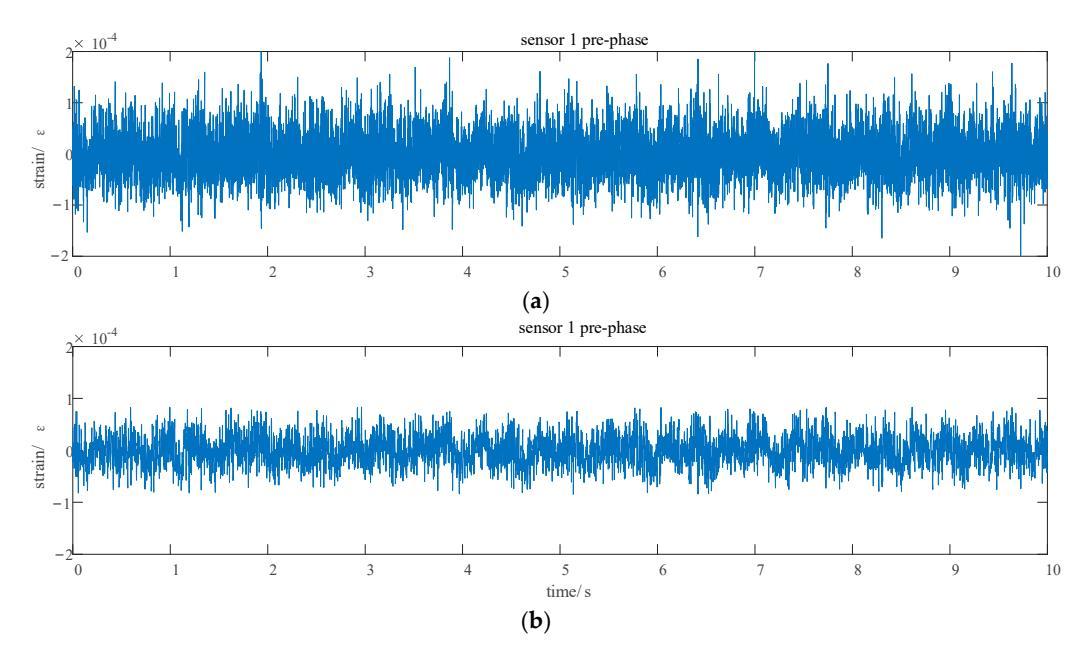
Figure 14. Strain signal preprocessing: (**a**) Strain signal before pretreatment; (**b**) Strain signal after pretreatment.

Due to the large time span of the bench test, the signals collected by the six strain sensors before and after the fault were selected for comparative analysis. After smoothing the strain signal, the mean value of each signal was calculated, and was then subtracted to adjust the initial value of the strain signal to 0. However, there remained some jump points in the smooth-processed signal that would have affected the subsequent analysis. Thus, the "filloutliers" function in MATLAB2018 was used to remove the jump points, and the early signal of sensor No. 1 is provided as an example to demonstrate the comparison before and after signal processing, as shown in Figure 14.

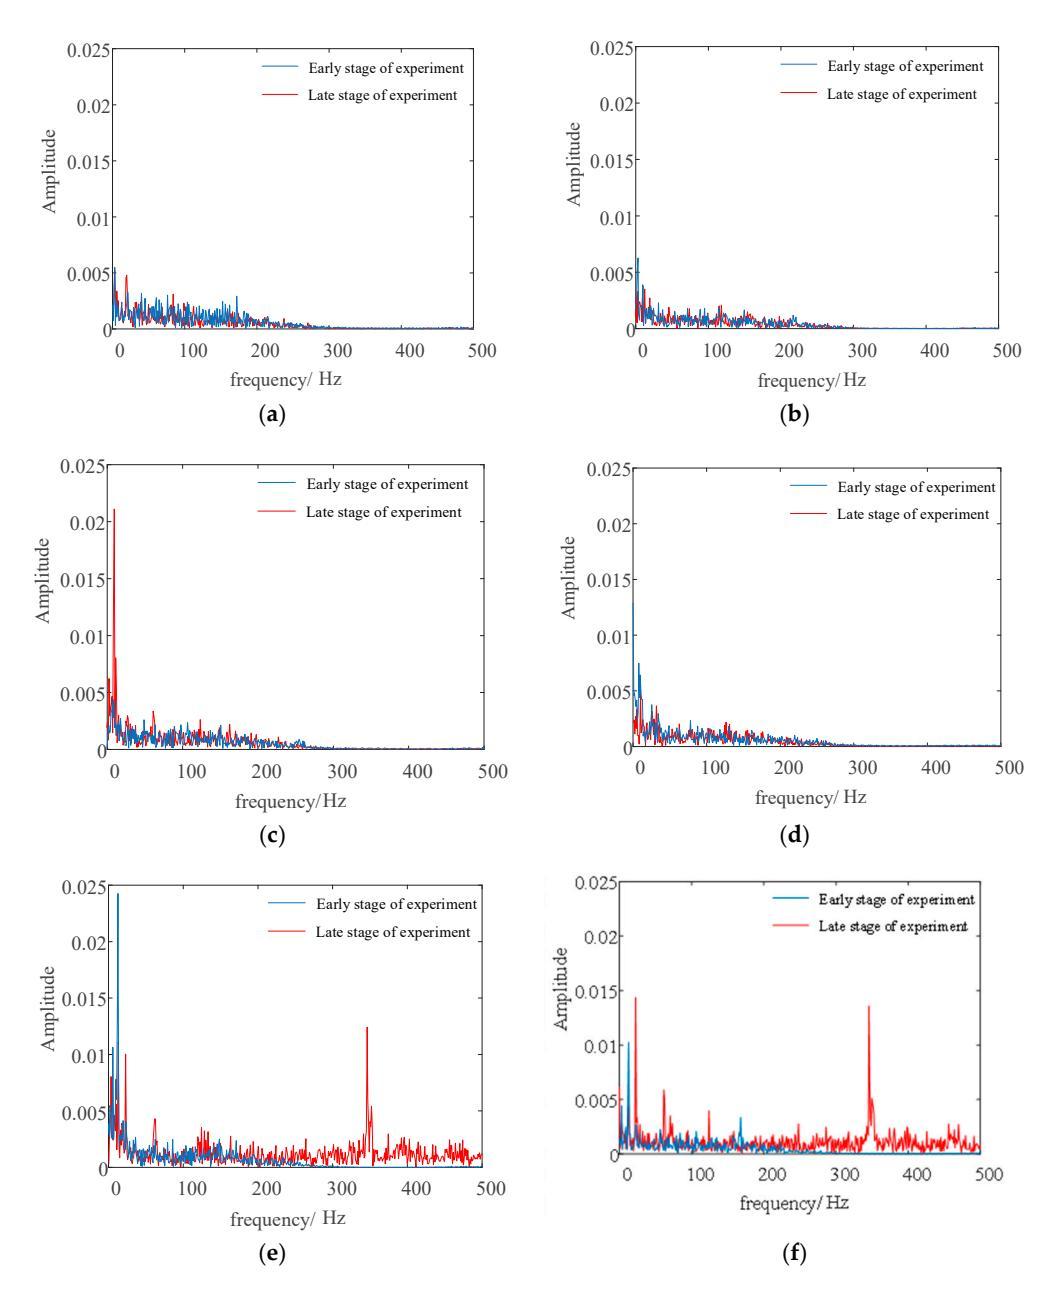
Figure 15. Strain signal spectrum diagram: (a) Spectrum of strain gauge sensor No. 1; (b) Spectrum of strain gauge sensor No. 2; (c) Spectrum of strain gauge sensor No. 3; (d) Spectrum of strain gauge sensor No. 4; (e) Spectrum of strain gauge sensor No. 5; (f) Spectrum of strain gauge sensor No. 6.

FFT and PSD were used to process the strain signal in the frequency domain, and the spectrum and power spectrum were obtained to study the change state of the strain signal at different frequencies. Figure 15 displaces the spectrum diagrams of the strain signal.

It can be seen from the figure that sensors Nos. 1, 2, and 4 experienced significant changes. Sensor No. 3 changed greatly in the later period, and its amplitude increased significantly near 10 Hz. The signals of strain gauge sensors Nos. 5 and 6 located on the rear sieve support plate also underwent large changes; they detected abnormal signals with frequencies exceeding 300 Hz and large peaks at 20 and 350 Hz. In summary, sensors Nos. 3, 5, and 6 were found to have good sensitivity to the abnormal state of the cleaning sieve.

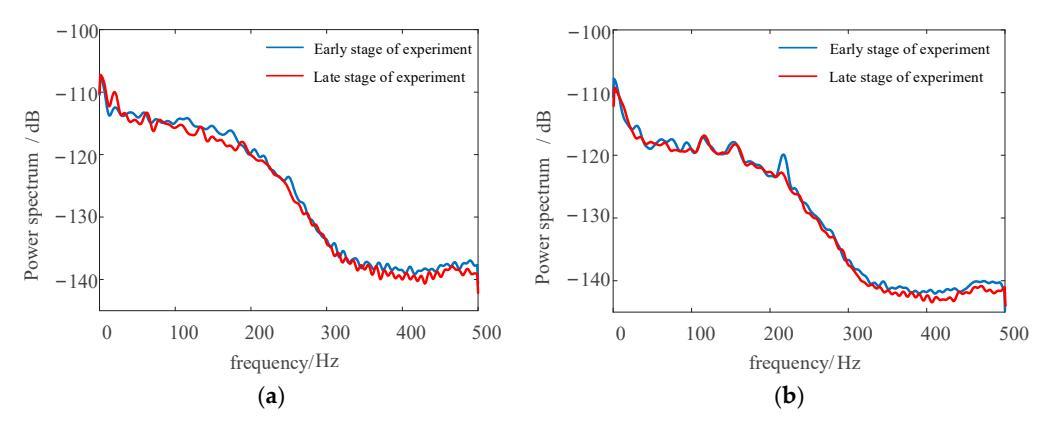
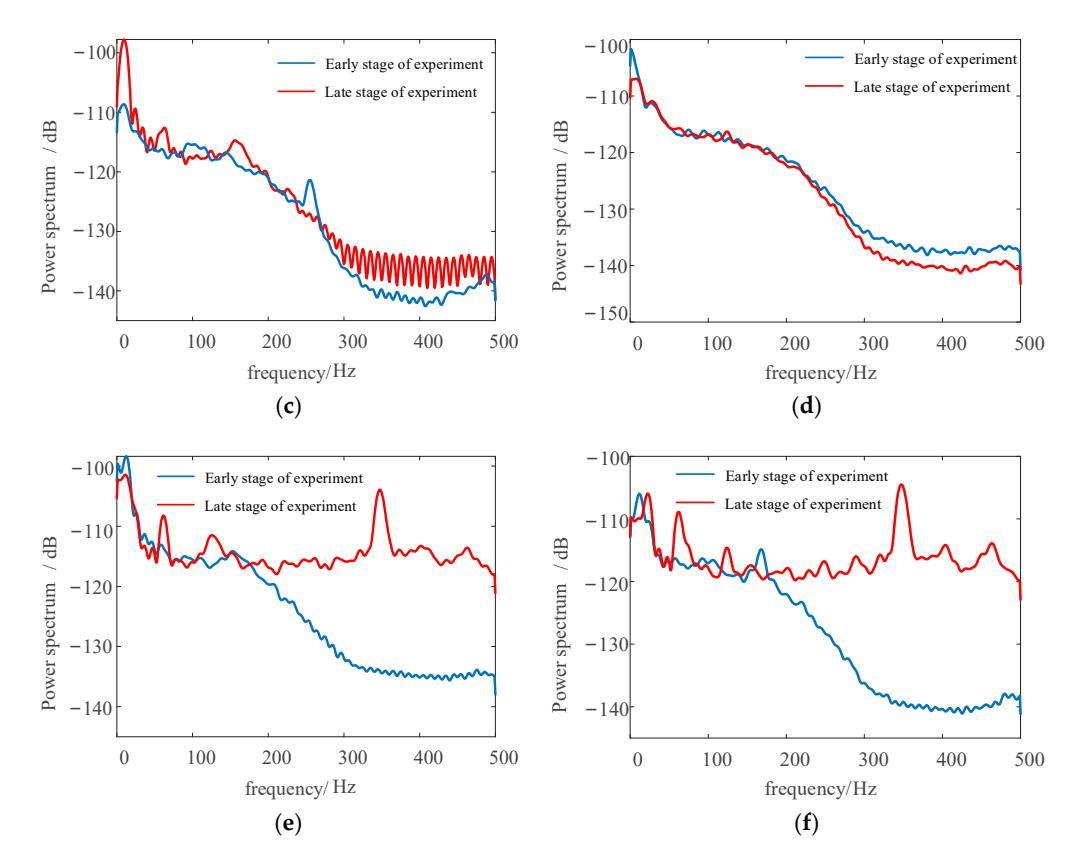
Figure 16. Power spectrum of strain signal: (a) Spectrum of strain gauge sensor No. 1; (b) Spectrum of strain gauge sensor No. 2; (c) Spectrum of strain gauge sensor No. 3; (d) Spectrum of strain gauge sensor No. 4; (e) Spectrum of strain gauge sensor No. 5; (f) Spectrum of strain gauge sensor No. 6.

As can be seen from the Figure 16, in the early stage of the test, the power spectra of sensors Nos. 1–6 were similar, showing a trend of first decreasing and then increasing with the increase of the frequency. By comparing the power spectra of the strain signals before and after the appearance of the abnormal sound in the cleaning sieve, it was found that the sensitivity of sensors Nos. 1–4 to the abnormal signal was poor. However, the abnormal signal detected by sensors Nos. 5 and 6 still maintained a high power spectral density after exceeding 200 Hz, and three large peaks appeared at 20, 60, and 350 Hz. Therefore, it can be concluded that the sensitivity of sensors Nos. 5 and 6 to the abnormal signal was better, which is consistent with the analysis results of the spectrum diagram. Thus, the strain gauge sensors installed on the rear sieve support plate of the cleaning sieve can effectively detect the state change of the sieve.
