High-Temperature Solid Particle Erosion of Aerospace Components: Its Mitigation Using Advanced Nanostructured Coating Technologies

Venkataramana Bonu * and Harish C. Barshilia *🝺

Nanomaterials Research Laboratory, Surface Engineering Division, CSIR-National Aerospace Laboratories, Bangalore 560017, India

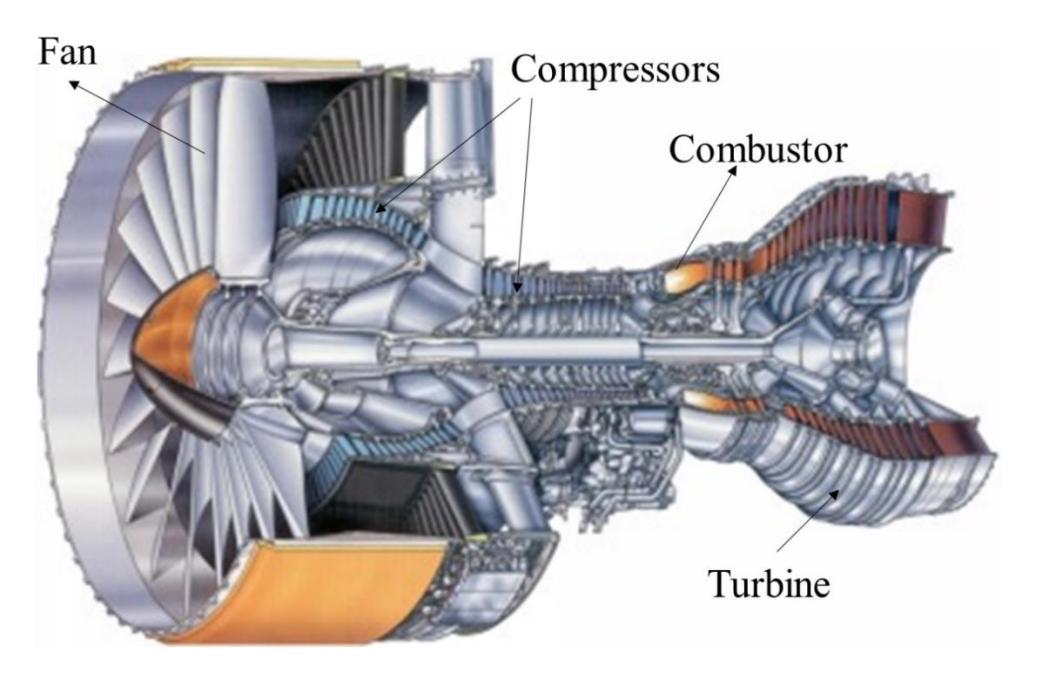
Figure 1. A modern jet engine used to power Boeing 777 aircraft. Reprinted with permission from ref. [1]. Copyright 2004, Elsevier.

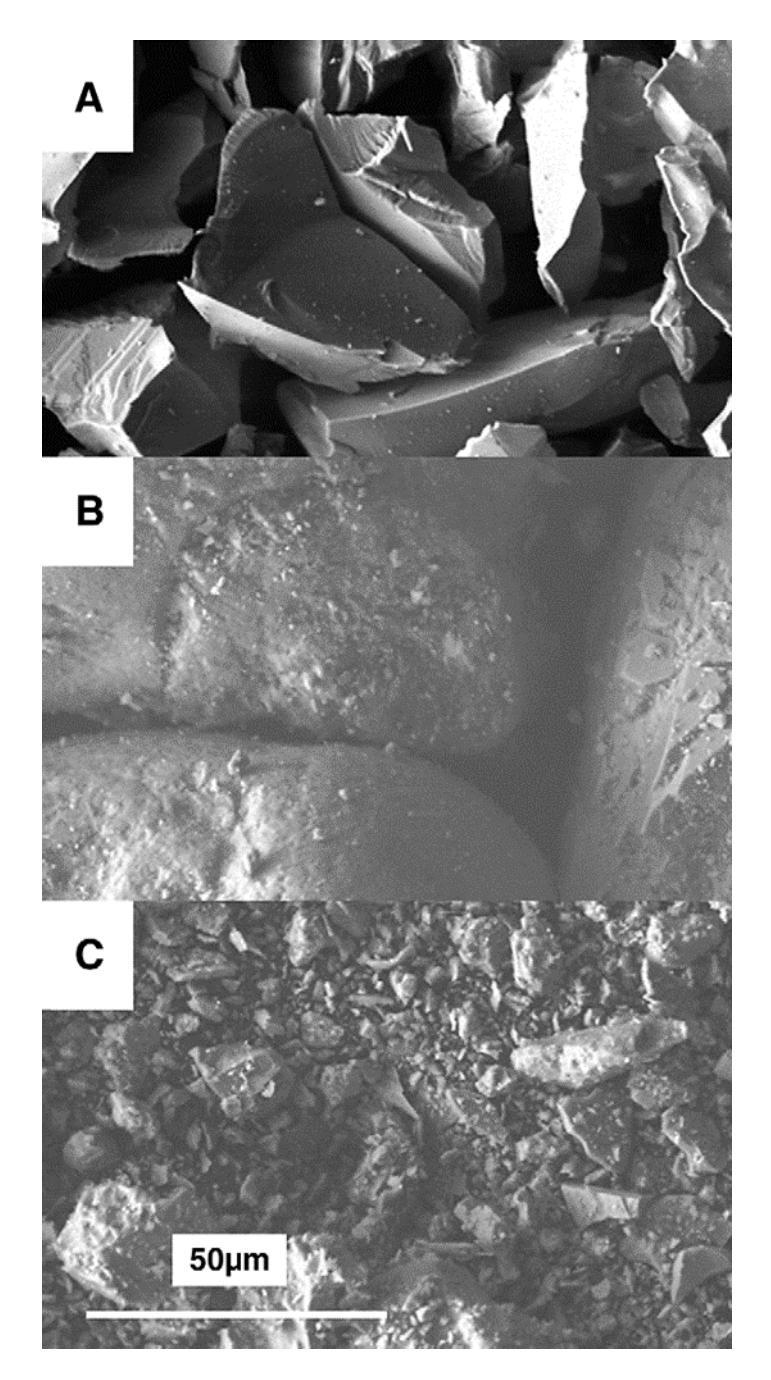
Figure 2. Typical erodent particles (**A**) Angular alumina, (**B**) silica sand, and (**C**) coarse Arizona road dust. Reprinted with permission from ref. [24]. Copyright 2009, Elsevier.

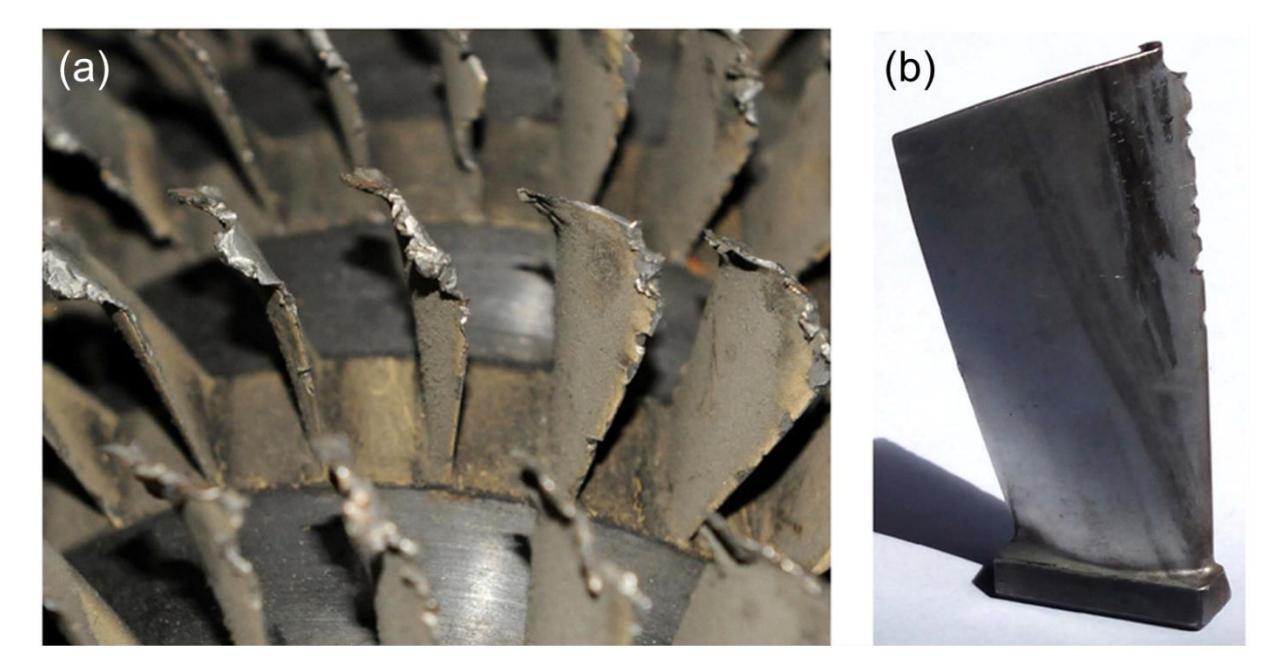
Figure 5. (a) Damaged compressor blades due to erosion (b) blade lost material at edges. Reprinted with permission from ref. [32]. Copyright 2015, Elsevier.

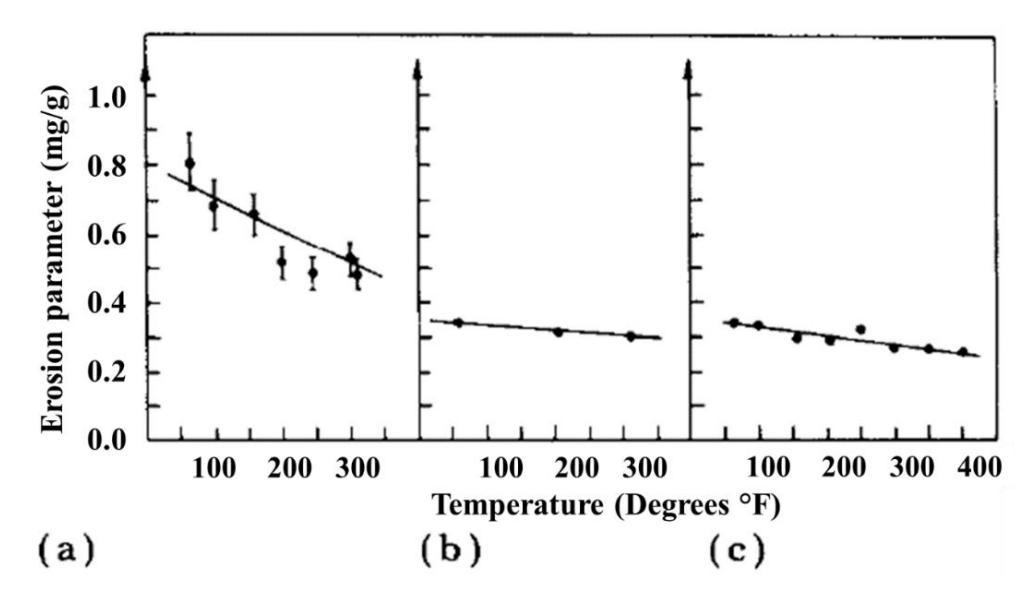
Figure 6. Erosion rate of Ti6Al4V with increasing temperature for impinging angle: (**a**) 20° (**b**) 60° (**c**) 90° . Reprinted with permission from ref. [66]. Copyright 1978, Elsevier.

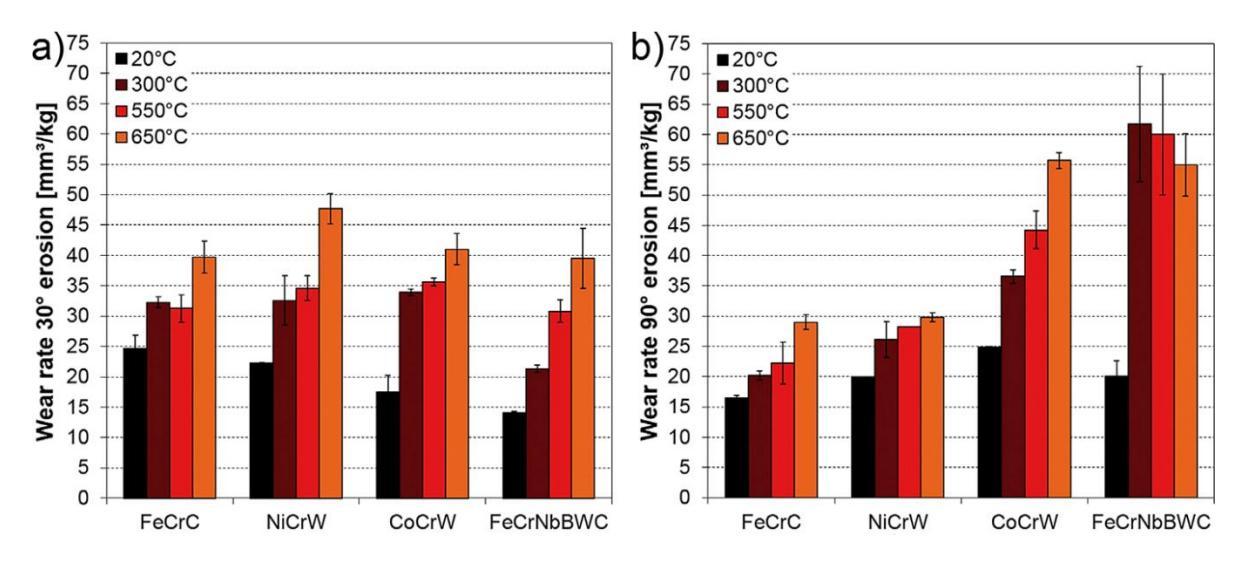
Figure 7. Wear rate of solid particle erosion testing at 80 m/s at (**a**) 30° and (**b**) 90° impact angle. Reprinted with permission from ref. [80]. Copyright 2017, Elsevier.

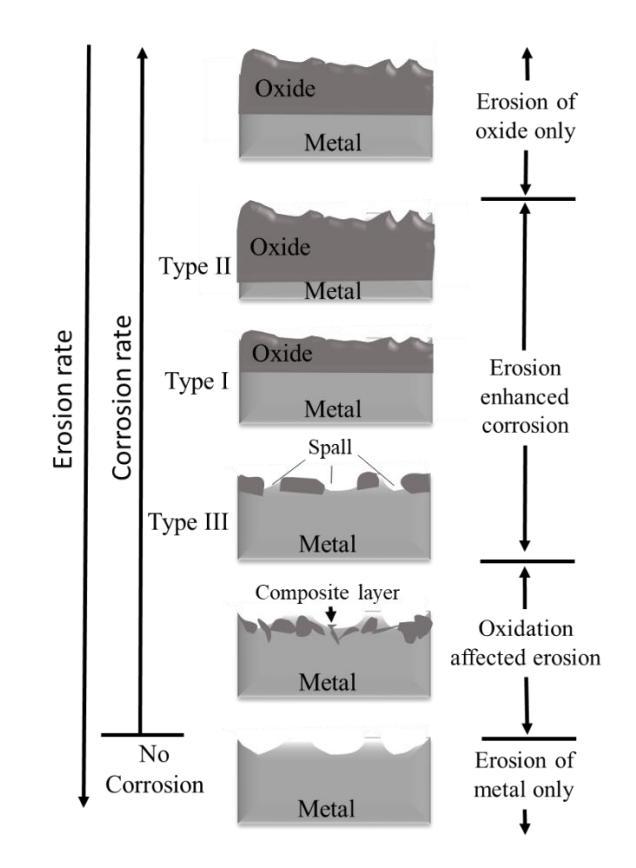
Figure 8. Classification of erosion–corrosion regimes in a target surface under high temperature erosion. Reprinted with permission from ref. [91]. Copyright 1994, Elsevier.

M. Roy [92] opined that the SPE of metallic materials at high temperatures depends on the interaction between erosion and oxidation. The author tried to improve the SPE resistance of Ni-based superalloys at high temperatures by tailoring strength and oxidation behavior. Ni-based superalloys are widely used in aircraft, naval, and vehicular gas turbines [89]. Several authors studied material loss by erosion and corrosion at high temperatures for metallic materials [90,93–95]. The studies indicated the presence of oxide layers along with the eroded rough surface on high-temperature erosion-tested metallic substrates [89,90]. Based on this, Roy et al. [89,90,96] classified four different interaction mechanisms between erosion and corrosion. They are: (1) metal erosion, (2) oxidation-affected erosion, (3) oxidation-controlled erosion, and (4) oxide erosion (Figure 8).

- Metal erosion: Most metal alloys do not get oxidized at low temperatures (<400 °C). In this scenario, the erosion mechanism is similar to the ambient conditions and follows a plastic cutting mechanism. Even though there is oxidation, the oxide layer should be thin, and it deforms similarly to the substrate. The erosion rate is thus higher at lower impact angles compared to normal impact. In this region, the erosion rate can be reduced for a given material if the critical strain for localization is reduced (Figure 8).

- 2. Oxidation affects erosion: When the temperature is in an intermediate range and the impact velocity and particle feed rate are moderate, an oxide layer of medium thickness is formed. During the SPE, the depth of deformation due to the impact of erodent particles goes beyond the oxide layer thickness and reaches the metallic substrate. As a result, the oxide layer is broken, and the softer metal comes out and mixes with the metal oxide flakes, forming a composite layer. Subsequent impacts thus cause the removal of composite material. Thus, this oxidation-affected erosion is converted from a ductile to a brittle erosion mechanism depending on the thickness of the oxide layer (Figure 8).

- Oxidation-controlled erosion: At higher temperatures (700 to 900 °C) with low erodent velocities and particle feed rates, the oxide layer grows to a certain critical thickness. However, the layer is brittle and not so adherent, resulting in easy spallation (Figure 8).

- 4. Oxide erosion: In the case of very high temperatures (>800 °C) during erosion testing, a thick oxide layer is formed on the metallic material's surface even at low impact velocities and particle feed rates. In this case, the deformation takes place only in the oxidized layer, and the metal underneath does not involve itself in the erosion process. As a result, material removal follows a brittle fracture mechanism. Since the adhesion of the oxide layer to the substrate is weak, the erosion rate values are usually high here.

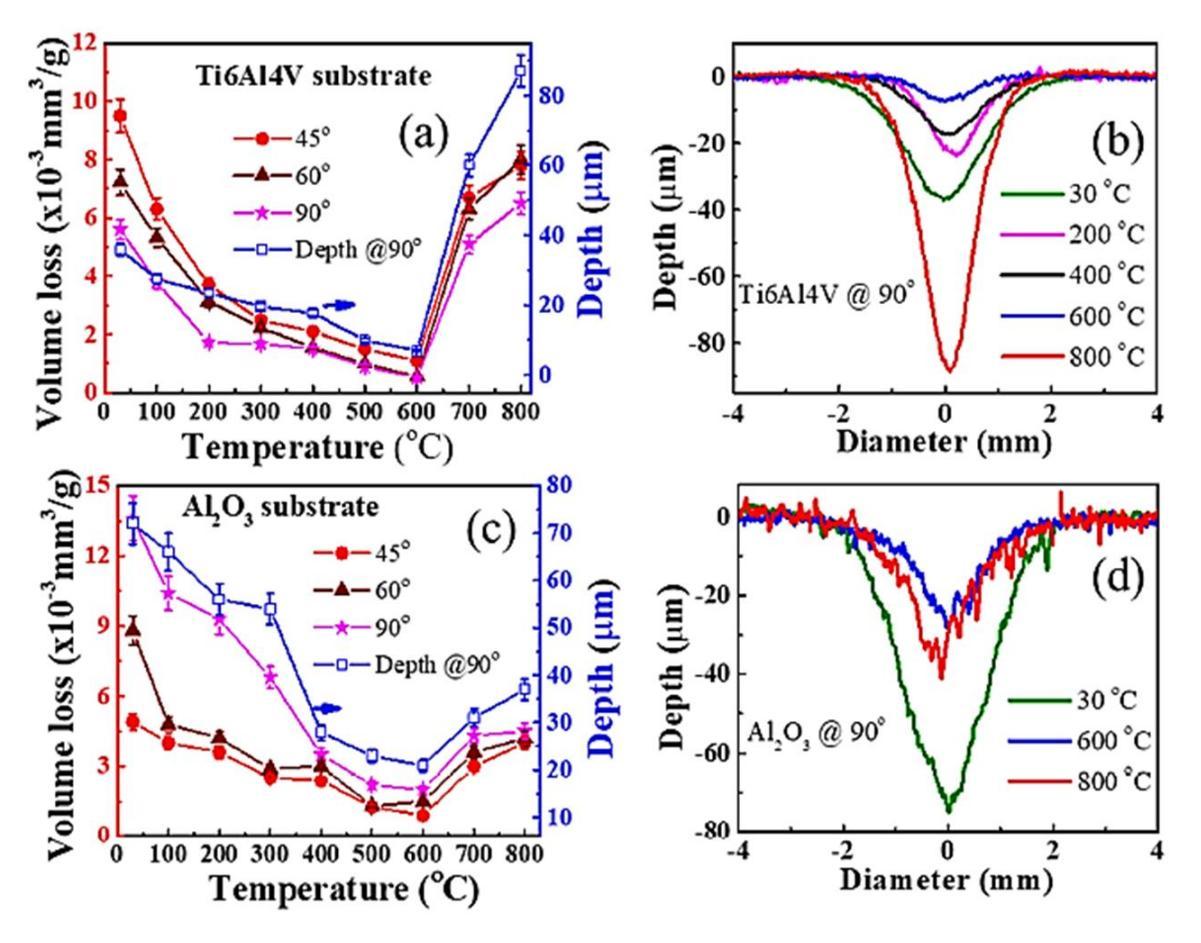
Figure 9. (a) Erosion rate of Ti6Al4V with respect to temperature. (b) 2D profiles of the erosion scars of Ti6Al4V substrate at different temperatures for a 90° impinging angle. (c) Erosion rate of Al_2O_3 substrate with respect to temperature. (d) 2D profiles of the erosion scars of the Al_2O_3 substrate at different temperatures for a 90° impinging angle. Reprinted with permission from ref. [60]. Copyright 2020, AIP Publishing.

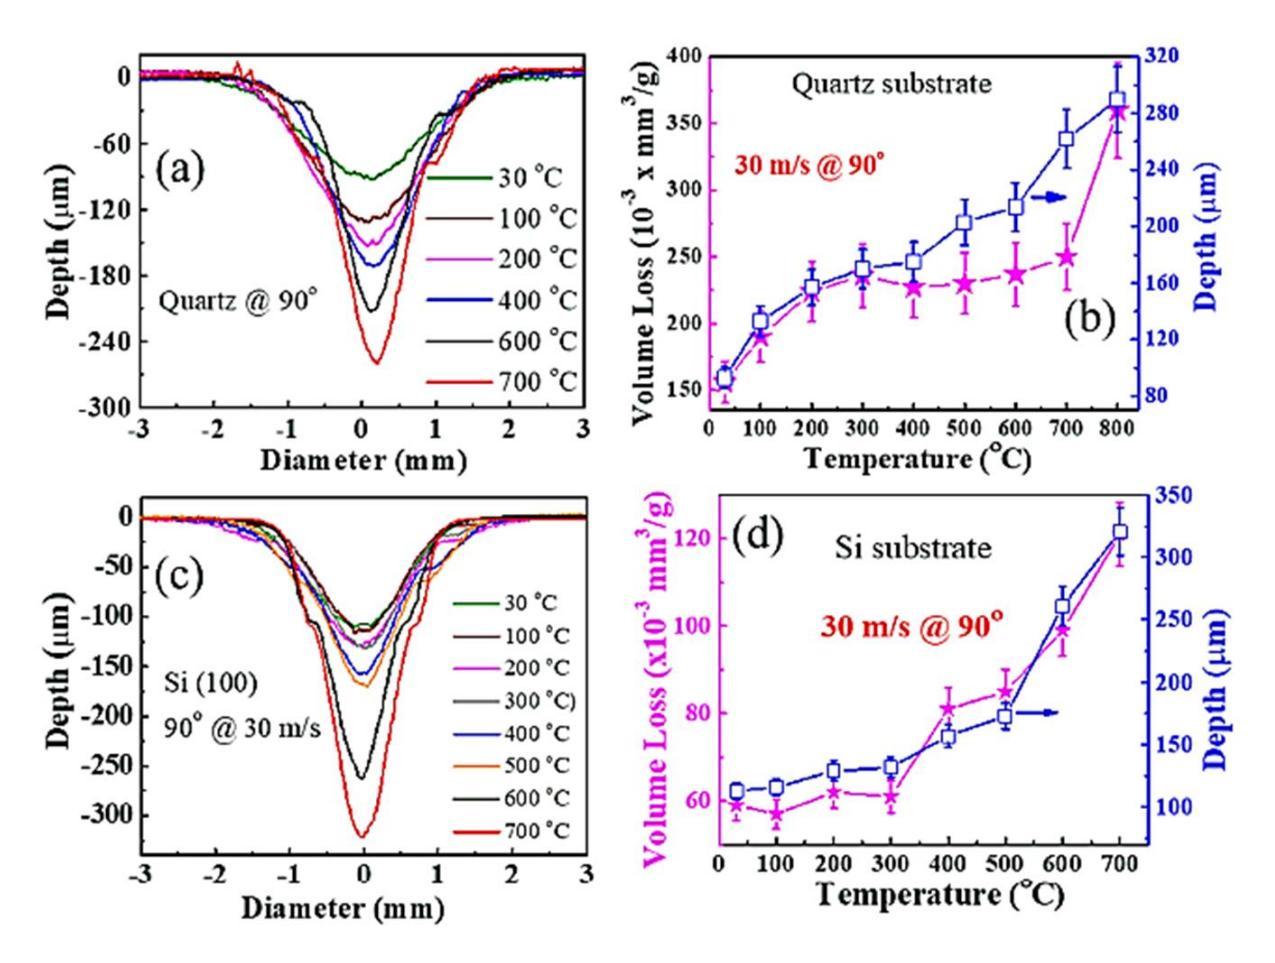
Figure 10. (a) 2D profiles of the erosion scars of fused quartz at different temperatures for 90° impinging angle. (b) Erosion rate of fused quartz substrate with respect to temperature. (c) 2D profiles of the erosion scars of Si (100) at different temperatures for 90° impinging angle. (d) Erosion rate of Si (100) substrate with respect to temperature. Reprinted with permission from ref. [60]. Copyright 2020, AIP Publishing.

RT to 700 °C (Figure 10) [60]. Along with the erosion rate, scar depth and the 2-D profiles of the erosion scars for different test temperatures can be seen in Figure 10. These two materials are covalently bonded. The study concluded that, with increasing temperature, lattice vibrations and bond flexibility increase in the case of non-directional ionic or metallic bonds. As a result, the ductility and load-bearing capacity of the materials increase, and the erosion rate decreases. However, at higher temperatures, the bonds become weaker, resulting in increased erosion after a certain temperature. On the other hand, covalent bonds are strong and directional. These bonds do not become flexible with increased temperature. This is the reason why the erosion rate increases in the case of quartz and Si substrates with increasing temperatures.

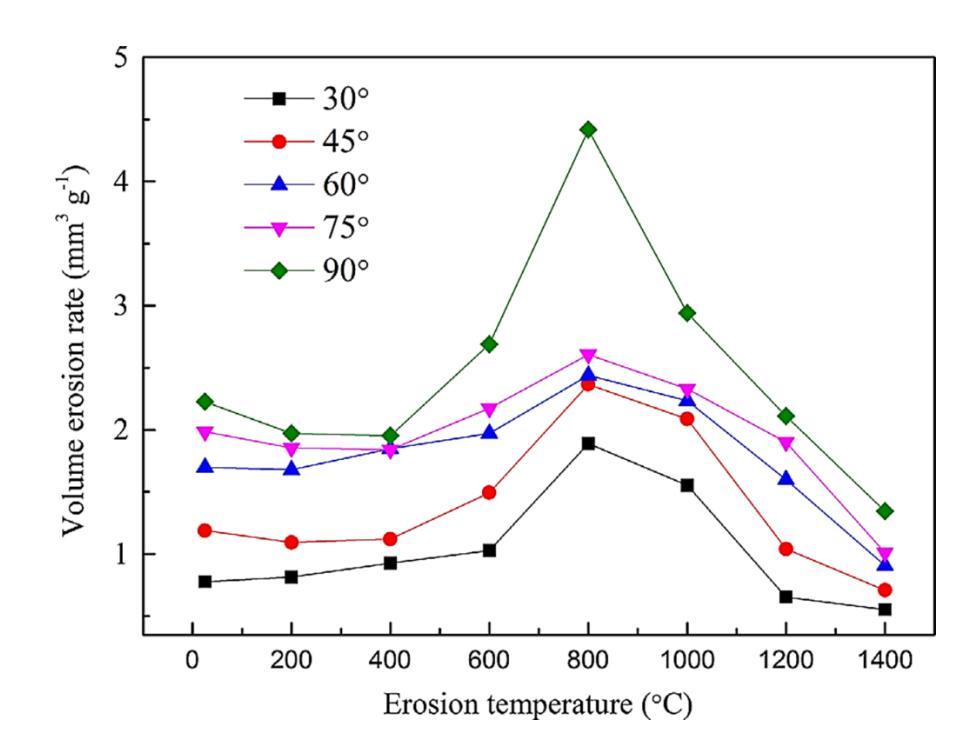
Figure 11. Erosion rates of SiC–Si₃N₄ composite ceramic with increasing test temperature and the impingement angle. Reprinted with permission from ref. [111]. Copyright 2014, Elsevier.

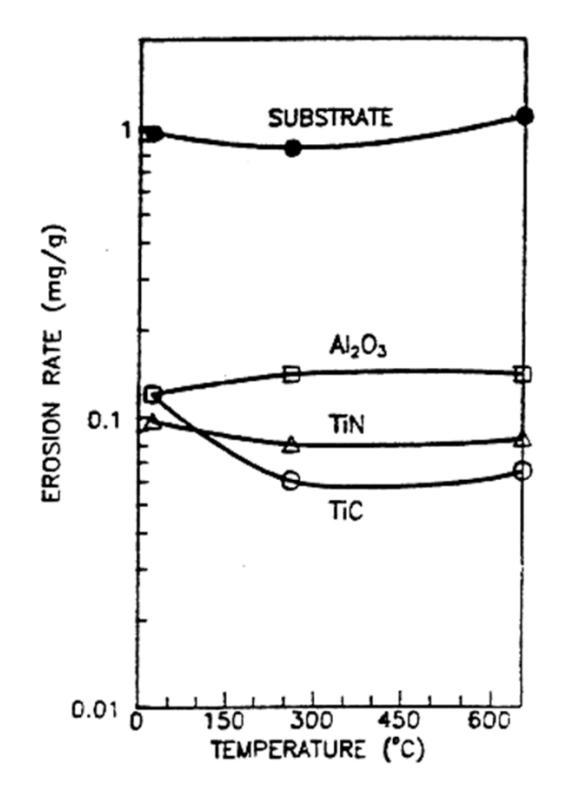
Figure 12. Variation of the coating erosion rate with the temperature at a 90° impingement angle. Reprinted with permission from ref. [74]. Copyright 1999, Elsevier.

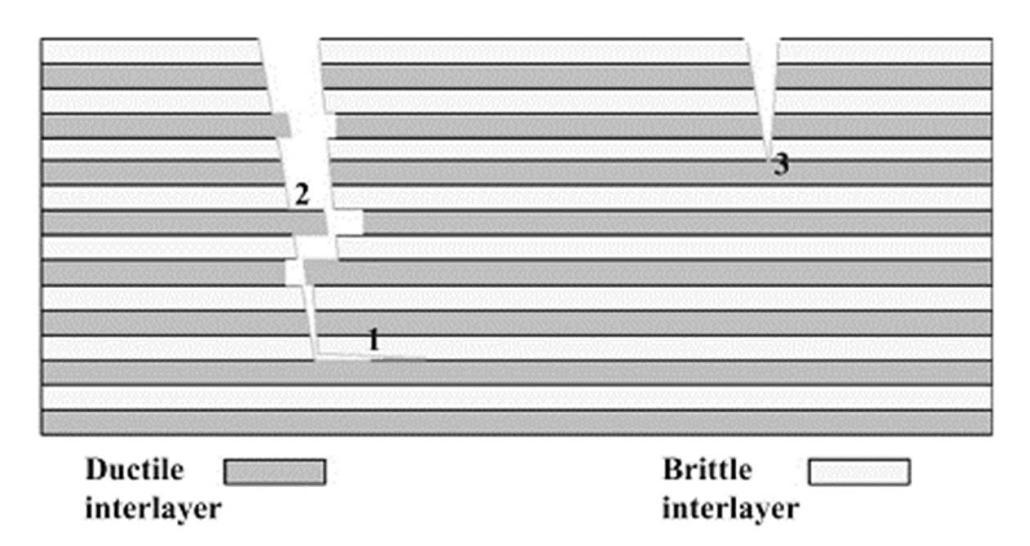
Figure 13. Schematic representation of toughening mechanisms in multilayer films: (1) crack deflection, (2) ductile interlayer ligament bridging, and (3) crack tip blunting due to nanoplasticity at the interlayer. Reprinted with permission from ref. [125]. Copyright 2005, Elsevier.

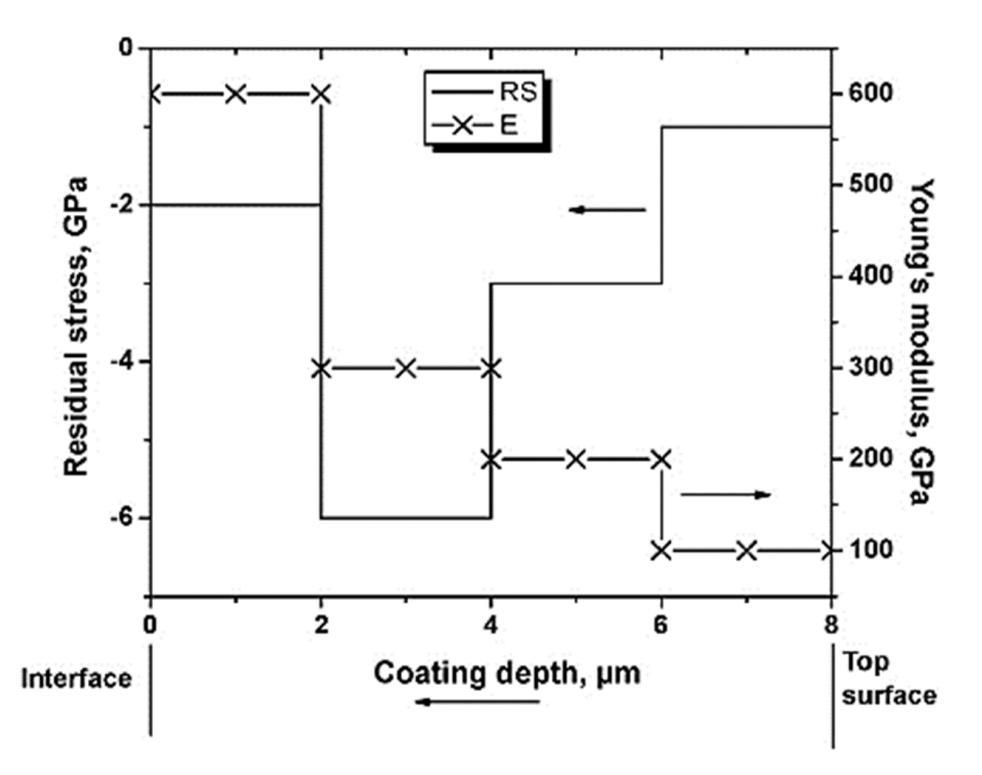
Figure 14. Optimal distribution of coating properties for enhanced erosion resistance for a four-layer system. Reprinted with permission from ref. [137]. Copyright 2010, Elsevier.

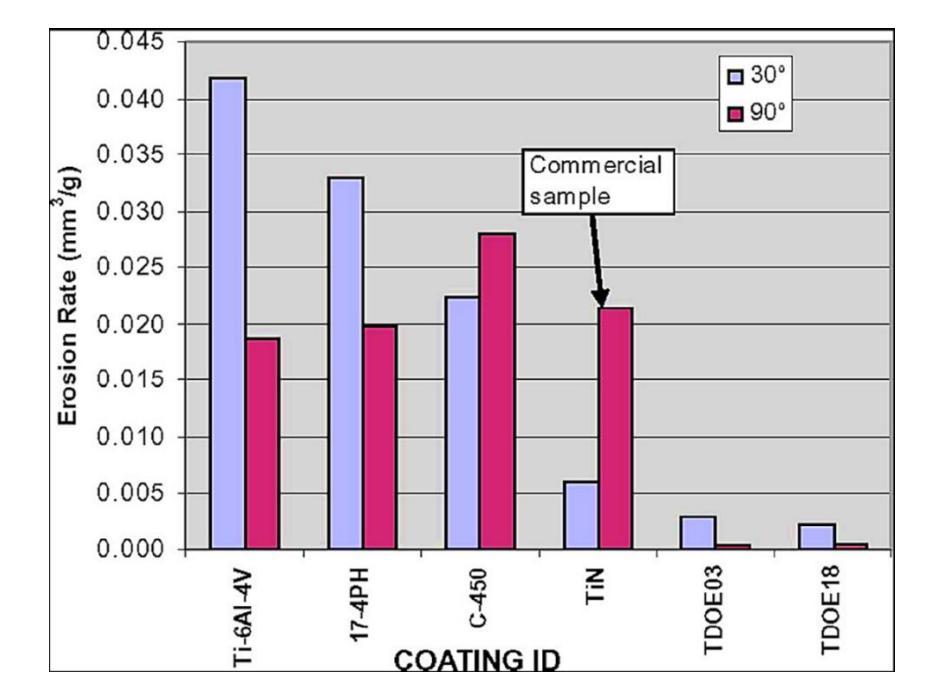
Figure 15. Comparison of erosion rates of commercial TiN coating by CAPVD and the advanced nano-composite coatings by PEMS. Reprinted with permission from ref. [113]. Copyright 2010, ASME.

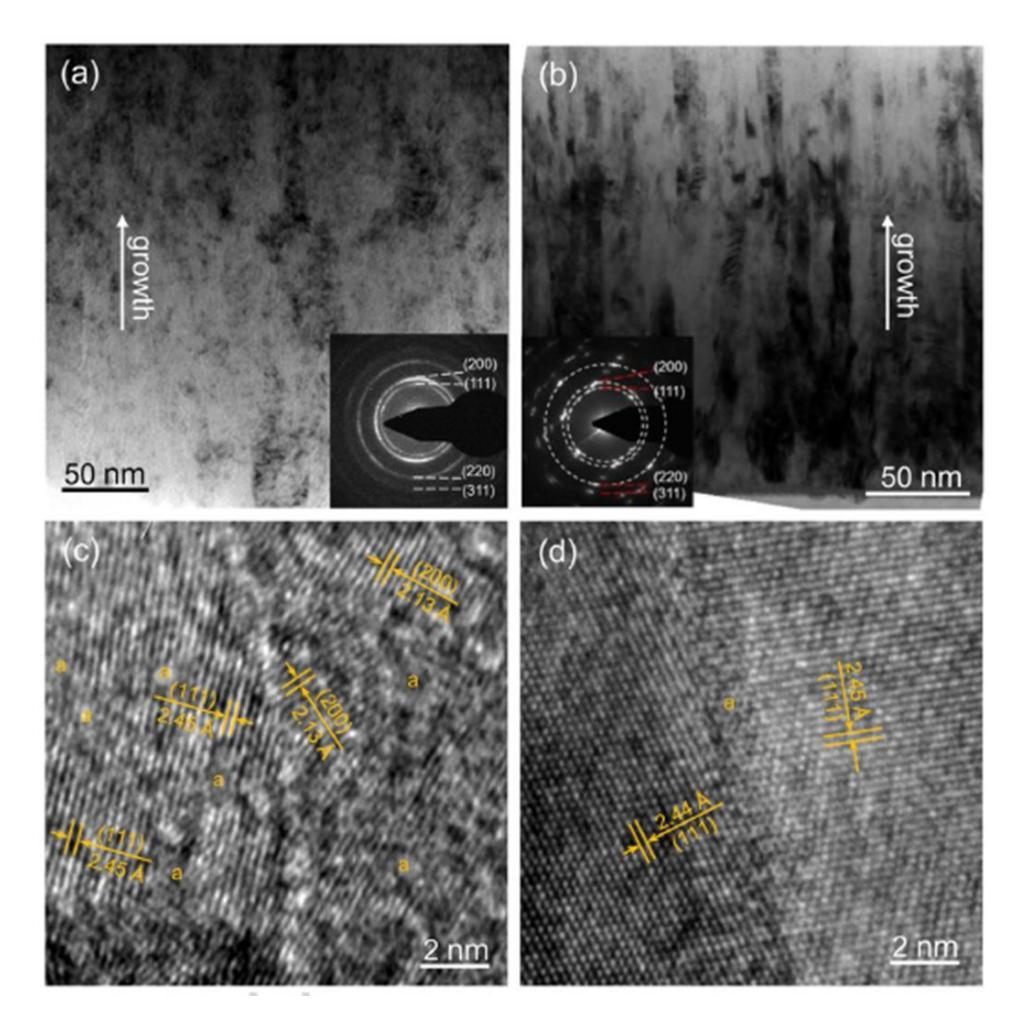
Figure 16. Cross-sectional TEM images, SAED patterns, and HRTEM images of the TiSiCN (2.6 at.% Si) (**a**,**c**); TiAlVSiCN (1.7 at.% Si) (**b**,**d**). Reprinted with permission from ref. [140]. Copyright 2018, Elsevier.

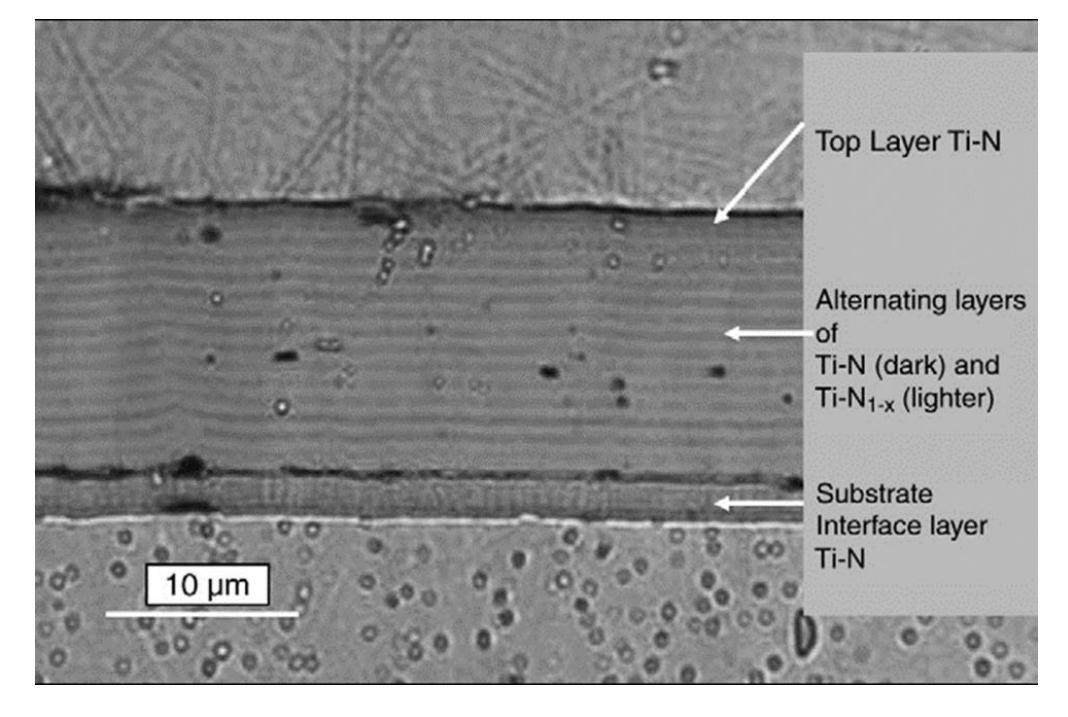
Figure 17. Coating architecture of a $\text{TiN}/\text{TiN}_{1-2}$ 4k Type IITM multilayer coating system for small and medium particle erosion protection. Reprinted with permission from ref. [24]. Copyright 2009, Elsevier.

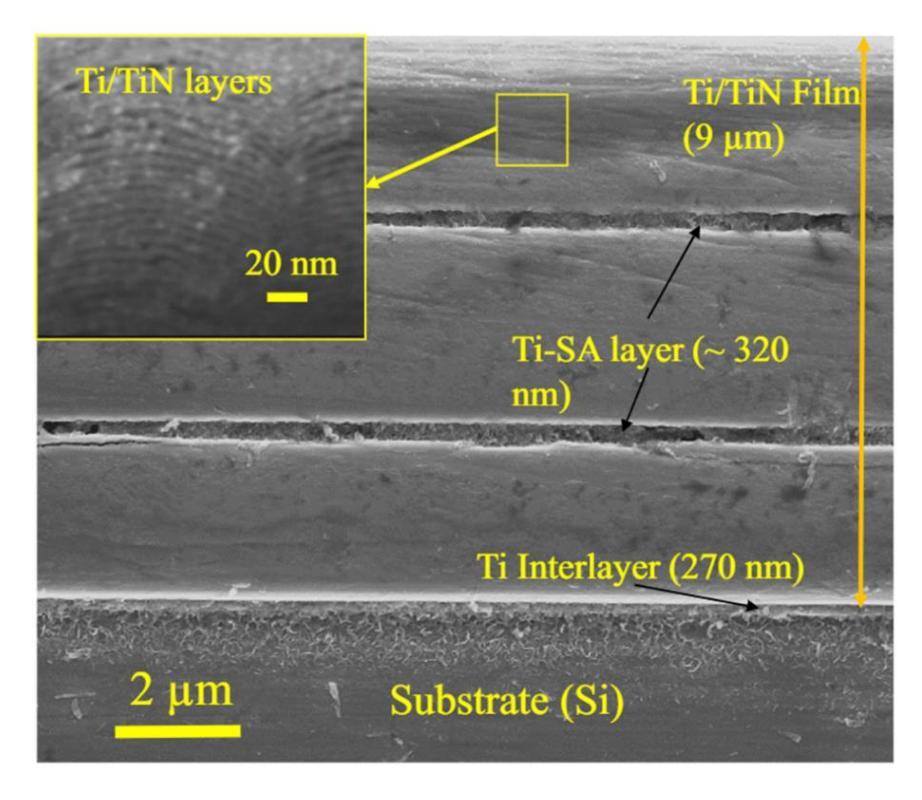
Figure 18. Cross-sectional FESEM image of Ti/TiN. The high resolution image in the inset shows the Ti/TiN multilayers. Reprinted with permission from ref. [115]. Copyright 2019, Elsevier.

As mentioned in the previous section, our group has developed an erosion-resistant Ti/TiN nanolayered multi-layered coating with stress-absorbing layers (Figure 18). The erosion performance of this coating was further improved by introducing porous metal layers [153]. Metallic foams such as Ti, Al, and Mg do have a higher energy absorption capacity compared to their dense counterparts [154–160]. So, these metallic foam materials are used in car crash protection and armor. Inspired by this, in the above-mentioned coating, Ti SA layers have been replaced with nanoporous Ti layers (Figure 20) [153]. Deposition of the porous Ti metal layer was realized by following Thornton's grain microstructure map for PVD coatings [161,162]. Two different ultra-thin Ti/TiN multilayered coatings with porous (Ti/TIN-P) and dense (Ti/TIN-D) Ti metal layers (~320 nm) were sputter deposited on Ti6Al4V substrates. The SPE tests were conducted according to ASTM-G76-13

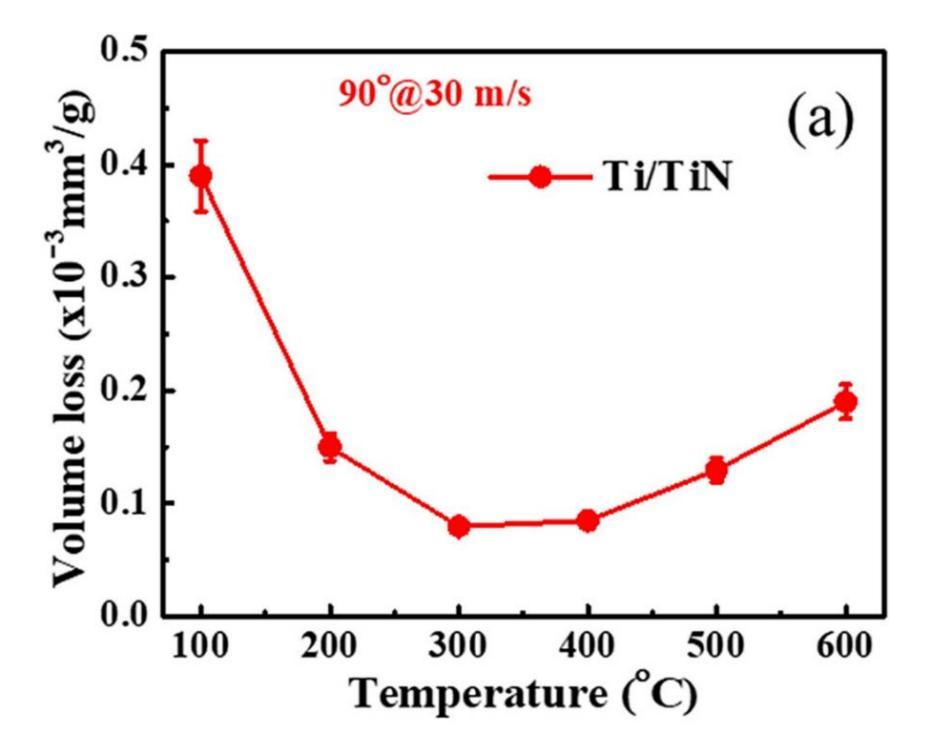
Figure 19. Erosion rate of a Ti/TiN film with respect to temperature for a 90° impinging angle. Reprinted with permission from ref. [60]. Copyright 2020, AIP Publishing.

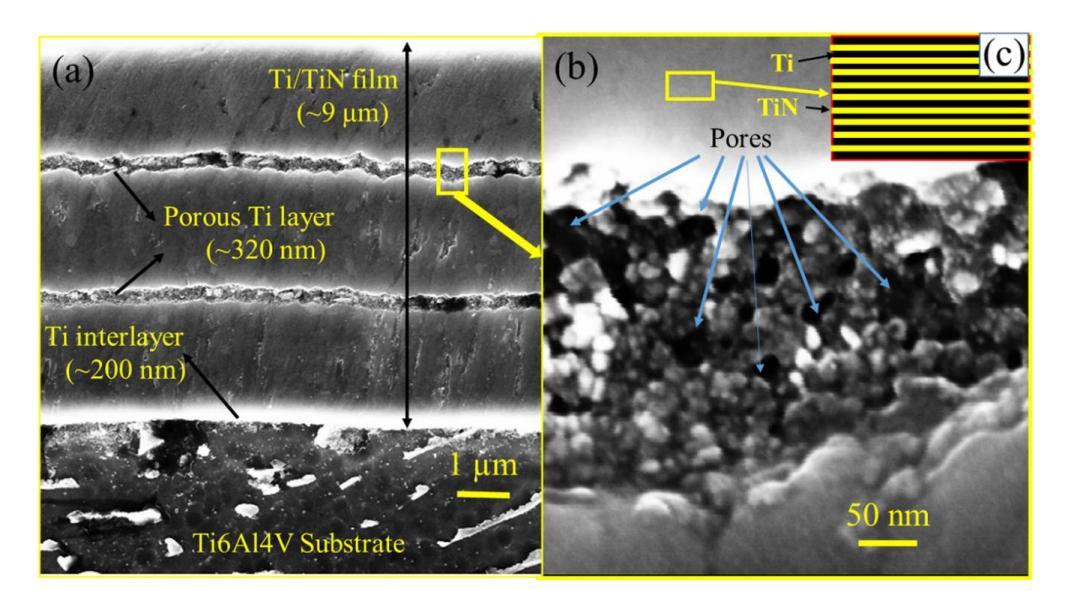
Figure 20. (a) Cross-sectional FESEM image of Ti/TiN-P coating, (b) porous Ti layer, and (c) schematic of Ti/TiN ultra-thin multilayers. Reprinted with permission from ref. [153]. Copyright 2021, Elsevier.

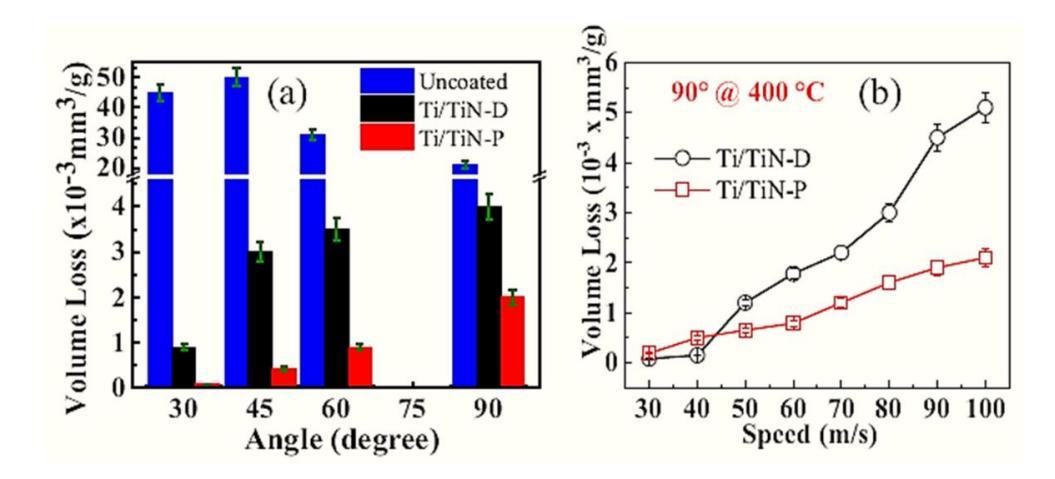
Figure 21. (a) Angle-dependent erosion rates of Ti/TiN-P and Ti/TiN-D coatings at conditions: temperature 400 °C and erodent speed 100 m/s. (b) Erodent speed dependent erosion rates of Ti/TiN-P and Ti/TiN-D coatings at conditions: impinging angle 90° and temperature 400 °C. Reprinted with permission from ref. [153]. Copyright 2021, Elsevier.
