Article Corrosion Behaviour of Titanium Alloy and Carbon Steel in a High-Temperature, Single and Mixed-Phase, Simulated Geothermal Environment Containing H₂S, CO₂ and HCl

Keywords: titanium alloy; carbon steel; H₂S; CO₂; HCl; multiphase; corrosion; high-temperature; geothermal

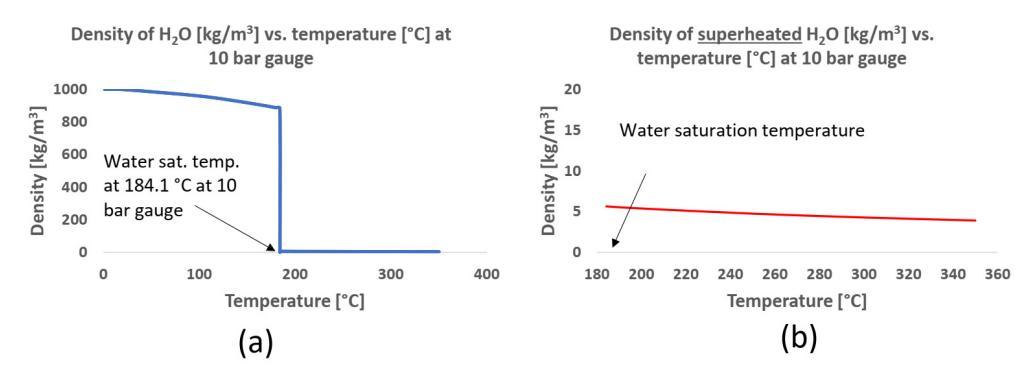
Figure 1. Density of pure H₂O at 10 bar gauge from (**a**) 0 to 350 $^{\circ}$ C and (**b**) at superheated conditions (>184.1 $^{\circ}$ C).

The two reactant solutions in separate mixing flasks were connected by PVC tubes to Labhut degassers and from there to Chromtech Series I high-pressure pumps, which injected the two fluids at the mixing junction before the inlet of the testing volume where the testing fluid was formed. The expected scenario of the testing fluid condition and phase transition inside the testing volume was as follows: The testing fluid flowed into the first reactor with a set temperature of 350 °C where the fluid was heated from room temperature to the saturation point of the testing solution, where it is completely evaporated to vapourphase state. As the fluid was almost pure H₂O, the expected saturation point was near 184 °C at 10 bar gauge [26]. The density of pure H₂O vs. temperature at 10 bar gauge can be seen in Figure 1 [27].

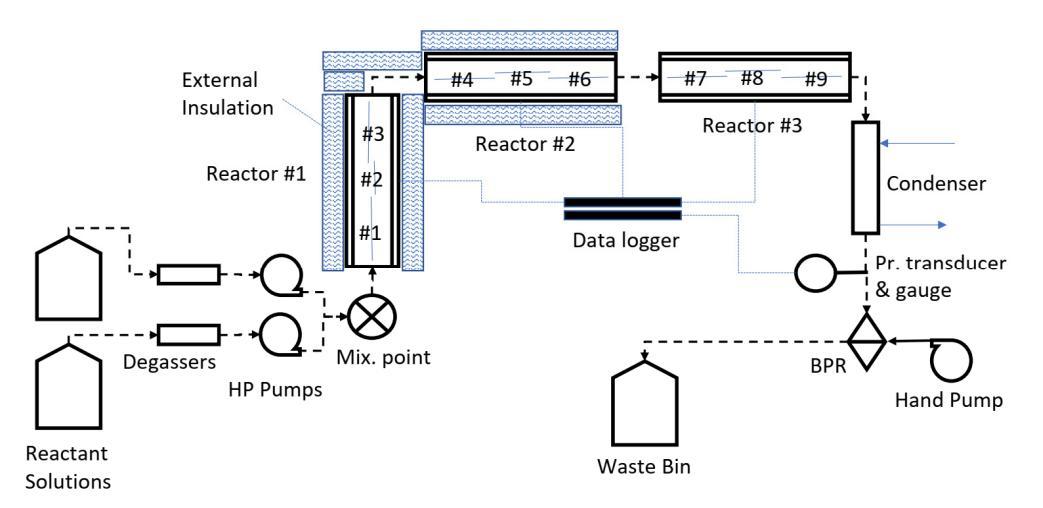
Figure 2. Flow diagram of the three reactors, flow-through testing facility. Three samples were accommodated in each reactor.

connected to the test flow line. The cold and condensed testing fluid was then inserted into a chemical waste bin where the toxic H₂S was neutralized with alkaline zinc acetate. The tubing between reactors and the tubing in the hot temperature volume in the testing facility was made of UNS N10276 (American Special Metals, Pompano Beach, FL, USA), the same material used in the reactor tubes. The sample holder and fasteners were made of Inconel UNS N06625 (Velvik, Reykjavik, Iceland). Ceramic alumina (Ortech, Sacramento, CA, USA) washers were inserted between the testing samples and the fasteners to prevent a galvanic coupling effect. The hot-part assembly (heaters, reactors and insulation surrounding the reactor pipes and heating elements) were custom made at the University of Iceland. Electrical parts for the heater were provided by Rafhitun ehf (Hafnarfjordur, Iceland). The temperature in the system was monitored with K-type thermocouples connected to a U6 datalogger (Labjack, Lakewood, CA, USA). The pressure in the test flow line was measured at the outlet of the condenser with S-20 digital pressure transducer (WIKA, Klingenberg, Germany) which was connected to the U6 datalogger. An analog pressure gauge meter was also connected at the outlet of the condenser. The pressure in the testing volume was regulated by a custom made back pressure regulator provided by Prologo (Kopavogur, Iceland) and the pressure set value was controlled with a SITEC 750 hand pump (SITEC, Maur, Switzerland). The testing facility design can be seen in Figure 2.

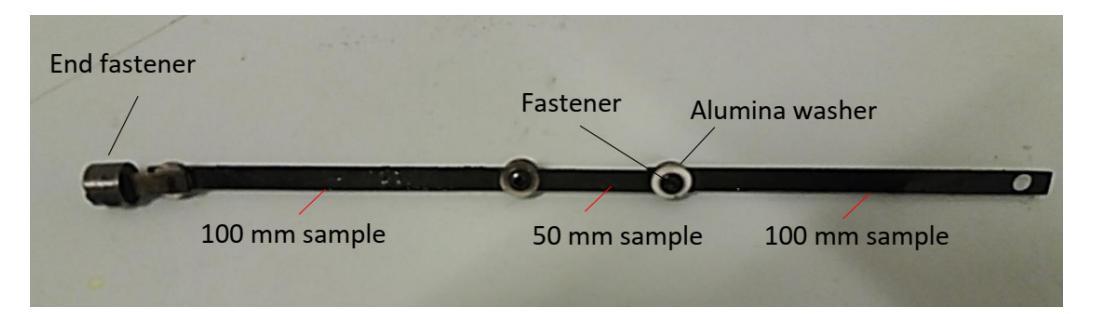
Figure 3. The carbon-steel samples in reactor 2 after the testing. All the carbon-steel samples in all three reactors had turned from shiny metal appearance to black appearance after the corrosion test.

The carbon-steel samples had turned from shiny metal to black in appearance after the corrosion test as seen in Figure 3, but the titanium alloy samples showed only small discolourization after the testing.

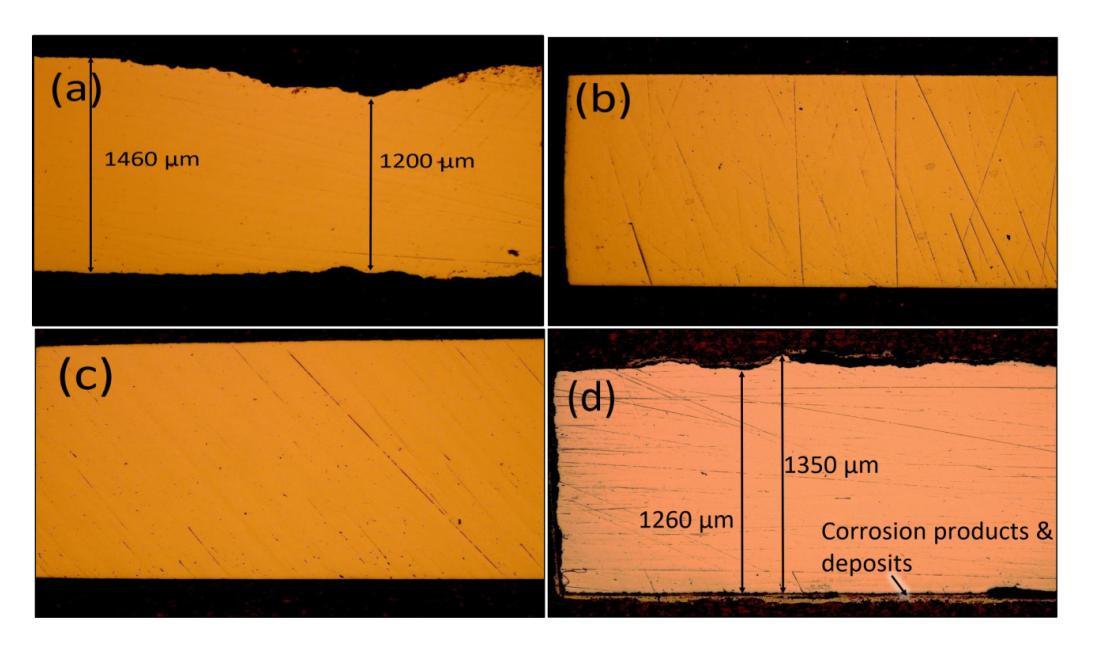
Figure 4. Optical microscope ($5 \times$ magnification) of a carbon-steel sample cross-section (**a**) 1 cm from the inlet end of sample 1, (**b**) 3 cm from the inlet end of sample 1 in the first reactor, (**c**) In the middle of sample 5 in the second reactor and (**d**) one cm from the outlet end of sample 9 in the third reactor.

Further visual inspection of the carbon-steel samples after the corrosion testing indicated that some corrosion had occurred on sample 1 at the inlet of the first reactor and sample 9 at the outlet of the third reactor. This observation was evident from the bulk mass removal effect and pitting on the surface; a lower corrosion effect was observed on the samples between these two samples. This observation was strengthened under an optical microscope where the thickness reduction was apparent in a cross-sectional view of the first and last sample in comparison with other samples tested as can be seen in Figure 4.

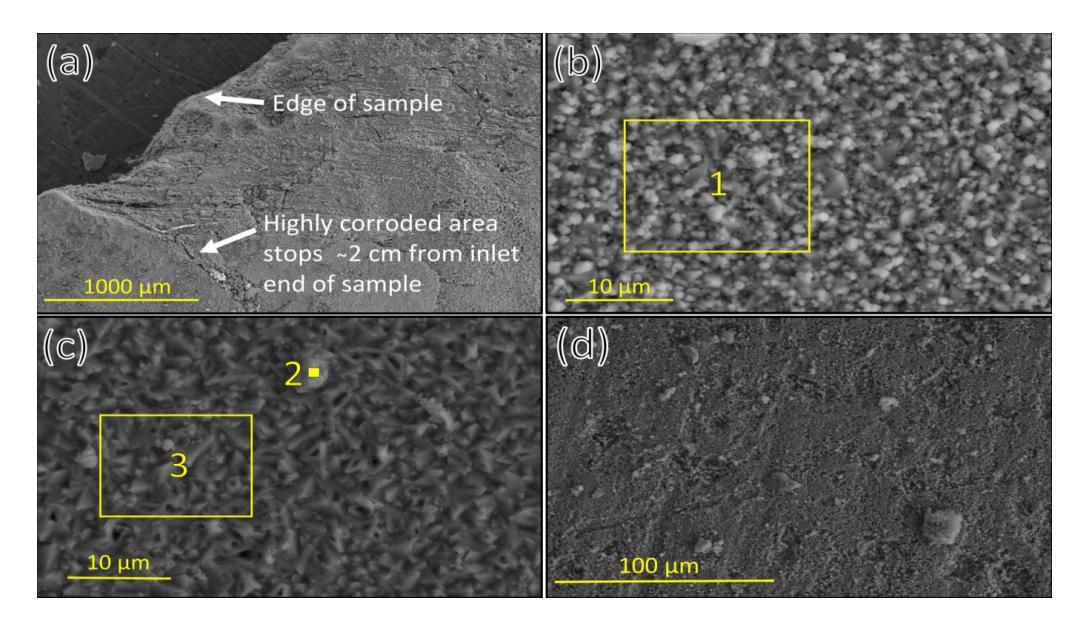
Figure 5. (a) Tested carbon-steel sample 1 only one cm from inlet end in the first reactor, (b) tested carbon-steel sample 1 now three cm from inlet end in reactor 1, (c) tested carbon-steel sample 5 in middle of the second reactor and (d) tested carbon-steel sample 9 at the outlet of the last reactor.

A surface analysis of all the carbon-steel samples showed that corrosion to some extent had occurred on the first few centimetres of sample 1 and sample 9. The first 1 to 2 cm of sample 1 had been prone to apparent corrosion, where part of the samples had been corroded away during the test. The corrosion observed on sample 9 had more micropitting texture rather than bulk mass removal. The samples in between had, to a large extent, surface texture similar to the surface texture characterized by the presence of magnetite (see Figure 5 and Table 6). This had been observed in other corrosion tests performed in the same testing equipment (but with different setup) in a superheated environment done by Thorhallsson et al. [15]. A broad range of corrosion forms was observed on the carbon-steel sample in the first few centimetres of sample 1: some locations had negligible oxide film observed on the surface; other locations had a dense oxide film present.

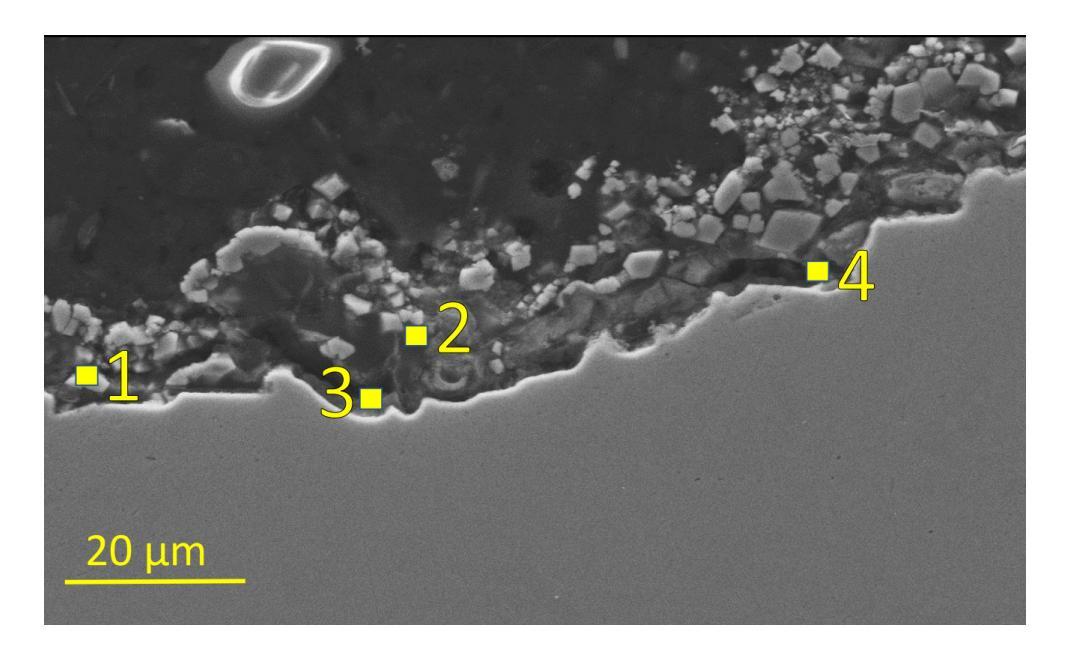
Figure 6. Cross-section of tested carbon-steel sample 1 one cm from the inlet of the first reactor.

These findings might indicate that wet (aqueous) corrosion could have occurred at the first few centimetres and at the last centimetre in the testing volume because of boiling at the inlet and condensation at the outlet. Elemental analysis of carbon-steel samples indicated that some corrosion products from the fasteners or the reactor pipes (nickel-based alloy) had likely been transported to the surface of the corroded carbon-steel samples because Ni and Mo were sometimes observed on the corroded samples as seen in Figure 5 and Table 7 (and in Figure 4 and Table 6). When the cross-section of the samples in the three reactors was studied, some corrosion behaviour variability was observed: the first few centimetres of sample 1 had an incident of corrosion damage both where carbon-steel material residuals inside the corrosion film were observed on the sample (Figure 6 and Table 7), and another incident where the thicker corrosion product (oxide film) was observed on the sample (Figure 7 and Table 8). The surface profile indicated in both cases that severe corrosion damage had occurred.

Table 7. Elemental analysis from locations in Figure 6.

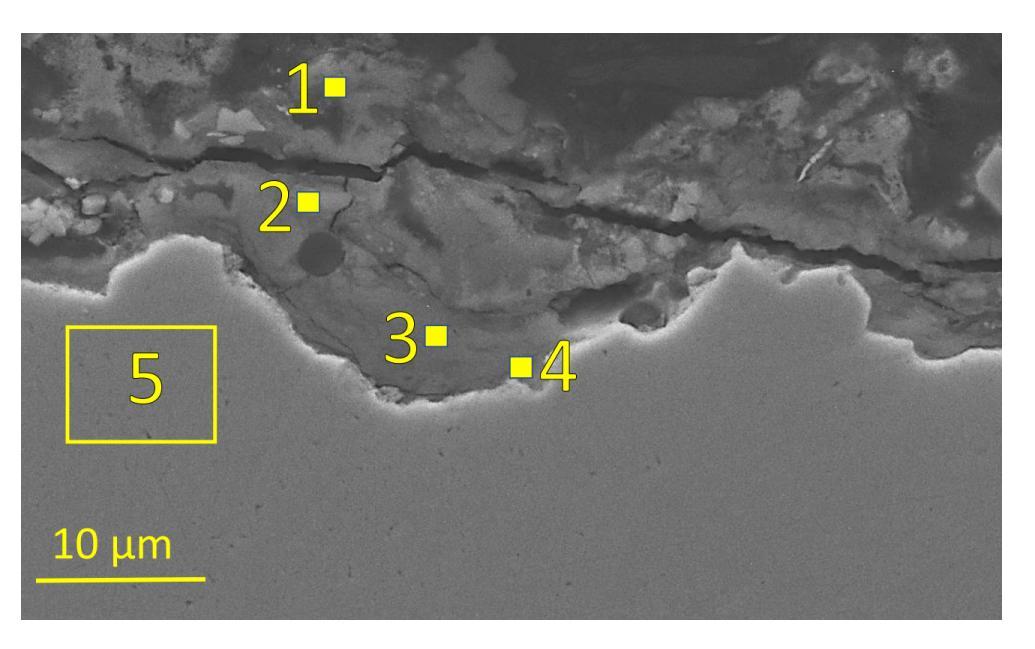
Figure 7. Cross-section of tested carbon-steel sample 1 one cm from the inlet of the first reactor. A continuous oxide layer was observed.

Table 8. Elemental analysis from locations in Figure 7.

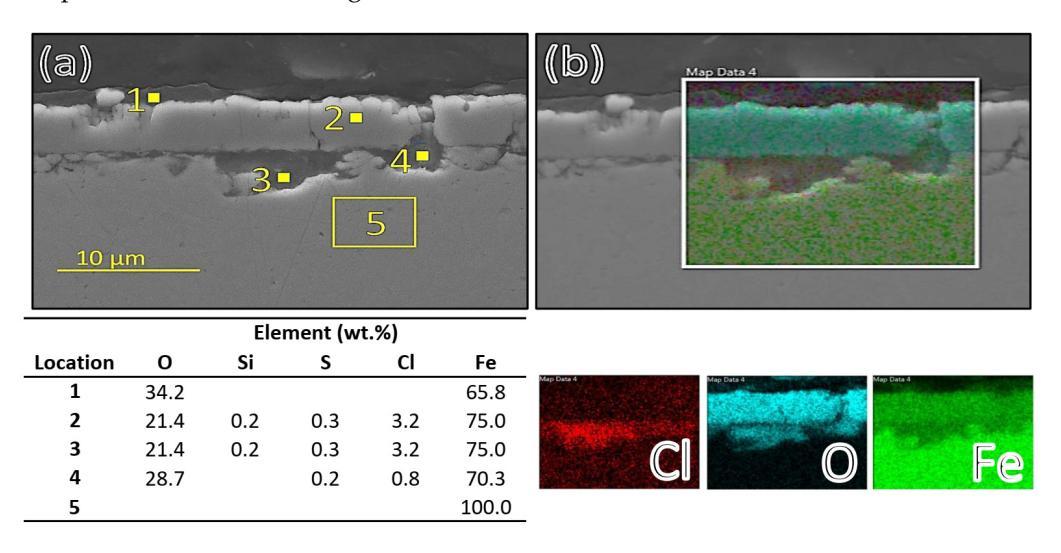
Figure 8. Cross-section of tested carbon-steel sample 1, three cm from the inlet of the first reactor with (**a**) localized chemical analysis and (**b**) elemental scanning.

Further into the testing volume or 3 cm from the inlet of the first reactor, the form of the corrosion products changed to a more consistent or homogeneous texture, i.e., chloride rich pits under oxide film were observed more consistently than in the first 1 to 2 cm of sample 1 as can be seen in Figure 8.

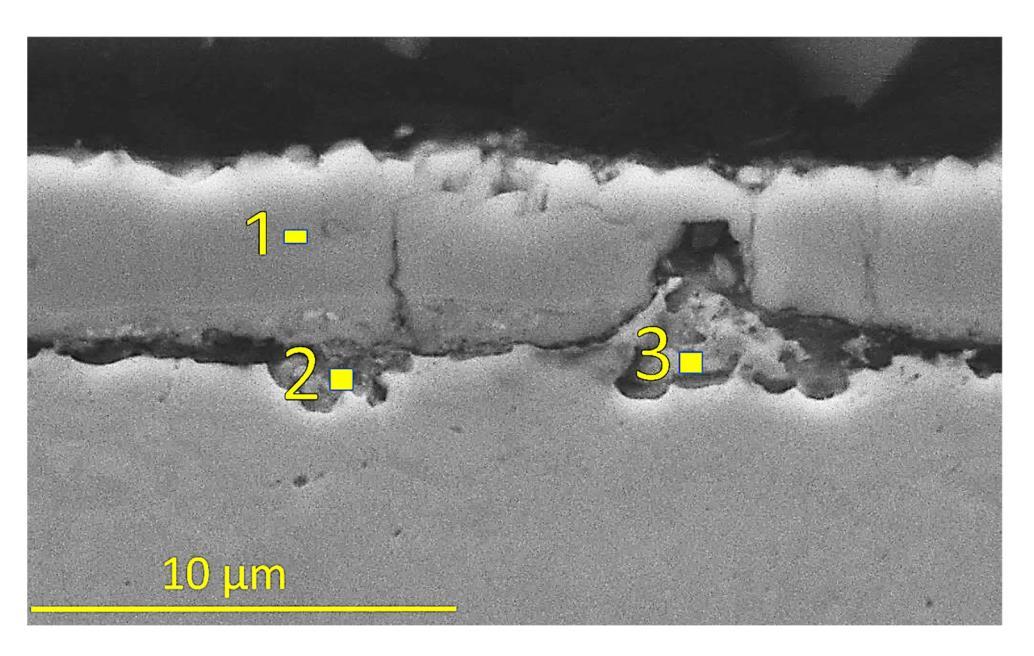
Figure 9. Cross-section in the centre of the tested carbon-steel sample 5 in the middle of the second reactor.

These findings might indicate that the transition from acidic aqueous solution to vapour phase fluid occurred at the first few centimetres of sample 1. The corrosion of carbon steel in an acidic H₂S environment at low and high temperatures showed that the carbon steel was prone to general and localized corrosion damage with an inner magnetite (Fe_3O_4) layer and outer iron sulphide layer in the corrosion film as reported by Gao et al. [30-32] in an aqueous environment. A study by Choi et al. showed that H₂S can have an inhibiting effect on the corrosion of carbon steel in an acidic CO₂/H₂S environment at 25 °C [33], and Mursalov addressed the multifactor dependence and complexity of corrosion of H_2S in an acidic environment [34]. The lack of an observed sulphide layer in our testing in the first few centimetres of carbon-steel sample 1 might have been due to the very high acidity of the testing fluid, which dissolved the sulphide layer, or to the high concentration of sodium chloride deposits on the corrosion samples that prevented sulphide formation by forming a mass transfer barrier at the surface when the testing fluid boiled in the first few centimetres of the first reactor. Furthermore, the kinetics of iron sulphide layer formation is slow in comparison to those of magnetite formation as concluded by Gao et al. [31]. In the sulphide layer formation process, magnetite layer forms first and iron sulphide then forms gradually in an acidic H₂S environment at 120 °C. The lack of sulphide film in the first few centimetres of sample 1 could, therefore, have been due to the synergistic effect of slow sulphide-formation kinetics, or to the effect of an enriched concentration of corrosive species and salt deposits on the surface due to boiling of the testing fluid in the first few centimetres of sample 1. The stability of iron sulphide layers, summarized by Gao et al. [31], showed that the stability of the sulphides was reduced significantly below pH = 4 and was dependent on the reduction potential of the environment. In light of our testing results, low pH = 3 in our testing environment, and the lack of an iron sulphide layer in the corrosion product film, it was likely that the iron sulphide(s) corrosion products were not stable in the aqueous testing environment in the first few centimetres in the first reactor. A low concentration of sodium chloride was, however, detected in the corrosion products in the first few centimetres of sample 1. It likely occurred after the testing period because of the flushing of deionized water through the testing volume after the testing period (to prevent acidic condensation at high temperatures) and before the samples were removed from the reactor. The sodium chloride deposited due to boiling likely dissolved in the flushing water after the testing period and was flushed away with the deionized water through the testing volume at the end of the experiment. The loss of material and the lack of corrosion film on the surface in the first few centimetres of sample 1 indicated that the acidic aqueous solution at high temperature caused the removal of the corrosion products at a rapid rate. The results also indicate that, further into the first reactor, the fluid became less corrosive and the corrosion behaviour trended towards a more localized corrosion attack, as observed in previous study by Thorhallsson et al., for materials tested in superheated conditions [15]. The corrosion behaviour observed for carbon-steel sample 5 in the second reactor resembled the corrosion behaviour observed for sample 1 after the first few centimetres. The exception was that less chloride was detected in the pits in sample 5 in the second reactor and in sample 8 in middle of the third reactor, as seen in Figure 9, Table 9 and Figure 10 and Table 10, respectively.

Table 9. Elemental analysis from locations in Figure 9.

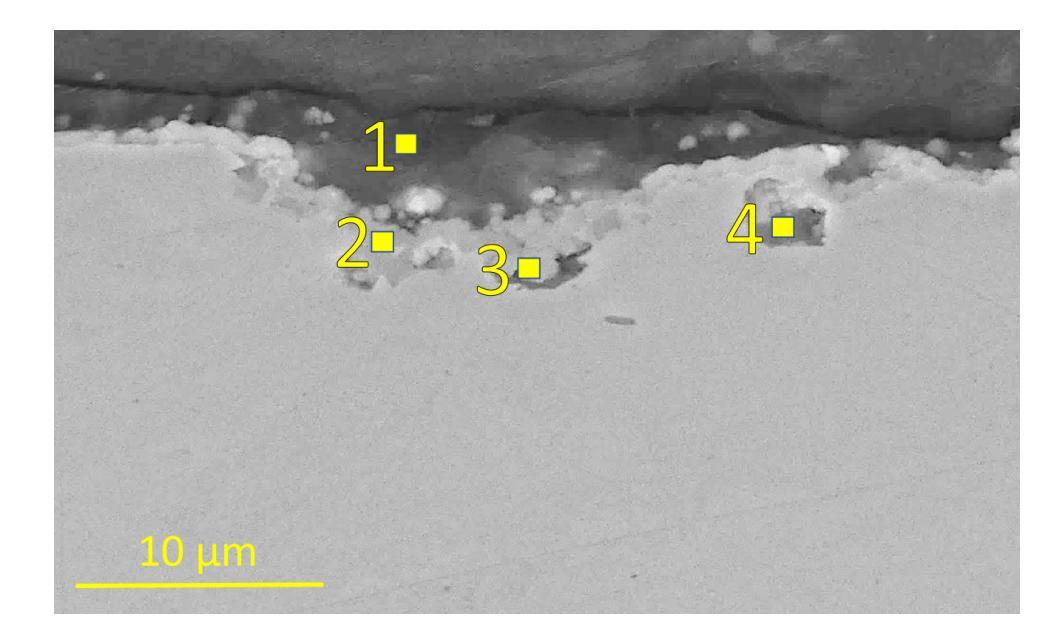
Figure 10. Cross-section in the centre of the tested carbon-steel sample 8 in the middle of the last reactor (condenser).

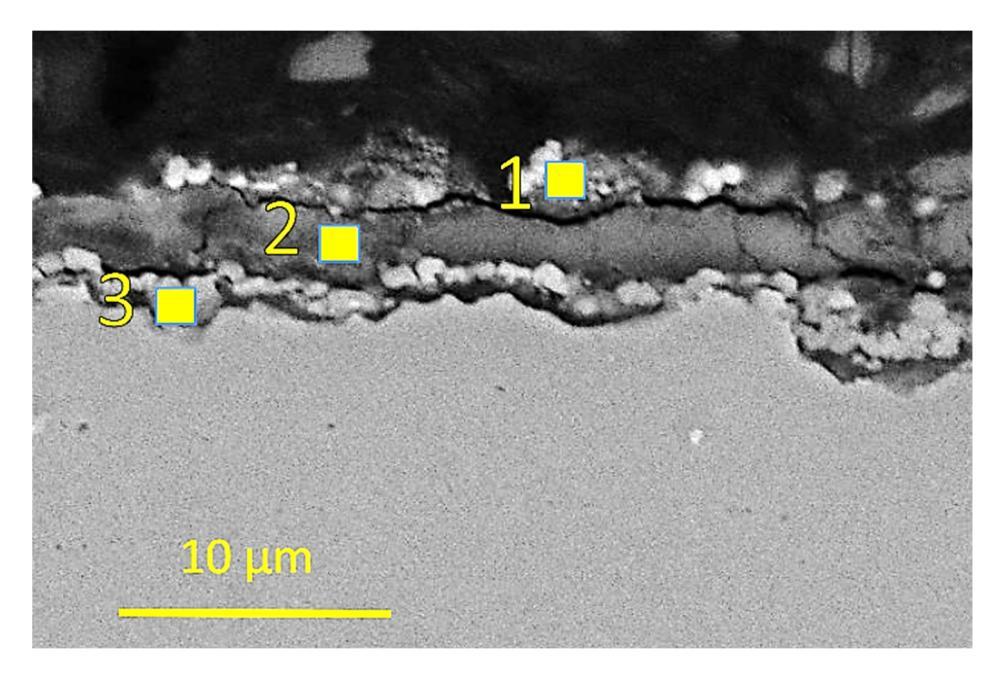
Figure 11. Cross-section 3 cm from the outlet end of tested carbon-steel sample 9 at the end of the last reactor (condenser).

The corrosion behaviour of the carbon steel started to change again in the last sample in the third reactor where the set temperature was 180 °C. The corrosion in sample 9, three centimetres from the outlet, had a corrosion film with multiple layers. In comparison with samples 2–8, some sulphur was detected in the corrosion layers of sample 9, three centimetres from the outlet as seen in Figure 11 and Table 11.

Table 11. Elemental analysis from locations in Figure 11.

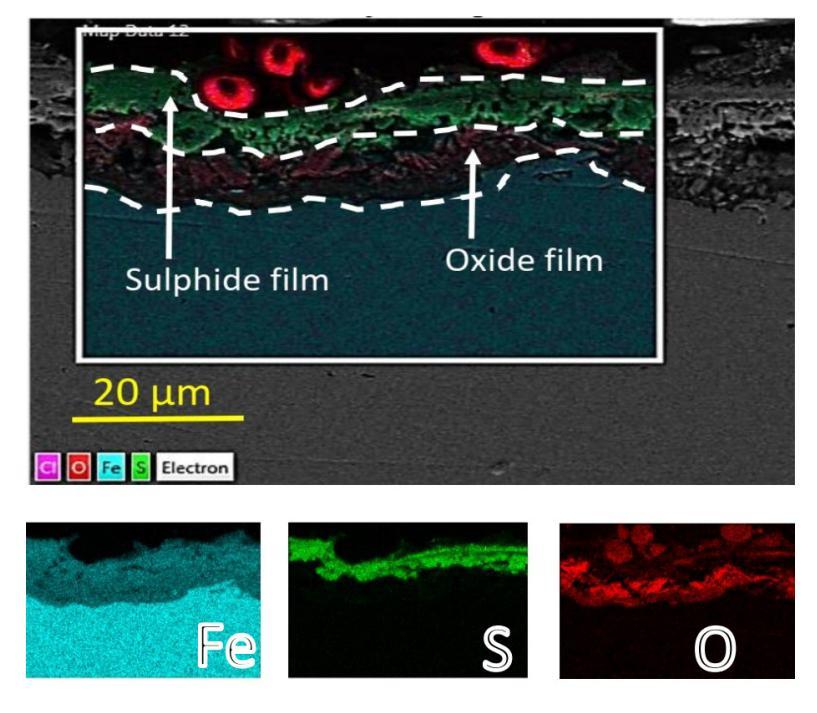
Figure 12. Elemental scanning of cross-section 1 cm from the outlet end of tested carbon-steel sample 9 at the end of the last reactor (condenser).

The transition to multiple-layer corrosion film behaviour became more apparent in the last centimetre of sample 9 in the third reactor. A sulphide-rich outer layer and an oxygen-rich sublayer formed, which was in an agreement with other study results of H_2S corrosion of carbon steel in an aqueous environment at high temperatures [30,31] (See Figure 12).

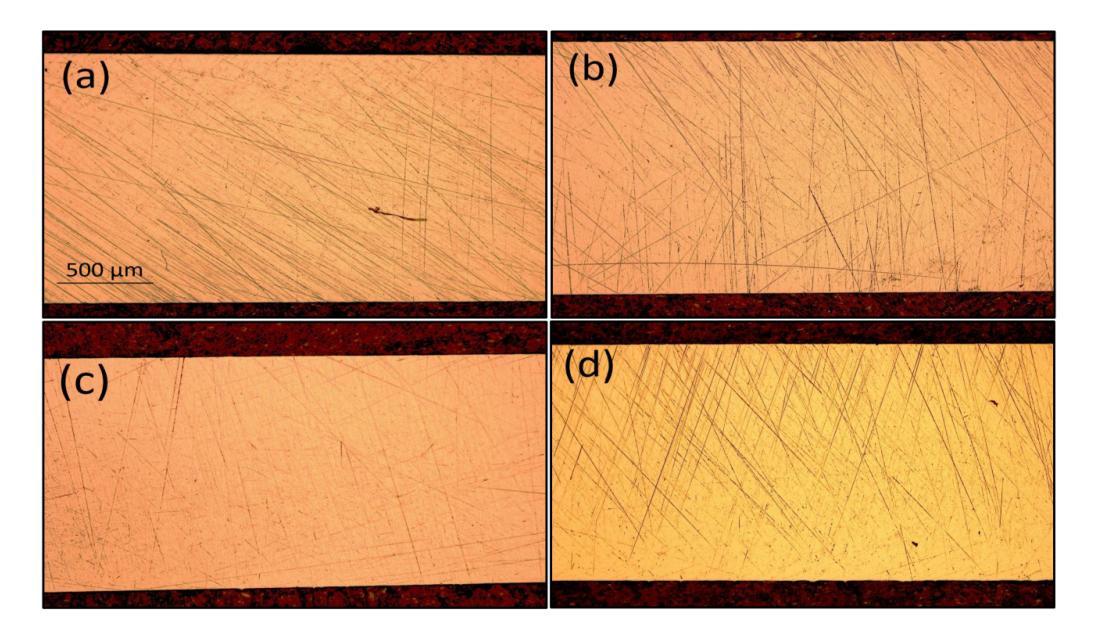
Figure 13. Optical microscope images of the cross-section of the titanium alloy sample ($5 \times$ magnification); (**a**) 1 cm from the inlet end of sample 1, (**b**) 3 cm from the inlet end of sample 1 in the first reactor, (**c**) In the middle of sample 5 in the second reactor and (**d**) 1 cm from the outlet end of sample 9 in the third reactor.

The same test setup was applied to testing the titanium-alloy samples. The appearance of the cross-section of the titanium-alloy samples after testing indicated that no corrosion damage was experienced as seen in Figure 13.

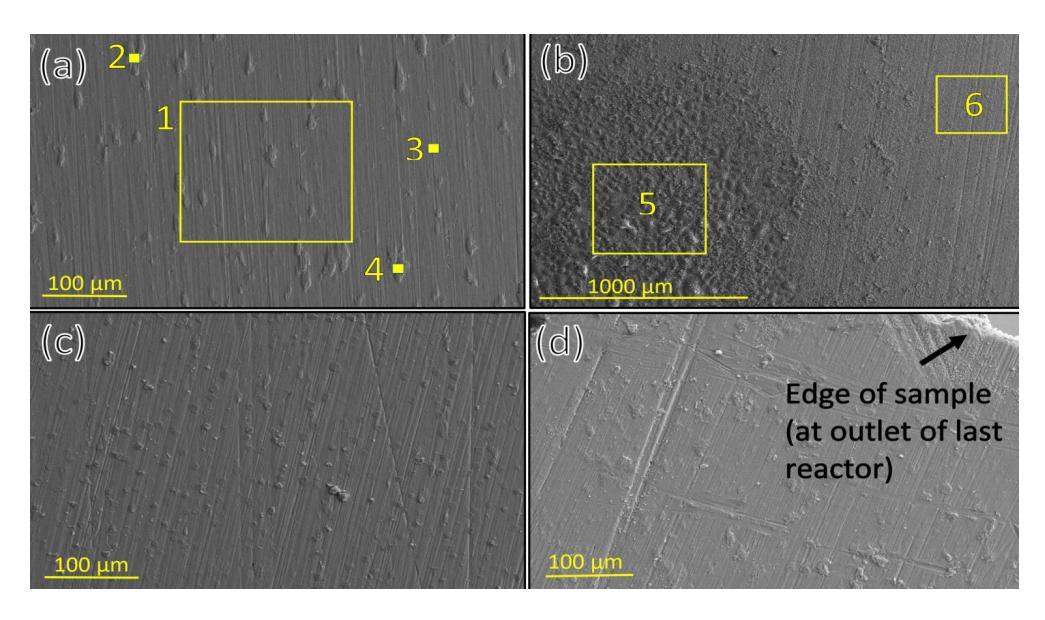
Figure 14. SEM images of the surface of; (**a**) the untested titanium-based alloy, (**b**) the tested titanium alloy sample 1, 1 cm from the inlet end in the first reactor, (**c**) tested titanium alloy sample 1 3 cm from the inlet end of the first reactor and (**d**) tested titanium alloy sample 9 at the end of the last reactor.

Table 12. Elemental analysis from locations in Figure 14.

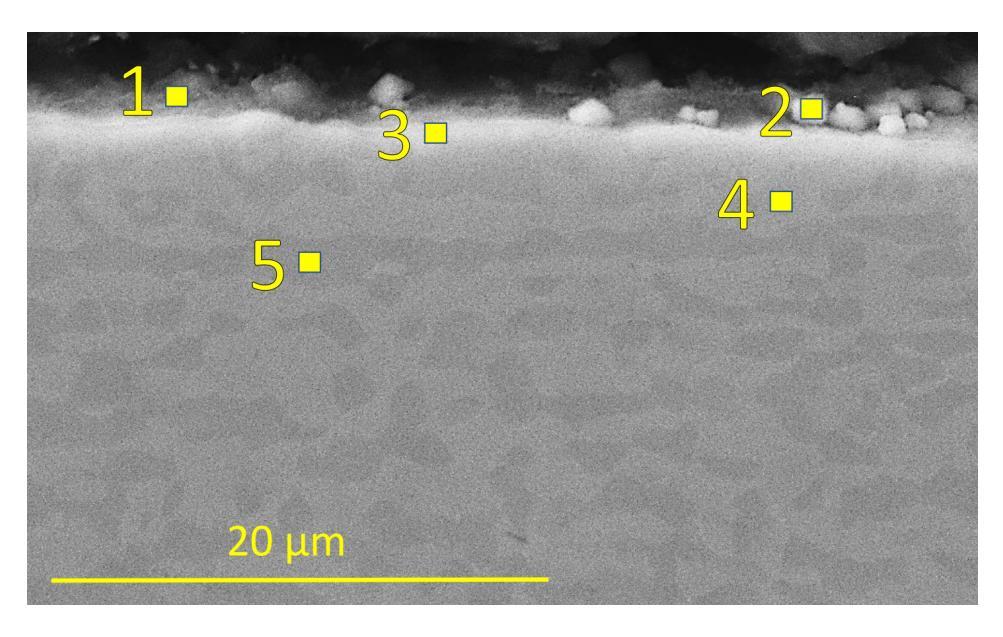
Figure 15. SEM and XEDS analysis of the cross-section of tested titanium alloy sample 1 at 1 cm from the inlet end of the first reactor.

Table 13. Elemental analysis from locations in Figure 15.

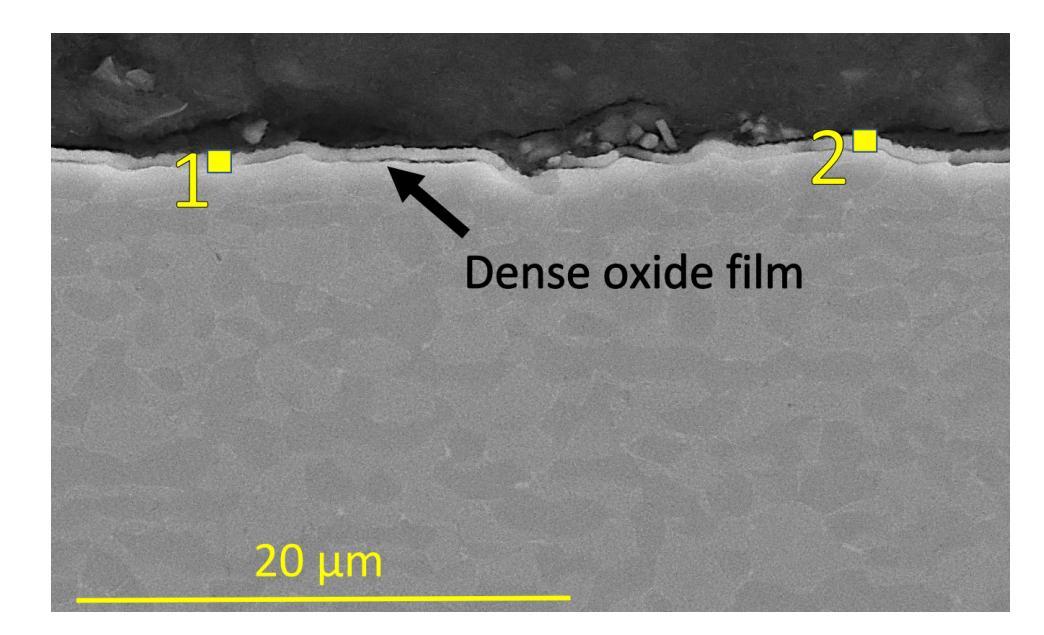
Figure 16. SEM image and XEDS analysis of a cross-section of the middle part of the tested titanium alloy sample 5 in the middle of the second reactor (superheated fluid).

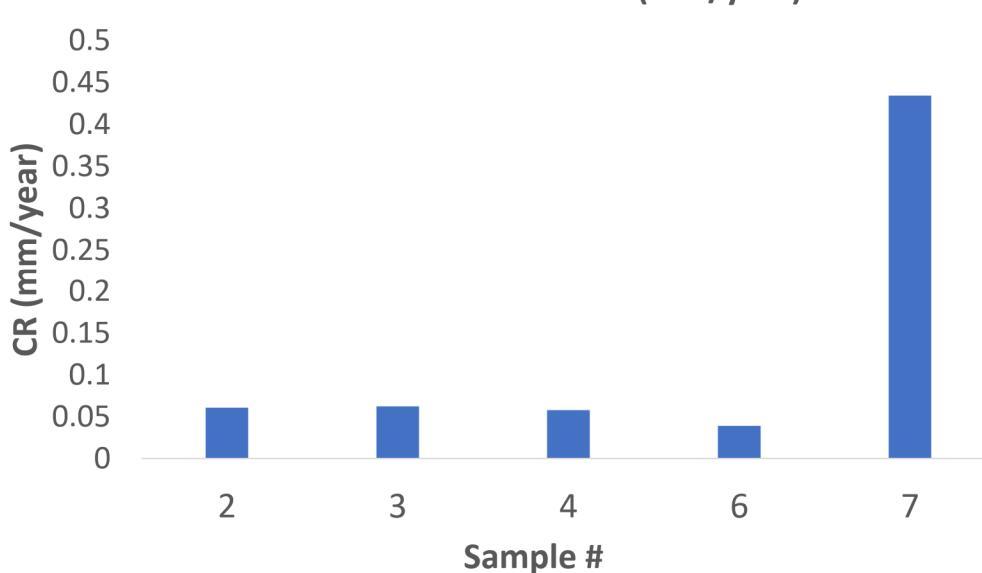
Figure 18. Weight loss analysis of carbon-steel samples. Samples 2 and 3 were accommodated in the 1st reactor, samples 4 and 6 in the 2nd reactor and sample 7 in the 3rd reactor.

Samples 2, 3, 4, 6, and 7 were used for weight-loss analysis for the tested carbonsteel material. The weight loss, and hence the calculated corrosion rate in the samples accommodated in the first and second reactors, had a corrosion rate of the same order of magnitude as the carbon steel tested in a superheated environment in a study by Thorhallsson et al. [15]. The first sample in the third reactor had a corrosion rate an order of magnitude higher than all other weight loss samples in the first and second reactor as can be seen in Figure 18. The increased corrosion rate of sample 7 in the third reactor might indicate that condensation of the testing fluid started at the inlet of the 3rd reactor, resulting in rapid electrochemical corrosion.

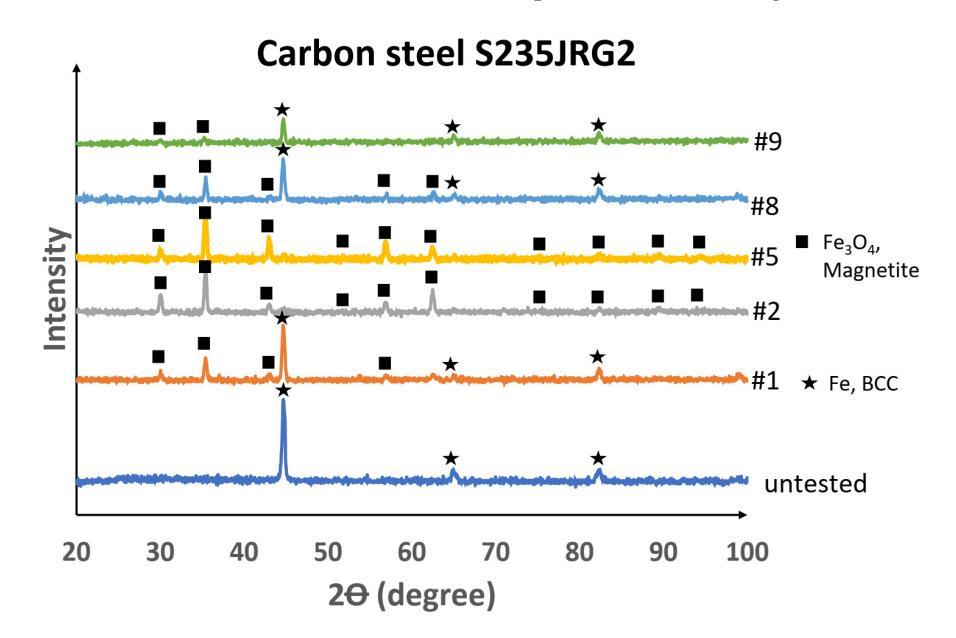
Figure 19. XRD scatters from carbon-steel samples from bottom to top: (untested) Unexposed sample, (1) tested sample at the inlet in the first reactor, (2) tested sample in the middle of the first reactor, (5) tested sample in the middle of the second reactor, (8) tested sample in the middle of the third reactor and (9) tested sample at the outlet of the third reactor.

It was necessary to evaluate the XRD results of the untested and corrosion-tested carbon steel in connection with the state of the fluid and with the SEM and XEDS results, which showed that the liquid state or condensation of the testing fluid occurred at the inlet of the first reactor (sample 1) and in all the volume of the third reactor (sample 9). From the XRD pattern of the surface of sample 1, the crystalline phases detected were the body-centred cubic (BCC) system with iron (Fe) and the cubic crystal system with iron oxide in the form of magnetite (Fe₃O₄). The samples in the proposed superheated testing volume, samples 2–5, had magnetite detected on the surface, but in sample 8 the transition from magnetite as a surface covering to an exposed BCC-Fe bulk material likely occurred. Sample 9 then had peaks of BCC-Fe crystal structure identified. From the Pourbaix diagram of iron at high temperatures [38], it was concluded that magnetite is not stable or present in an acidic (pH < 4) aqueous solution. Since the peaks for magnetite were not present in the XRD pattern for samples 1 and 9, it further strengthened the conclusion that acidic, aqueous conditions were present in the testing volume where sample 1 and sample 9 were located. Weak magnetite scattering from sample 8 indicated that the extent of acidic condensation (condensate) was likely less on sample 8 in comparison with sample 9. The XRD patterns of the untested and tested carbon-steel samples are shown in Figure 19.

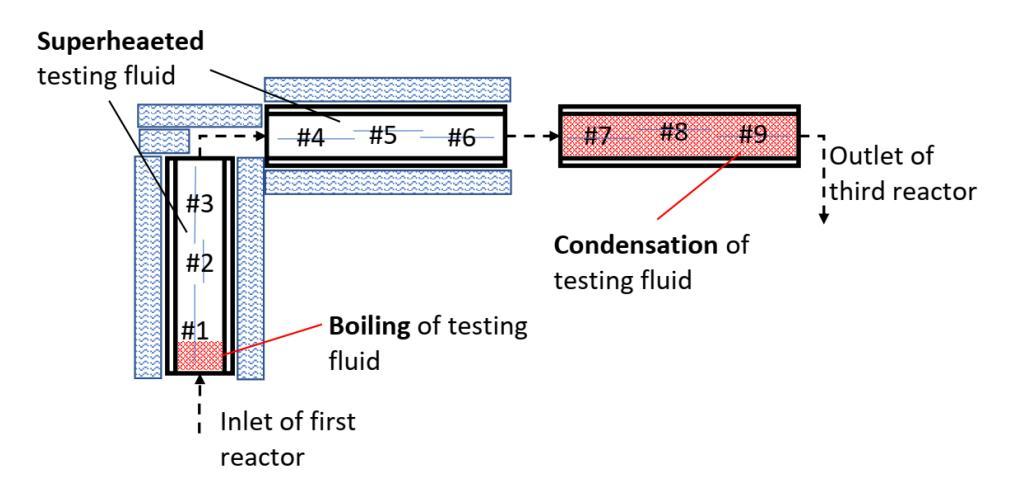
Figure 20. Boiling was thought to have occurred in the volume in the first few centimetres in the first reactor and condensation of testing fluid was thought to have occurred in the third reactor.

From the microstructural, weight-loss and XRD analysis of the carbon steel, it was concluded that the testing fluid was likely in a two-phase state at the first few centimetres in the inlet of the first reactor and in a two-phase state or condensing condition in the third reactor. The results indicated that the testing fluid was in a superheated state in the testing volume between the two-phase volumes as illustrated in Figure 20.

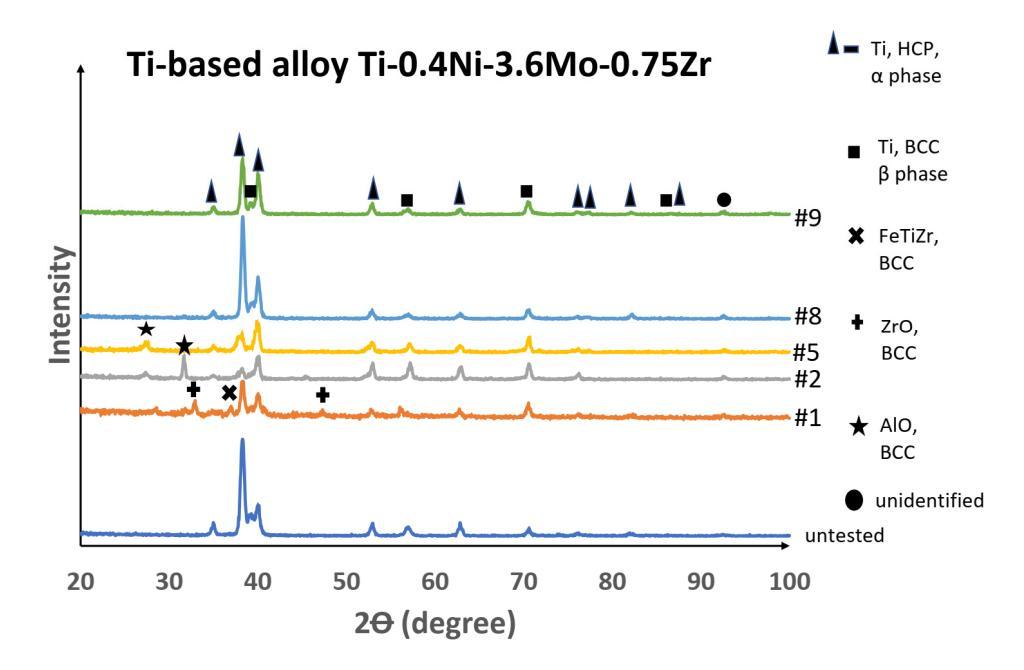
Figure 21. XRD scatters from the titanium alloy from bottom to top: (untested) Unexposed sample, (1) tested sample at the inlet in the first reactor, (2) tested sample in the middle of the first reactor, (5) tested sample in the middle of the second reactor, (8) tested sample in the middle of the third reactor and (9) tested sample at the outlet of the third reactor.

The XRD results of the surface of the titanium alloy samples showed little difference in crystal structure for the tested sample in comparison with the untested sample. Some changes were observed for sample 1 (a zirconium oxide crystal structure), which was not detected in other samples. Alumina oxide–BCC phase was detected on samples 2 and 5, which was likely due to corroded alumina oxide washers' being transported to the samples. The XRD result for the tested titanium alloy samples was in good agreement with the results from the SEM and XEDS analysis, i.e., an insignificant corrosion effect as illustrated in Figure 21.
