# The Analysis of Polyethylene Hip Joint Endoprostheses Strength Parameters Changes after Use inside the Human Body

*Materials* **2021**, *14*, 7091.

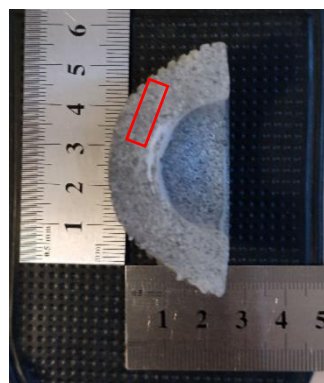
The test samples were collected from the surface cooperating in the artificial joint with the metal head, from the areas with the highest degree of degradation. For structural tests using the DSC method, samples were taken from the surface to a depth of about 2 mm while maintaining the sample weight of about 10 mg. For the DMTA tests, samples were also taken from the work surface, but due to the method, the cut sample had to be formed into a rectangular beam with dimensions of 12 mm in length and a cross-section of 6 by 2 mm (Figure 8). Such treatment resulted in the destruction of part of the surface, but took into account the changes in the stiffness of the tested part.

**Figure 8.** Preparation samples to tests.

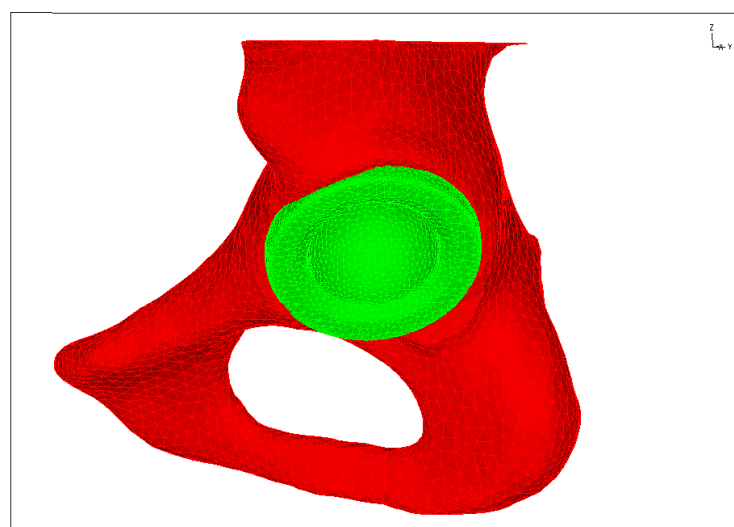
implanted prosthesis was developed on the basis of computed tomography of a specific patient (Figure 9).

**Figure 9.** Numerical model of the pelvic bone after implantation of an artificial hip cup.

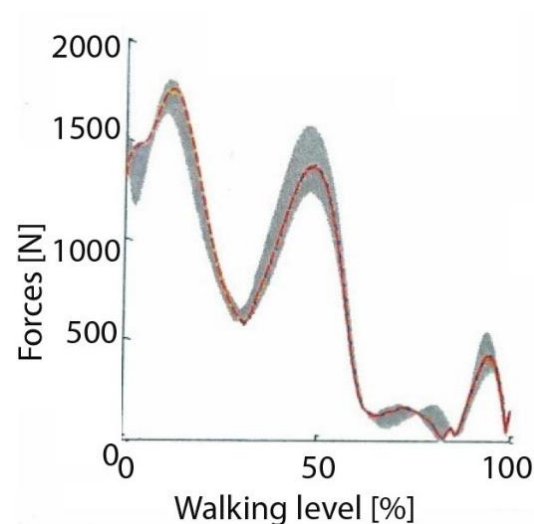
The load on the hip joint was based on the dynamic model and the load on the limb during the gait phase. Two load variants were analysed for the extreme values of the body weight of patients who underwent reimplantation of the damaged artificial joint, i.e.,  $BW_1 = 735$  [N] oraz  $BW_2 = 820$  [N]. The values of forces acting in the hip joint during the phase of walking at a speed of 4 [km/h] were developed on the basis of literature data and their characteristics are shown in Figure 10 [32,33].

**Figure 10.** Values of forces loading the head-acetabular system during human walk [32,33].

The values of the forces loading the artificial cup during the maximum limb load in the gait phase for the patient's weight  $BW_1 = 735$  [N] were:  $P1x = 228$  [N],  $P1y = 419$  [N] and  $P1z = -1646$  [N], while for the patient with  $BW_2 = 820$  [N], the values of the forces were:  $P2x = 254$  [N],  $P2y = 467$  [N] and  $P2z = -1837$  [N].

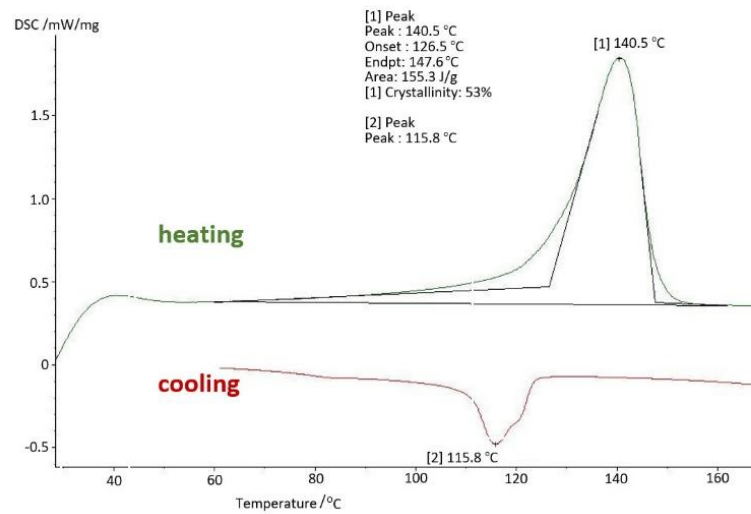
The basic sample was a new acetabulum, never used, not subjected to mechanical and chemical tests. The parameters obtained in the DMTA and DSC tests were the baseline measurements to which the results of the tests of samples used in the human body were compared. The test results for the base sample are shown in Figures 11 and 12.

**Figure 11.** Differential scanning calorimetry (DSC) thermogram—base sample.

On the basis of the carried out research, it was determined that at the temperature of use of the artificial hip joint inside the human body, i.e., about 40 °C, with cyclical loads of 1 Hz close to the speed of the acetabular load during the patient's gait, value of the storage modulus  $E' = 528$  [MPa], and mechanical loss coefficient  $\tan \delta = 0.13$ . The melting point of UHMW-PE was 140.8 °C and the enthalpy of fusion  $Q = 155.3$  [J/g]. The degree of crystallinity of the base sample was  $K = 53\%$ .

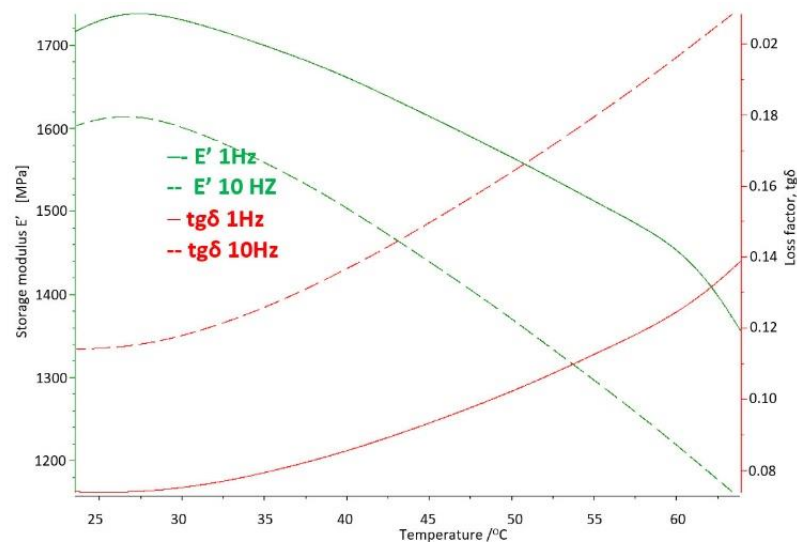
**Figure 12.** DMTA thermogram for the base sample made of UHMW-PE.

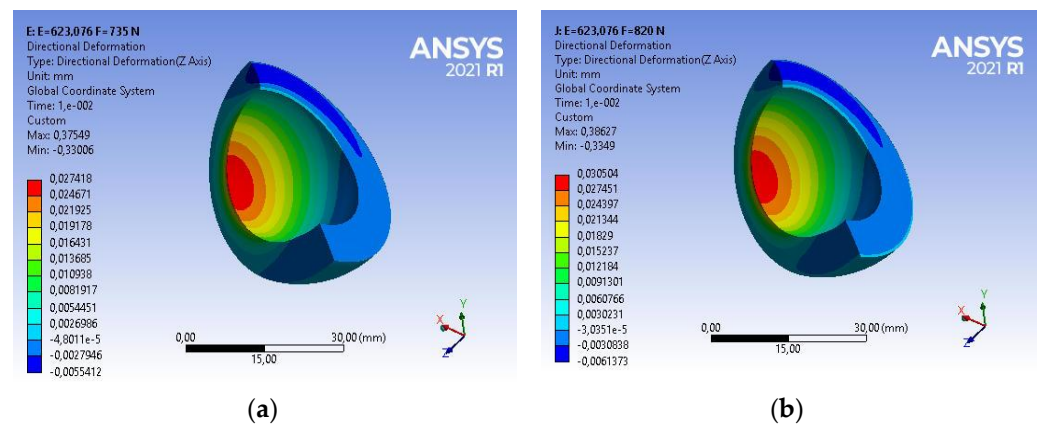
Taking into account the above strength parameters, the state of strains of the base acetabulum was assessed during the gait of patients with the assumed body weight. For a patient with a body weight of  $BW_1 = 735$  [N], the main deformations in the direction of the dominant vertical axis are equal to  $\varepsilon_{z1} = 0.37549$ , as shown in Figure 13a.

The use of this type of acetabulum in a patient with  $BW_2 = 820$  [N] causes a change in the strains state of the acetabulum (Figure 13b). Very good UHMW-PE parameters, i.e., vibration damping or low frictional resistance, will allow for a comfortable course of usage. The main strain in the direction of the dominant vertical axis is in this case  $\varepsilon_{z2} = 0.38627$ , and is greater by about 2% than the strain of the acetabular under the load  $BW_1 = 735$  [N], as shown in Figure 13a.

**Figure 13.** Strains distribution of the base acetabular during patient usage: (a)  $BW_1 = 735$  [N], (b)  $BW_2 = 820$  [N].

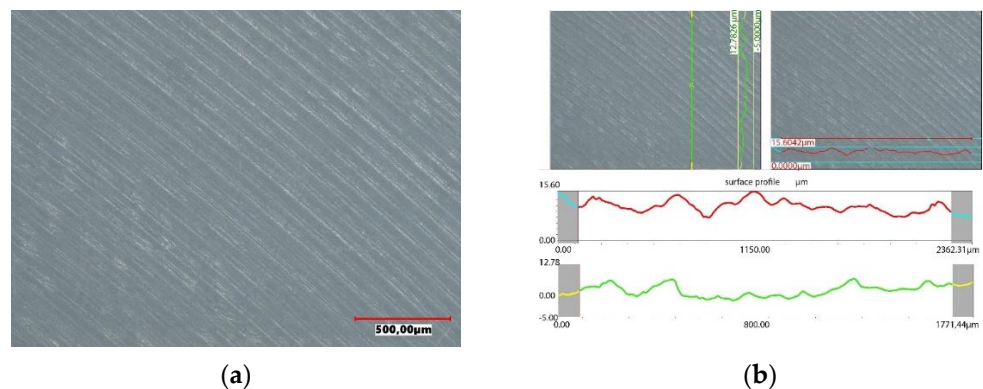
The accuracy of the new polyethylene hip joint cups is very high. The topography of the inner surface of the cup used as a friction node shows only slight traces of unevenness resulting from the machining of the surface, but their roughness does not exceed  $15\text{ }\mu\text{m}$ . The surface topography was assessed using a Keyence VHX-7000 digital microscope. The image of the surface and the roughness profile of the new polyethylene insert is shown in Figure 14.

**Figure 14.** Surface profile of the base acetabular: (a) surface of the cup, (b) surface topography.

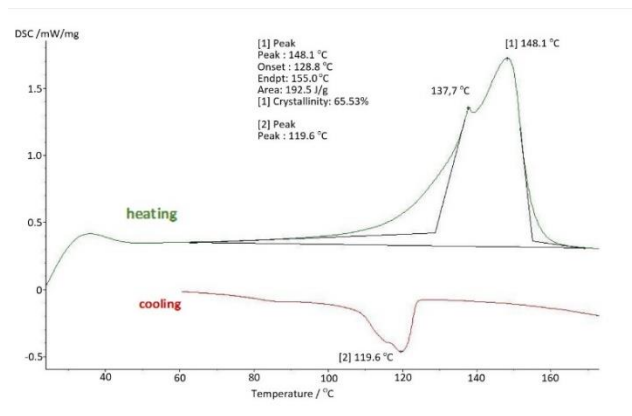
The use of UHMW-PE in the human body for 4 years causes changes in strength parameters and the degree of crystallinity. In comparison with the basic samples, a 23% increase in the degree of crystallinity of the samples was noted to the value of  $K = 65.53\%$  (Figure 15).

**Figure 15.** DSC thermogram: polyethylene used in the body for 4 years.

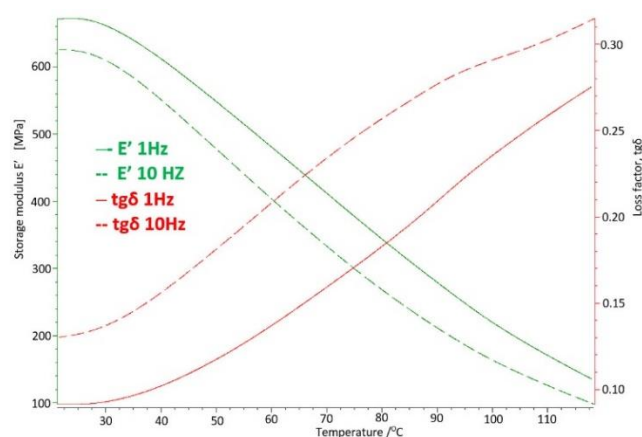
Cyclic fatigue loads and the aggressive environment inside the human body for 4 years caused changes in the strength parameters of UHMW-PE and so for the storage modulus the value increased by about 5.5% to  $E' = 557$  [MPa], while the mechanical loss coefficient increased by about 23% to the value of  $\text{tg}\delta = 0.16$  (Figure 16).

**Figure 16.** DMTA thermogram for polyethylene used in the body for 4 years.

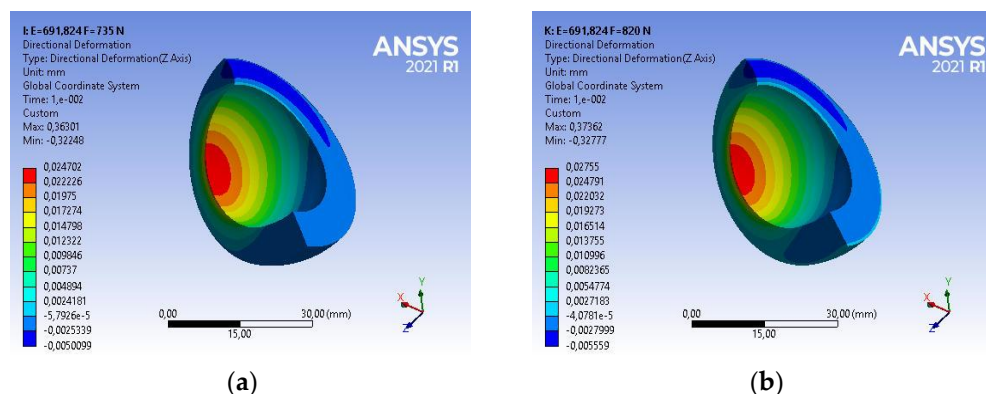
Taking into account the above strength parameters, the strains state of the acetabulum was assessed. For a patient with body weight  $BW_1 = 735$  [N], the main strain in the direction of the vertical axis are, respectively,  $\varepsilon_{z1} = 0.36301$ , while for a patient with  $BW_2 = 820$  [N], the value of strain  $\varepsilon_{z2} = 0.37362$ —in both cases it is about 97% of the base value. The nature and magnitude of the strains are shown in Figure 17.

**Figure 17.** Strains distribution of the acetabular used in the body for 4 years during patient usage: (a)  $BW_1 = 735$  [N], (b)  $BW_2 = 820$  [N].

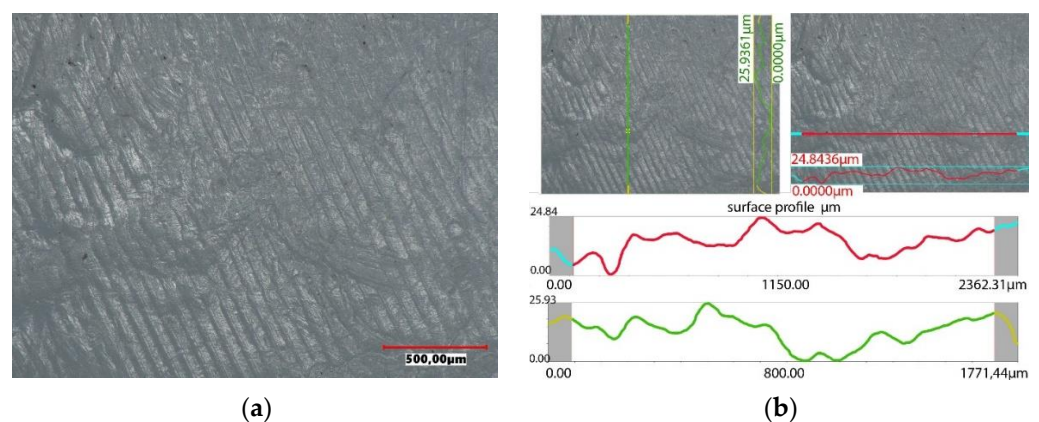
Under the influence of the loads acting on the endoprosthesis, a new accuracy of the contact surfaces is achieved on the surfaces of the artificial joint. The forces acting on the surfaces of the artificial joint are distributed only to the highest peaks of the roughness. Hence, the higher the precision workmanship, the more peaks come into contact with the cooperating joint components. The tops of rough surfaces deform elastically and after exceeding a certain pressure value in combination with frictional resistance, plastic deformation of the peaks occurs, connected with their micro-abrasion, as shown in Figure 18. Assessing the surface topography of the acetabulars used in the human body for 4 years, it was found that during this period the wear process is minimal. On the used surface, small scratches running in the direction of movement of the friction node were observed, however, from the operational point of view, this process can be treated as a matching of a pair of elements cooperating in an artificial bio-bearing. The size of surface roughness does not exceed  $26\text{ }\mu\text{m}$ .

**Figure 18.** Surface profile of the acetabular used in the body for 4 years: (a) surface of the cup, (b) surface topography.

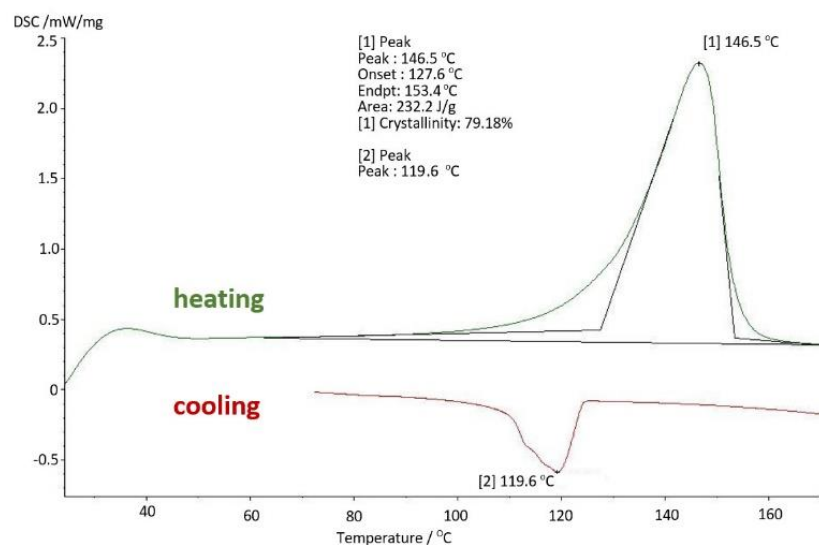
With the extension of the period of use of UHMW-PE inside the body to 8 years, consecutive increase in the strength parameters of the material can be observed. This proves that cyclical dynamic loads resulting from the patient's motor skills and the aggressive environment inside the body gradually degrade the polymer. The degree of crystallinity of the samples is  $K = 79.18\%$ , which in comparison with the basic samples gives a nearly 50% increase in the proportion of the crystalline phase, and in comparison with the samples used for 4 years, this increase is about 20% (Figure 19). The analysed strength parameters of UHMW-PE take the following value: storage modulus  $E' = 1164\text{ [MPa]}$  and the mechanical loss coefficient  $\text{tg}\delta = 0.17$ . The melting point of polyethylene is  $146.5\text{ }^{\circ}\text{C}$ , while the enthalpy of melting  $T_m = 146.5\text{ [J/g]}$  (Figure 20).

Figure 19. DSC thermogram for polyethylene used in the body for 8 years.

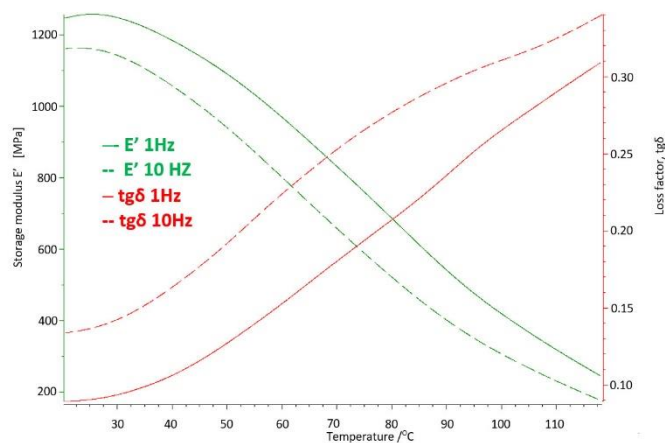
Figure 20. DMTA thermogram for polyethylene used in the body for 8 years.

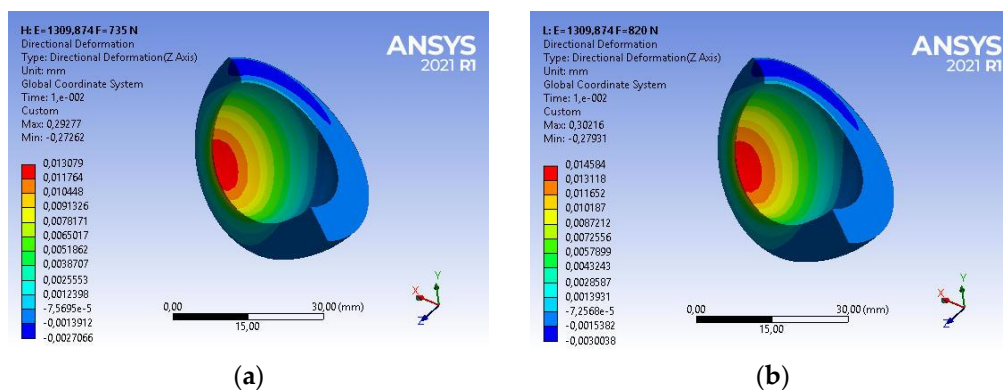
For such strength parameters during loads generated by the patient  $BW_1 = 735$  [N], the main strains UHMW-PE are equal to  $\epsilon_{z1} = 0.29277$  (Figure 21). Compared to the state of strains after 4 years of use, a nearly 20% decrease in strains was recorded.

Figure 21. Strains distribution of the acetabular used in the body for 8 years during patient usage: (a)  $BW_1 = 735$  [N], (b)  $BW_2 = 820$  [N].

Analysing the strain state, taking into account the configuration—patient load  $BW_2 = 820$  [N] and the material parameters of UHMP-PE used inside the body for 8 years, it can be indicated that the main strain in the direction of the vertical axis is 22% smaller than for the base material and is  $\varepsilon_{z2} = 0.30216$ .

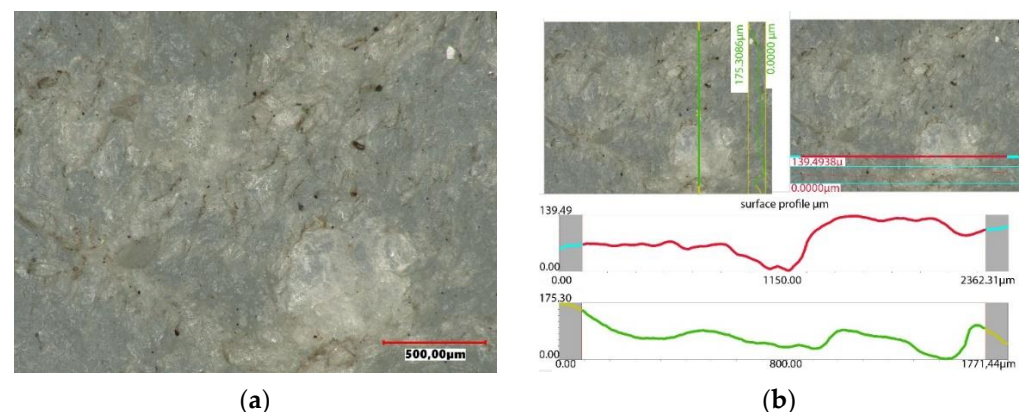
Over the operating time, the degradation of the surface progresses, which causes a change in the topography of the cooperating surfaces (Figure 22). The wear of the implant surfaces is primarily a set of processes taking place in the surface layer of the contact surfaces of the implants, characterised by the loss and displacement of mass and permanent deformation of the surface. In the 8-year period of use, high wear can be observed, characterised by quite deep scratches and the displacement of the UHMW-PE mass towards the main loads. The size of the resulting roughness is large and ranges from 130  $\mu\text{m}$  to 175  $\mu\text{m}$ . It can be assumed that the friction of the head on such a worn surface may generate micro-vibrations transferred to the acetabular and the frictional resistance is many times higher than in the new friction node of the artificial joint.

**Figure 22.** Surface profile of the acetabular used in the body for 8 years: (a) surface of the cup, (b) surface topography.

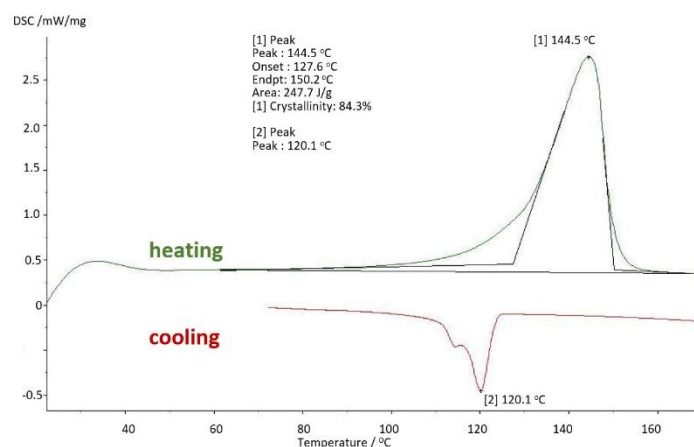
The samples removed from the human body after 10 years of use were characterised by high surface degradation. In the area of maximum loads, a significant change in the shape of the surface was also visible, indicating cold creep of the material. Figures 23 and 24 below show the results of DMTA and DSC studies of a sample removed from the human body after 10 years of use. On the basis of the conducted tests, it is possible to observe a progressive course of changes in strength parameters and an increase in the stiffness of the material. At this stage of usage, it can be concluded that one of the basic functions of the polyethylene cup, which is vibration damping, has ceased to exist. The amount of the crystalline phase reached  $K = 84.3\%$ , the material became brittle, cracks and numerous surface defects of UHMW-PE appeared. The melting enthalpy reached the value  $Q = 247.7$  [J/g].

Figure 23. DSC thermogram for polyethylene used in the body for 10 years.

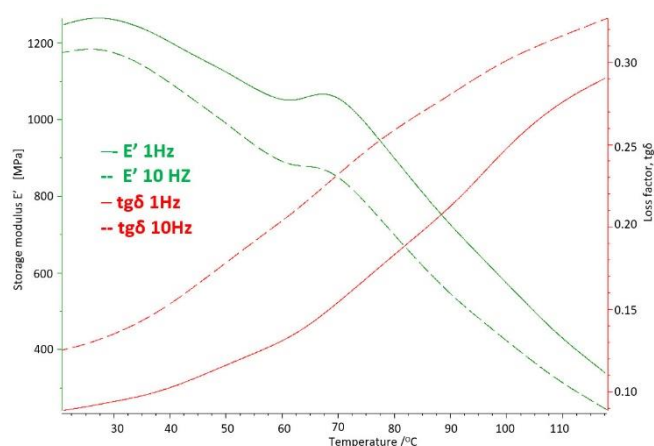
The analysed strength parameters, i.e., the storage modulus is more than twice as high as for the base sample and amounts to  $E' = 1101$  [MPa] and the mechanical loss coefficient equals  $\text{tg}\delta = 0.15$ .

Figure 24. DMTA thermogram for polyethylene used in the body for 10 years.

The above processes confirm the results of DMA tests, where a significant increase in the  $E'$  storage modulus can be observed from about 528 [MPa] for the base sample, to 1101

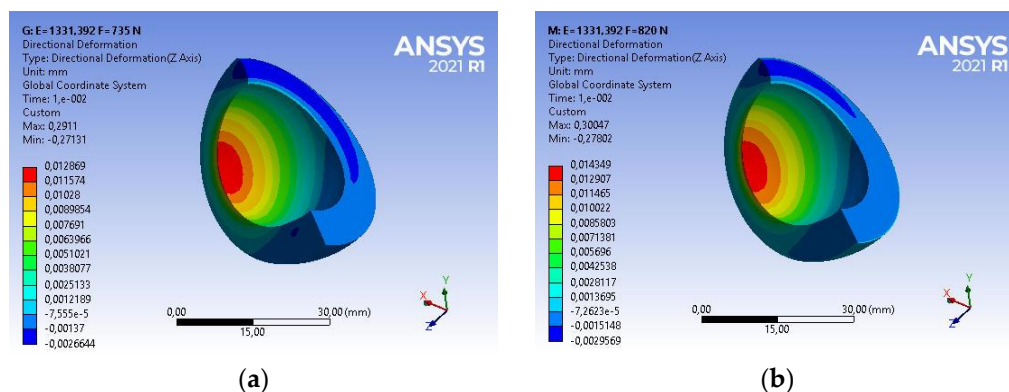
For a material with strength parameters developed on the basis of DMTA and DSC tests, the strains state of the polyethylene cup is presented in accordance with Figure 25.

Figure 25. Strains distribution of the acetabular used in the body for 10 years during patient usage: (a)  $BW_1 = 735$  [N], (b)  $BW_2 = 820$  [N].

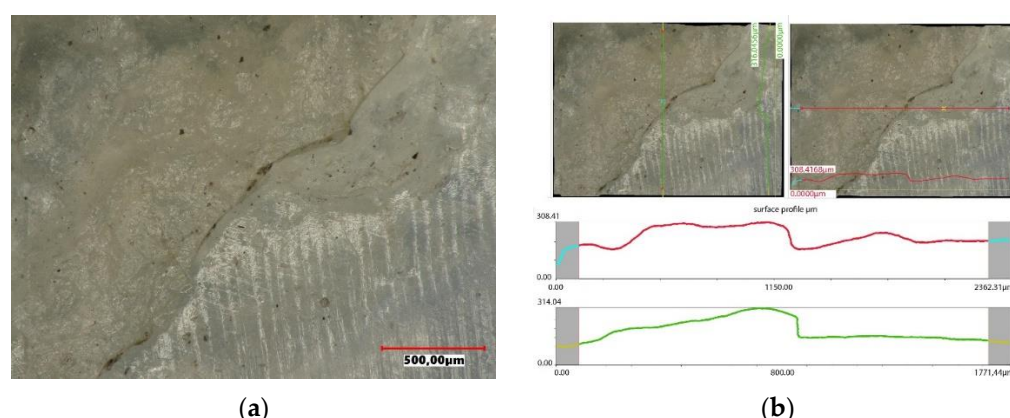
The exploitation of the artificial joint for more than 10 years resulted in ridging and the formation of grooves and deep scratches on the implant surface and the separation of fragments of the UHMW-PE surface layer, which is characteristic of fatigue wear of the surface. The UHMW-PE surface topography is characterised by a significant plastic strain, a change in the shape of the contact surface and the presence of numerous wear products associated with the base surface, as shown in Figure 26. Areas with numerous cracks in the layer and layer build-ups, as well as numerous cracks into the base material, were recorded. The wear of the support layer is very high, which leads to an increase in the migration of wear products into the body and a perceived discomfort and pain not only during usage, but also at rest.

**Figure 26.** Surface profile of the acetabular used in the body for 10 years: (a) surface of the cup, (b) surface topography.
