Article

Evaluation of Selected Accelerated Above-Ground Durability Testing Methods for Wood after Ten Years Exposure

Scion, 49 Sala Street, Rotorua 3010, New Zealand; dave.page@scionresearch.com

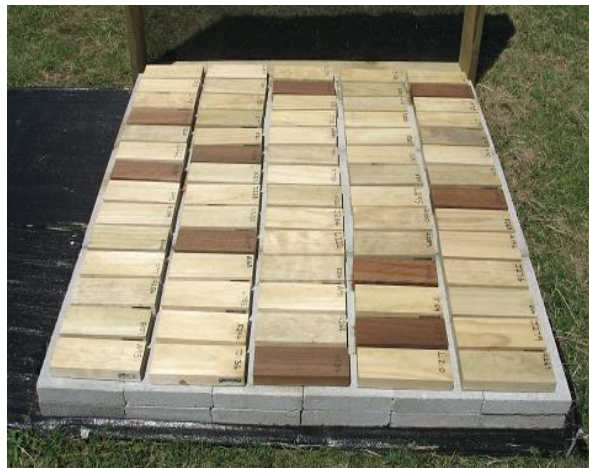
Figure 1. Ground proximity test at installation with the shade-cloth and frame removed. The samples are placed on two layers of 40 mm thick pumice slabs with plastic weed mat underneath.

The dimensions of test specimens were 75 × 25 × 200 mm. The test method was as described by Archer et al. [23]. Test specimens were laid flat on top of two layers of 40 mm thick concrete blocks with a sheet of plastic “weed cloth” between the concrete blocks and the ground. The specimens were randomly arranged in five rows with about 10 mm gaps between samples on all sides. A 150 mm deep wooden frame covered with shade cloth was placed over the whole assembly (Figure 1).

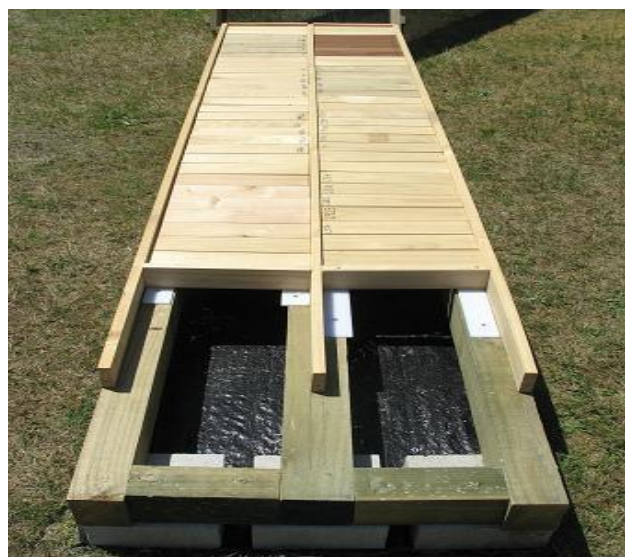
Figure 2. Double layer test at installation. 100 mm square bearers supported on concrete blocks with plastic weed cloth underneath. The plastic strips between the samples and bearers were removed after a few weeks exposure. The batten along the centre was untreated pine, those on the outside were H3 treated. The whole assembly was surrounded by a 300-mm-deep frame covered with shade cloth.

The dimensions of test specimens were $75 \times 25 \times 300$ mm, which was different to the recommendation by Rapp and Augusta [24], to minimise the variation in test specimen sizes in this comparative trial. A plastic weed mat was placed on the ground and three rows of 90-mm-thick concrete blocks were placed on top of that. Three 100-mm-deep copper-chrome arsenate (CCA)-treated bearers were placed on the blocks. A 70×25 mm untreated pine strip was fixed on edge along the centre of the central bearer, while 70×25 mm H3.2 (Hazard Class H3.2, NZS 3640: 2003) [25]-treated strips were fixed along the outer edge of the outer bearers. Samples from each treatment group were in two layers, with five samples in the one layer, six in the other and samples overlapping those in the other layer by half the sample width. The samples were in close contact with untreated pine samples separating the treatment groups. One end of each sample was in contact with the central untreated strip, while the other end was in contact with the outer H3.2-treated strip (Figure 2). The whole assembly was surrounded by a 300-mm-deep frame covered with shade cloth;

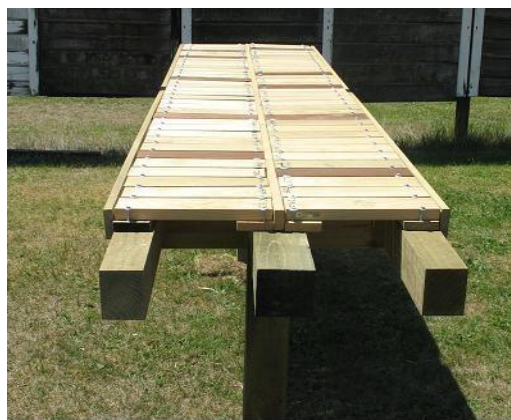
Figure 3. Raised decking test at installation showing treated bearers and battens at the outer ends of the samples and untreated bearers plus separating strip in the centre. For the ground-level decking test, the treated bearers were placed directly on the ground, but other details were the same as for raised decking.

The 1-m above-ground decking sample sizes and set up was like ground-level decking, except for the 1-metre test the bearers were supported on posts 1 metre above the ground in the same grassed area (Figure 3);

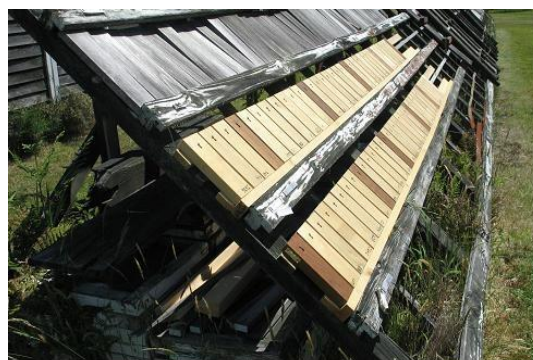
Figure 4. Flat panel test after installation. The upper rail holding the screws is H3-treated radiata pine. The lower L-shaped rail is untreated radiata pine.

A standard flat panel test was set up as described in AWPC (2015) [26]. The dimensions of test samples were $75 \times 25 \times 200$ mm. They had a keyhole-shaped slot cut in them close to one end. They were exposed on 45° sloping racks, facing north. The samples were randomly arranged in two rows, resting on an H3.2-treated batten at the upper end and on an L-shaped untreated pine support at the bottom end. A screw through the keyhole slot fixed the samples to the upper batten (Figure 4).

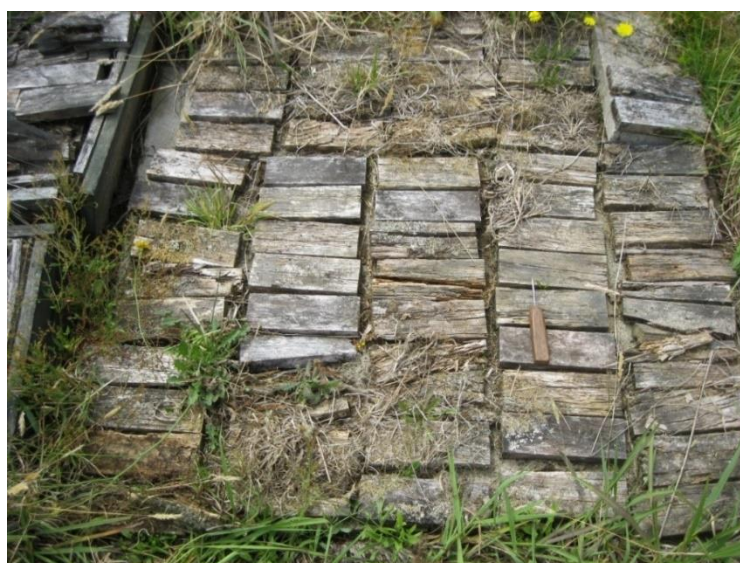
Figure 5. Ground proximity test after 10 years exposure. The samples were originally covered with shade cloth but this was damaged and debris from mowing the surrounding grass supported vegetation growth between and on samples. Most of the samples, including preservative-treated, ones were in poor condition.

The conditions produced by the various types of exposure were quite different. Ground level decking tests and flat panel tests are standard above-ground testing methods used in the assessment of wood preservatives in the Australasian Wood Preservation Committee's protocols [26]. The ground proximity test originally produced damp, close-to-ground contact conditions on the underside of the samples, but relatively dry conditions on the upper-side, except during rainy periods (Figure 1). The samples had originally been protected by shade cloth, but this had largely gone by the ten-year assessment, which allowed wind-blown debris to collect on the upper surface and in the gaps between samples. Samples were on-concrete paving slabs with weed-mat underneath, as per the original installation (Figure 5).

The loss of part of the shade cloth cover over the ground proximity test allowed windblown and other debris, such as grass clippings, to collect on the surface and in the spaces between samples over the six years from the four to ten-year assessments. This supported some vegetation growth and would have increased the decay hazard. This problem also occurs with the existing ground level decking test method, where debris collects on samples, and on the bearers between samples vegetation often grows up between samples also. This also occurs to some extent in exterior building structures such as decks. In accelerated tests, the protection of the samples with shade cloth reduces the decay hazard likely to develop during the service life of normal exterior components. In this test, loss of the shade cloth cover, while resulting in the decay hazard increasing more than if the shade cover had remained in place, was not considered to negate the results from the ground proximity test. Furthermore, the ground proximity test gave meaningful results after four years and it would not be necessary to carry the tests for ten years.

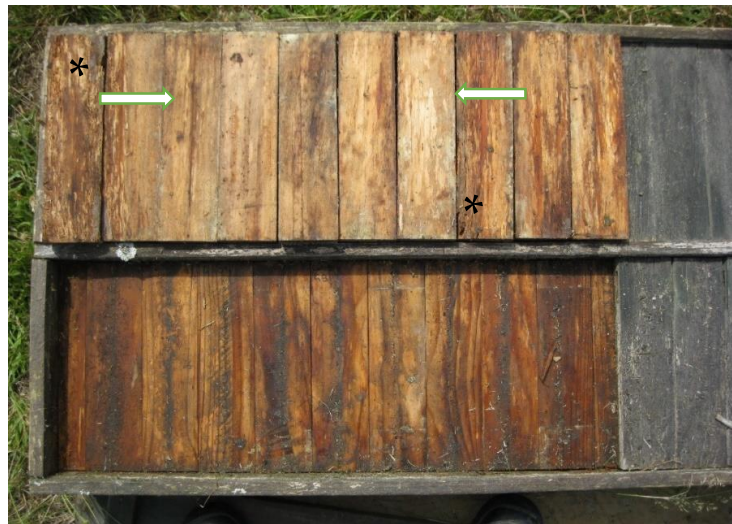
Figure 6. Double layer test after 10 years exposure. The upturned samples 3rd–7th from left, upper row) are copper-chrome arsenate (CCA)-treated (between two arrows), all others are untreated controls. The upper surface of the second layer opposite in the lower row is the same treatment. Note that there is very little decay in the CCA treated samples but there is severe decay in all of the untreated samples (examples of visible decay are indicated by asterisk * symbol).

In the double layer test, the shade cloth cover was still largely intact. Samples were all very wet and slimy, close to saturated, although the upper side of the top layer was relatively dry (Figure 6). The close contact between samples and the surrounding timber/shade cloth protection prevented surfaces from drying rapidly after rain.

The very high moisture content in the double-layer test, even when climatic conditions were very dry, clearly reduced the activity of some decay fungi. Only a few of the control and HFK-treated samples had completely failed after ten years. Resistance to decay in the CCA-treated samples was better than the spotted gum because a small amount of soft rot and some white rot had developed on the spotted gum samples. While the other three preservative-treated groups showed similar resistance to decay, Azoles were slightly better than ACQ, which was better than TBT.
