# Water Saving in CSP Plants by a Novel Hydrophilic Anti-Soiling Coating for Solar Reflectors

**Abstract:** In this work, results of the outdoor exposure campaign of a newly developed hydrophilic anti-soiling coating for concentrated solar thermal power (CSP) mirrors are presented. The material was exposed for nearly two years under realistic outdoor conditions and the influence of two different cleaning techniques was evaluated. Mirror samples were analyzed during exposure and their reflectance and cleanliness were measured. The performance of the anti-soiling coated mirror samples was compared to conventional uncoated silvered-glass mirrors. The coatings showed appropriate anti-soiling and easy-to-clean behavior, with a mean cleanliness gain of 1 pp and maximum values under strong soiling conditions of up to over 7 pp. Cleanliness of the coated samples stayed higher throughout the whole campaign before and after cleaning, resulting in lower soiling rate compared to the reference material. Taking into account these values and supposing a threshold for cleaning of 96%, the number of cleaning cycles could be decreased by up to 11%. Finally, the coated material showed negligible deg

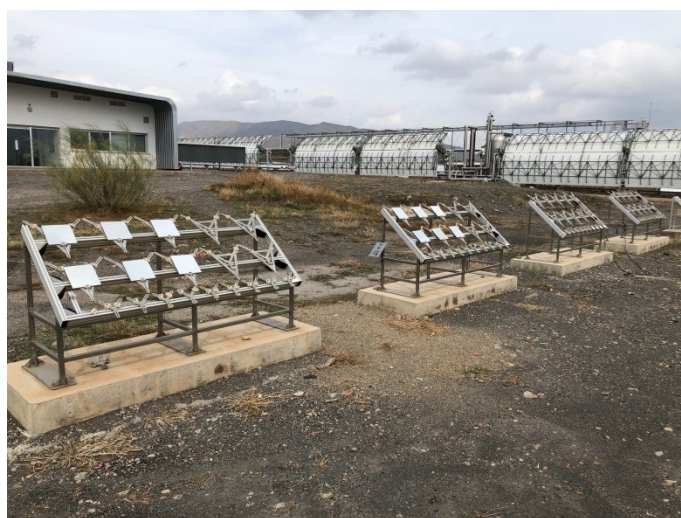
**Figure 1.** Exposure racks with mirror samples installed in south direction at the Plataforma Solar de Almería (PSA) facilities.

Six 4 mm silvered-glass reflector samples with dimensions of 20 cm × 40 cm, developed by IK4-Tekniker and Rioglass, were installed at the PSA from 25 October, 2017 until 31 August, 2019 comprising a period of nearly two years. These samples are divided into two parts, one of which is covered with a hydrophilic anti-soiling coating while the other one does not have the coating layer. The reflectors were exposed on two metallic racks with a tilt of 45 degrees in south direction (see Figure 1).

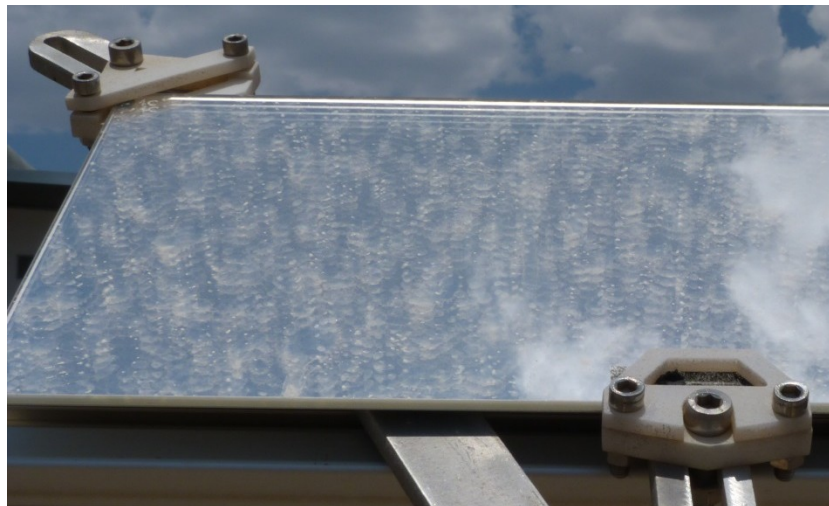
**Figure 3.** Sample surface after a strong soiling event, showing an inhomogeneous soiling pattern.
